ATLAS Stage 3 – ATLAS Pre-clearance Survey Report The Peaks South (WPA22A)

Prepared for:
Senex

Report issued:
August 2024

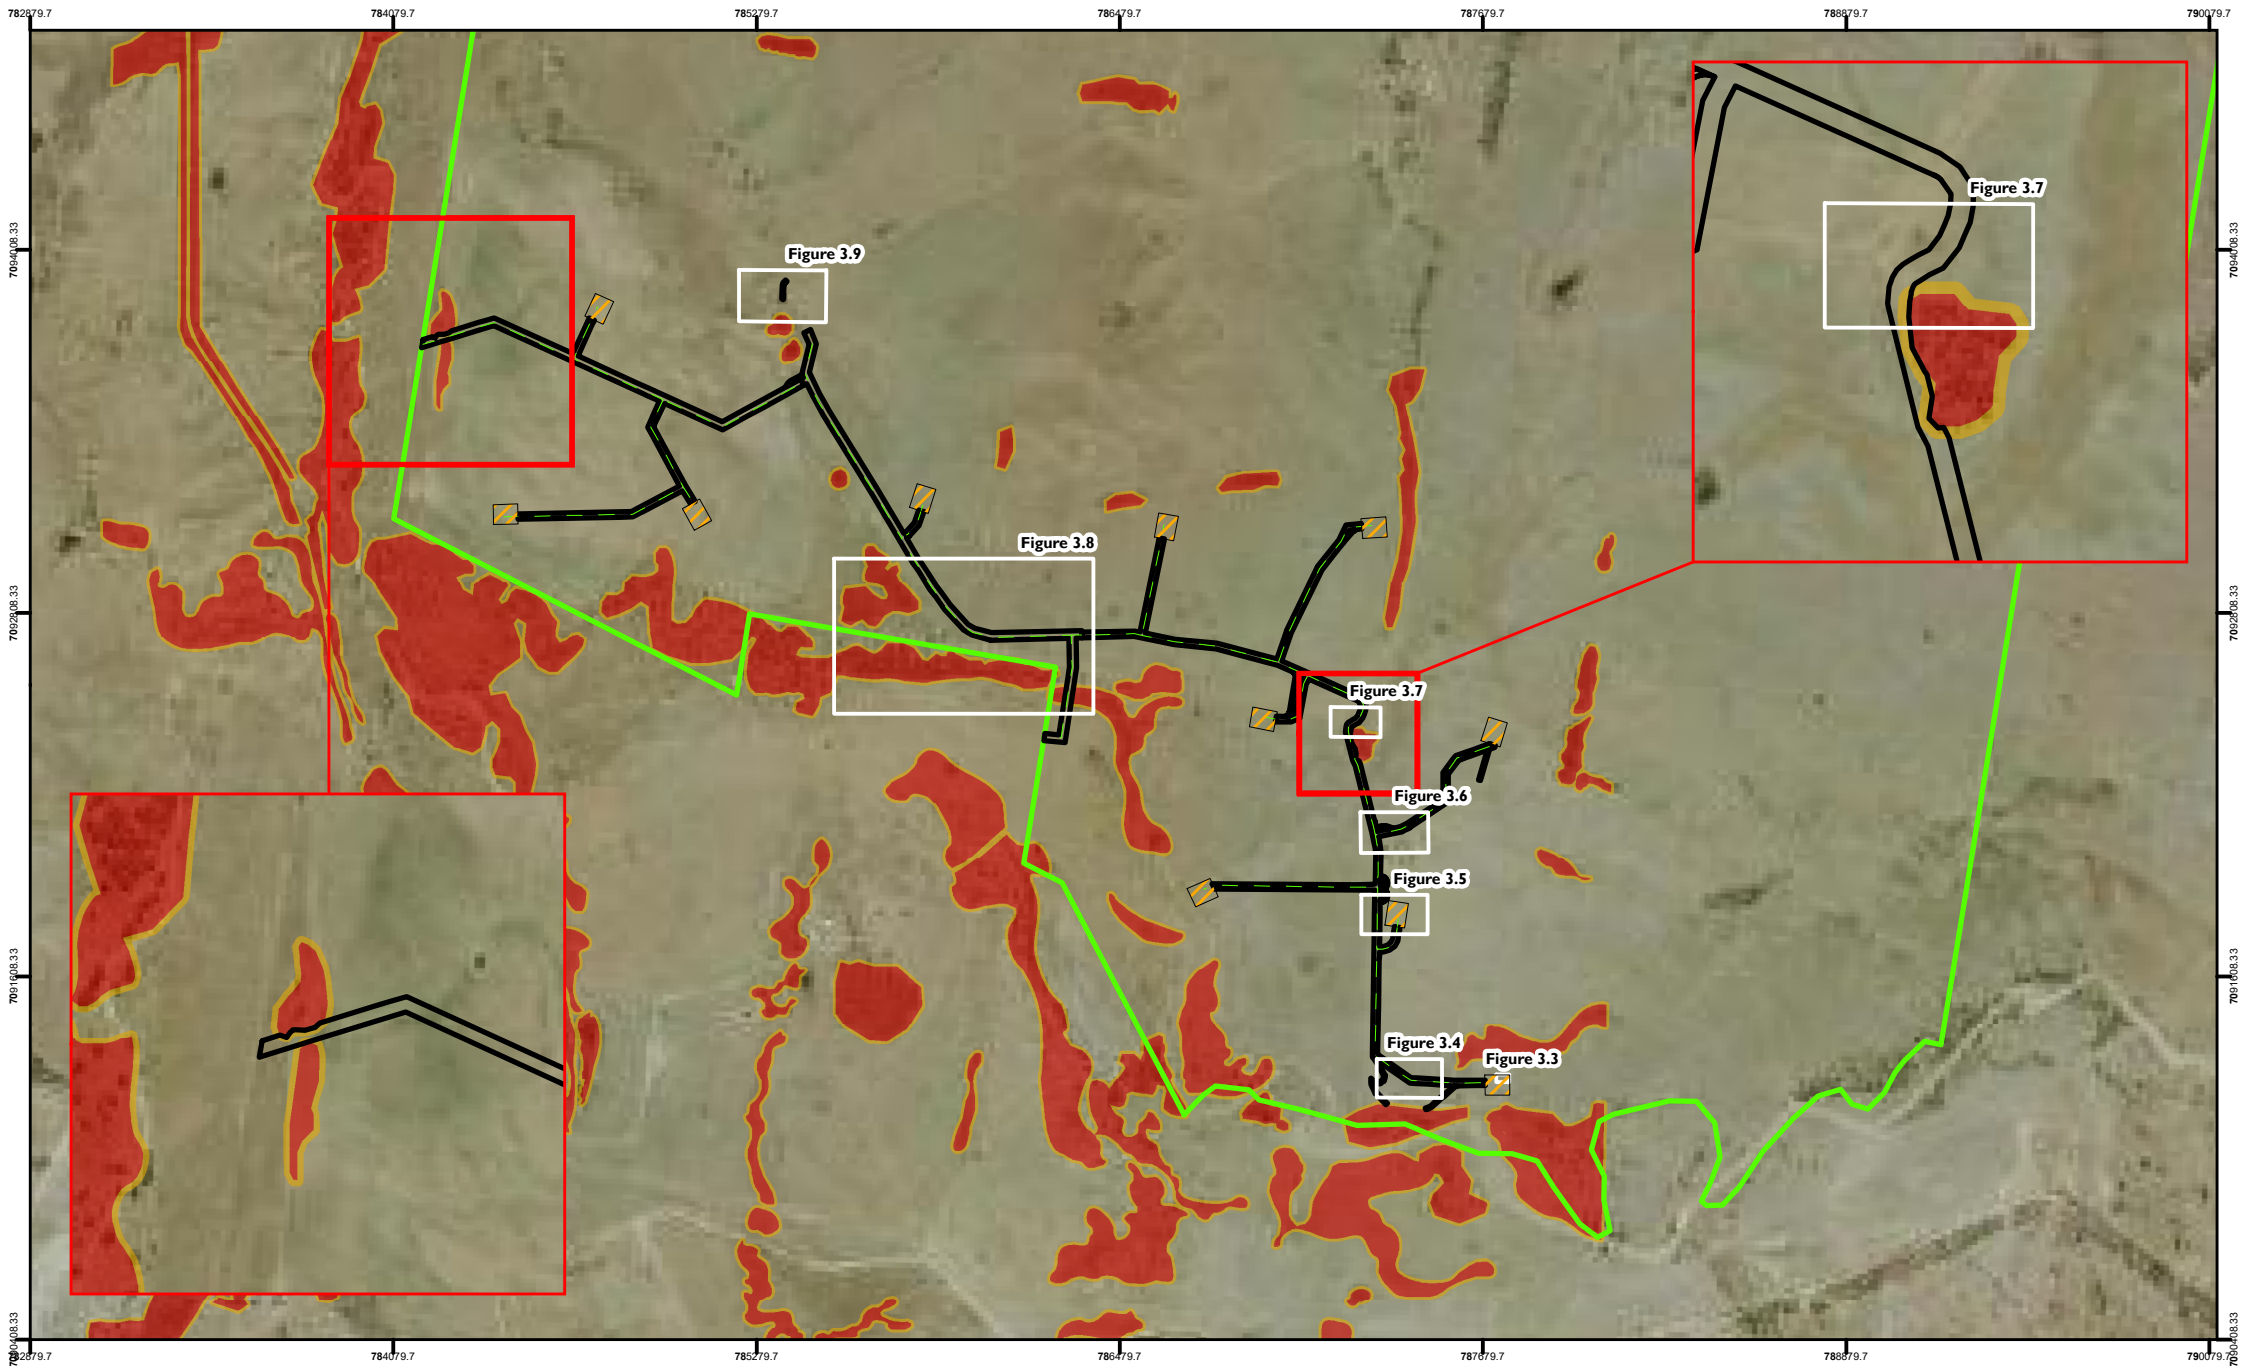
FIGURE 2-2:
Desktop and Ground-Truthed
Koala Dispersal Habitat Verification
The Peaks South

- ▬ The Peaks Property Boundary
- Proposed Wellpads
- No Go Area
- High Constraint Area
- ▬ Proposed Gathering Lines
- Map Extents

An Ausecology principal ecologist (Suitably qualified) and ecologist conducted field surveys on foot on the 6th of July 2024 with the Senex construction team to determine any further impacts not already identified to be avoided by re-aligning gas gathering, access tracks and well pads. The area surveyed and mapped in this report include The Peaks South property as shown in **Figure 2-1**.

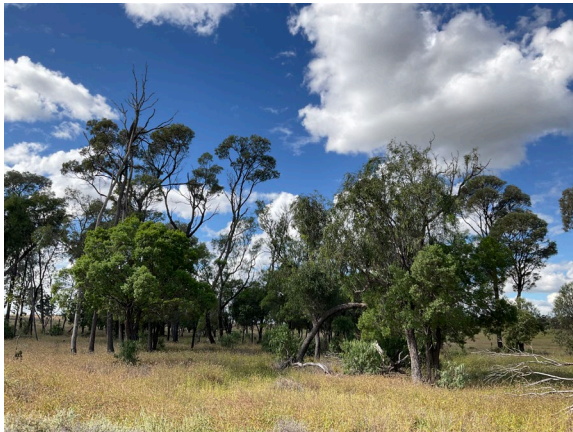
Figure 3-1 Patches of *Acacia* regrowth that will be avoided

The “The Peaks” property has been historically cleared for cattle grazing and is dominated by cleared pasture lands with some native but mainly introduced pasture grasses, with scattered patches of remnant and regrowth woodlands. Individual and small patches of paddock trees of various ages and species were scattered across cleared pastures (Figure 3-1 and Figure 3-2).

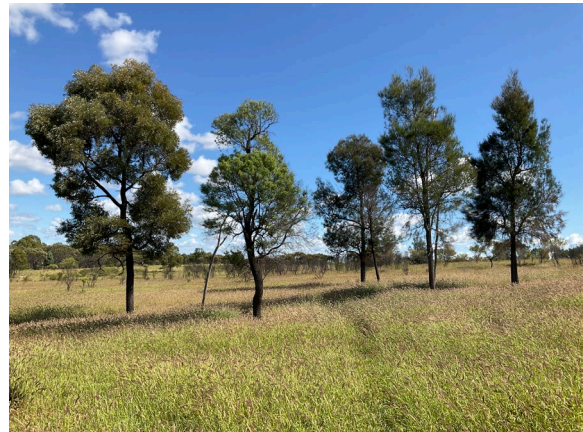
Figure 3-2 Fragmented brigalow/belah paddock trees

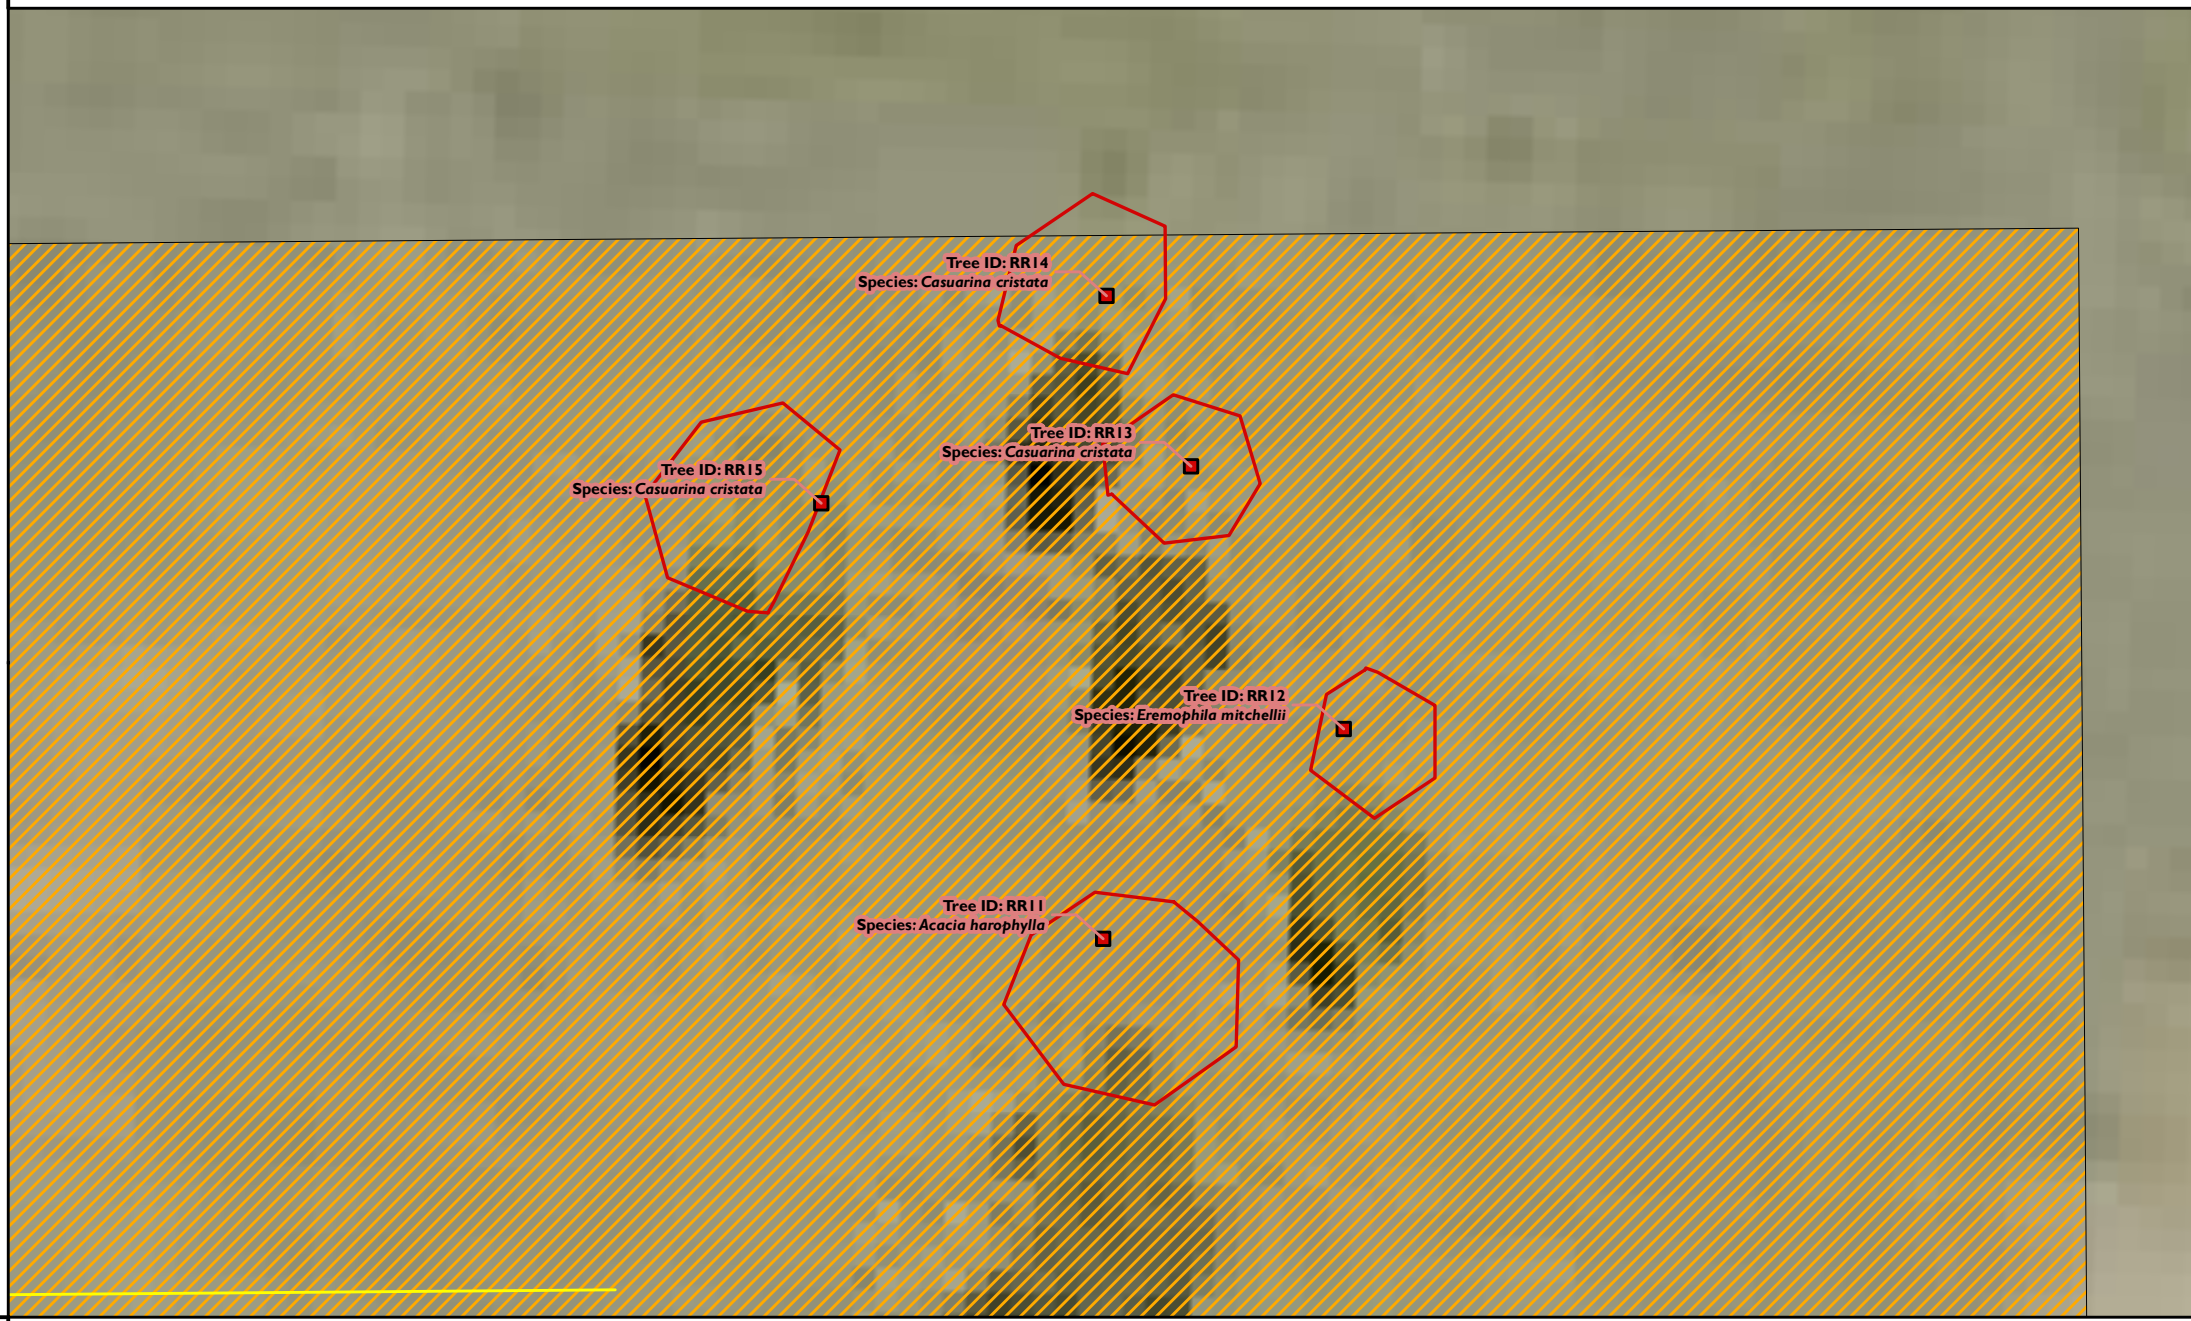
Figure 3.3:
 Desktop and Ground-Truthed
 Koala Dispersal Habitat Verification
 The Peaks South

- Proposed Gathering Lines
- Proposed Wellpads
- Ground-Truthed Tree Centrepoint
- Dripline Extent
- Remove
- Remove

Table 3-1 provides the results including canopy cover, height and DBH of the trees assessed in the field in koala dispersal areas. All trees were assessed and where determined they could be avoided (through underground boring or realignment) they have been marked up as “retain” and will be avoided during construction. Trees unable to be avoided have had their canopy cover assessed and calculated under disturbance limits. Mapping of each location (Desktop ID) are shown in Figure 3-3 to Figure 3-9.

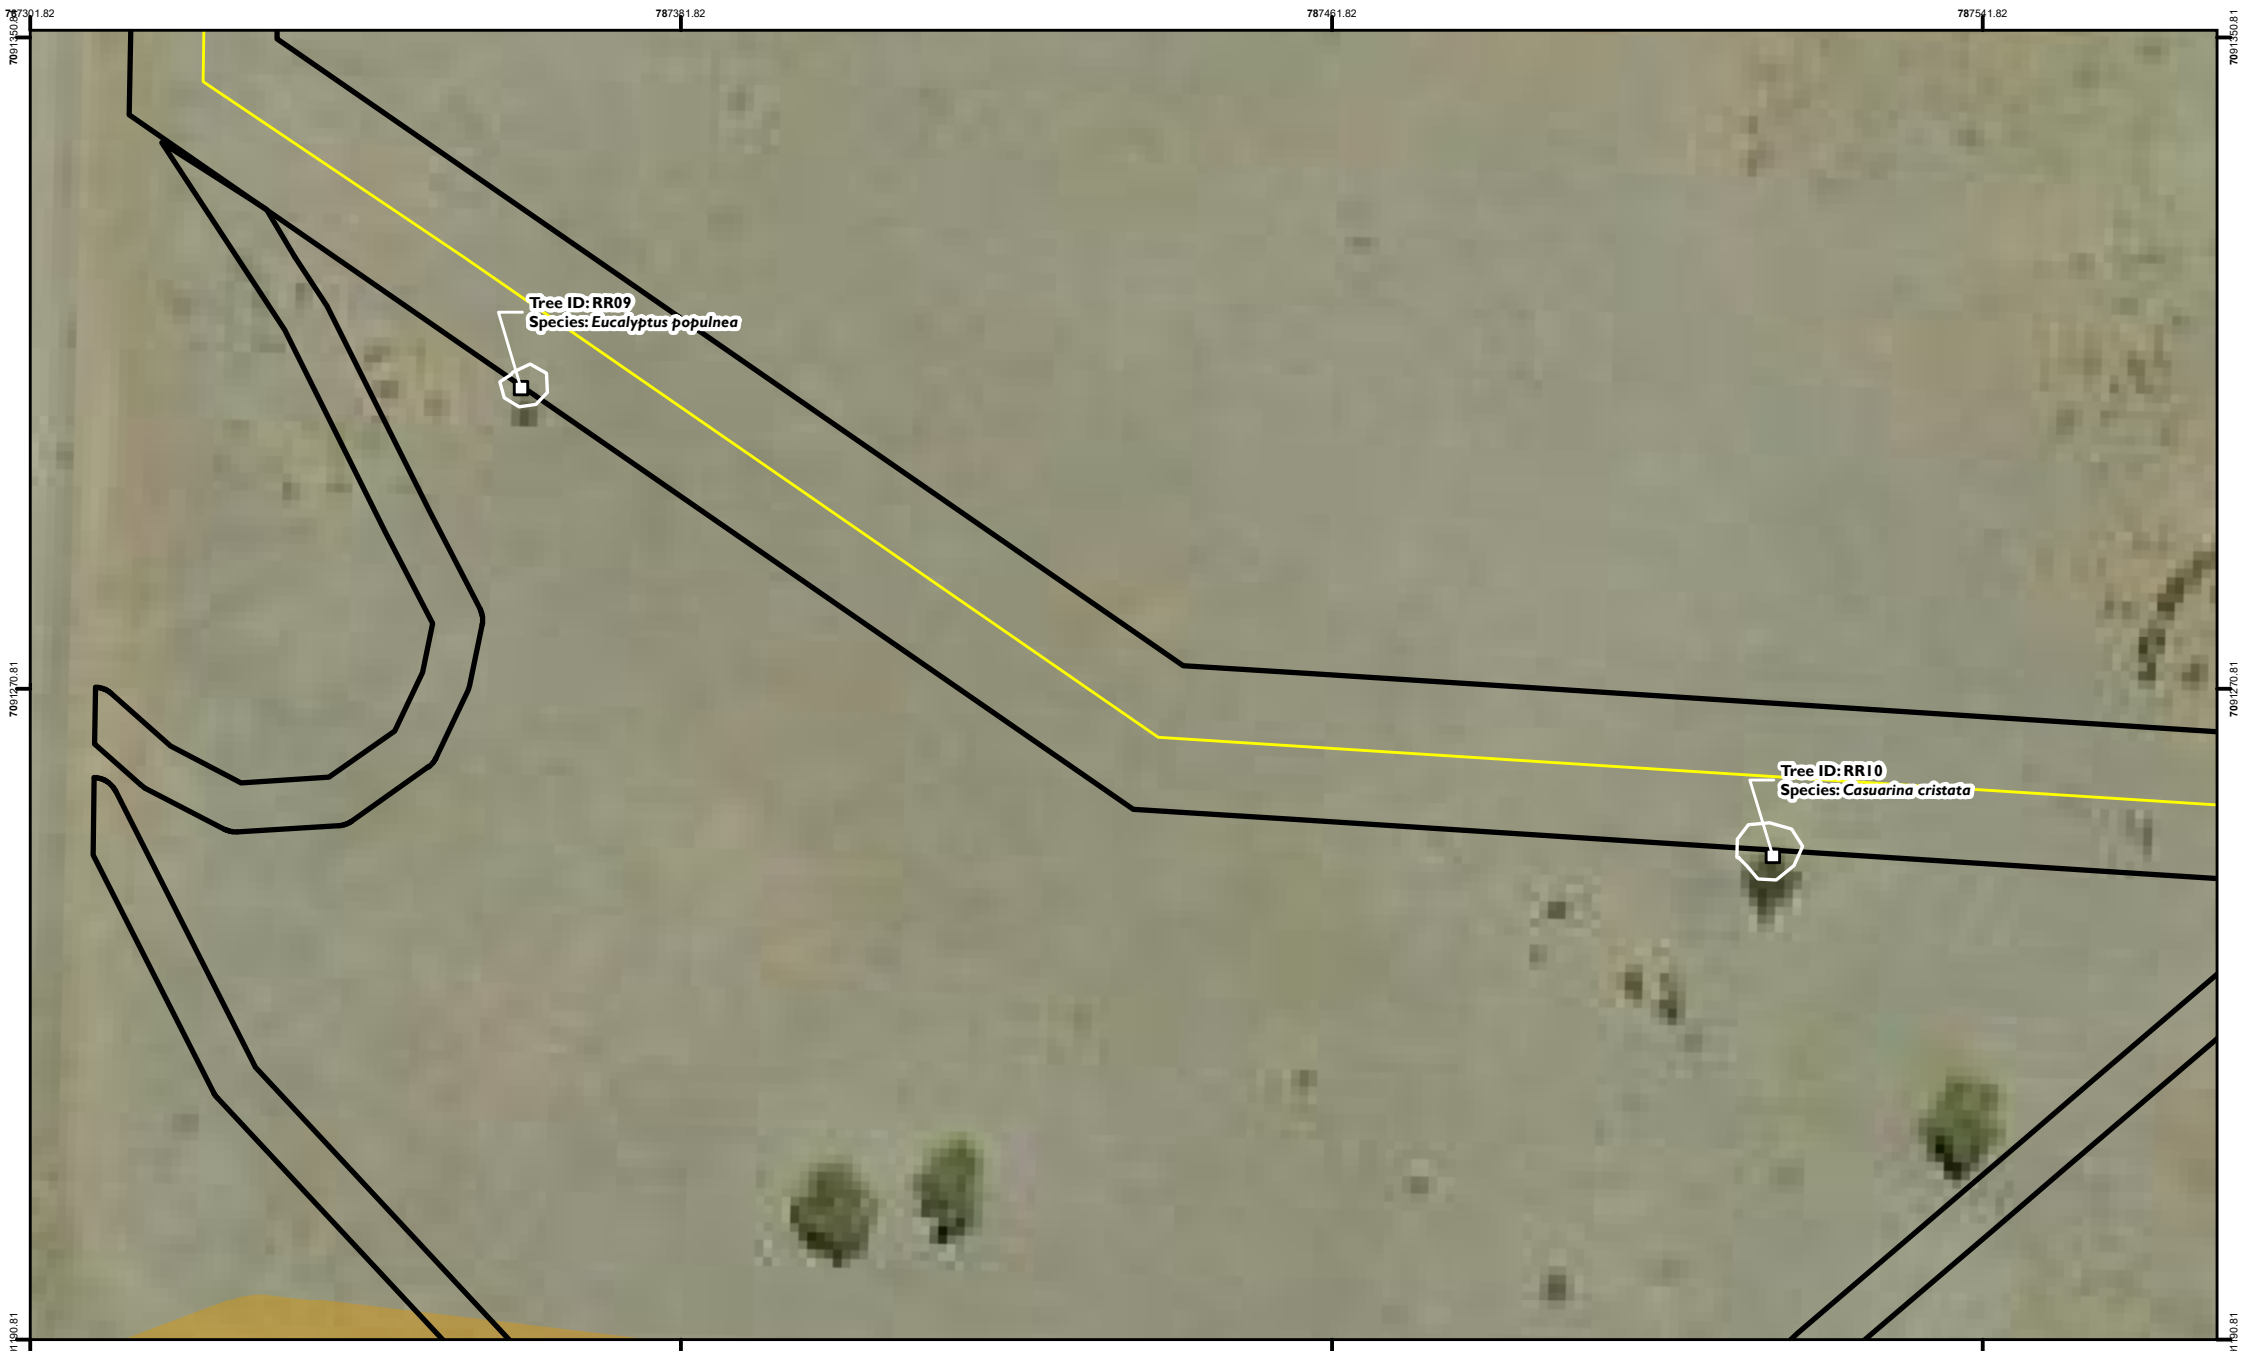
Figure 3.4:
Desktop and Ground-Truthed
Koala Dispersal Habitat Verification
The Peaks South

- Ground-Truthed Tree Centrepoint**
- Retain
- Dripline Extent**
- Retain

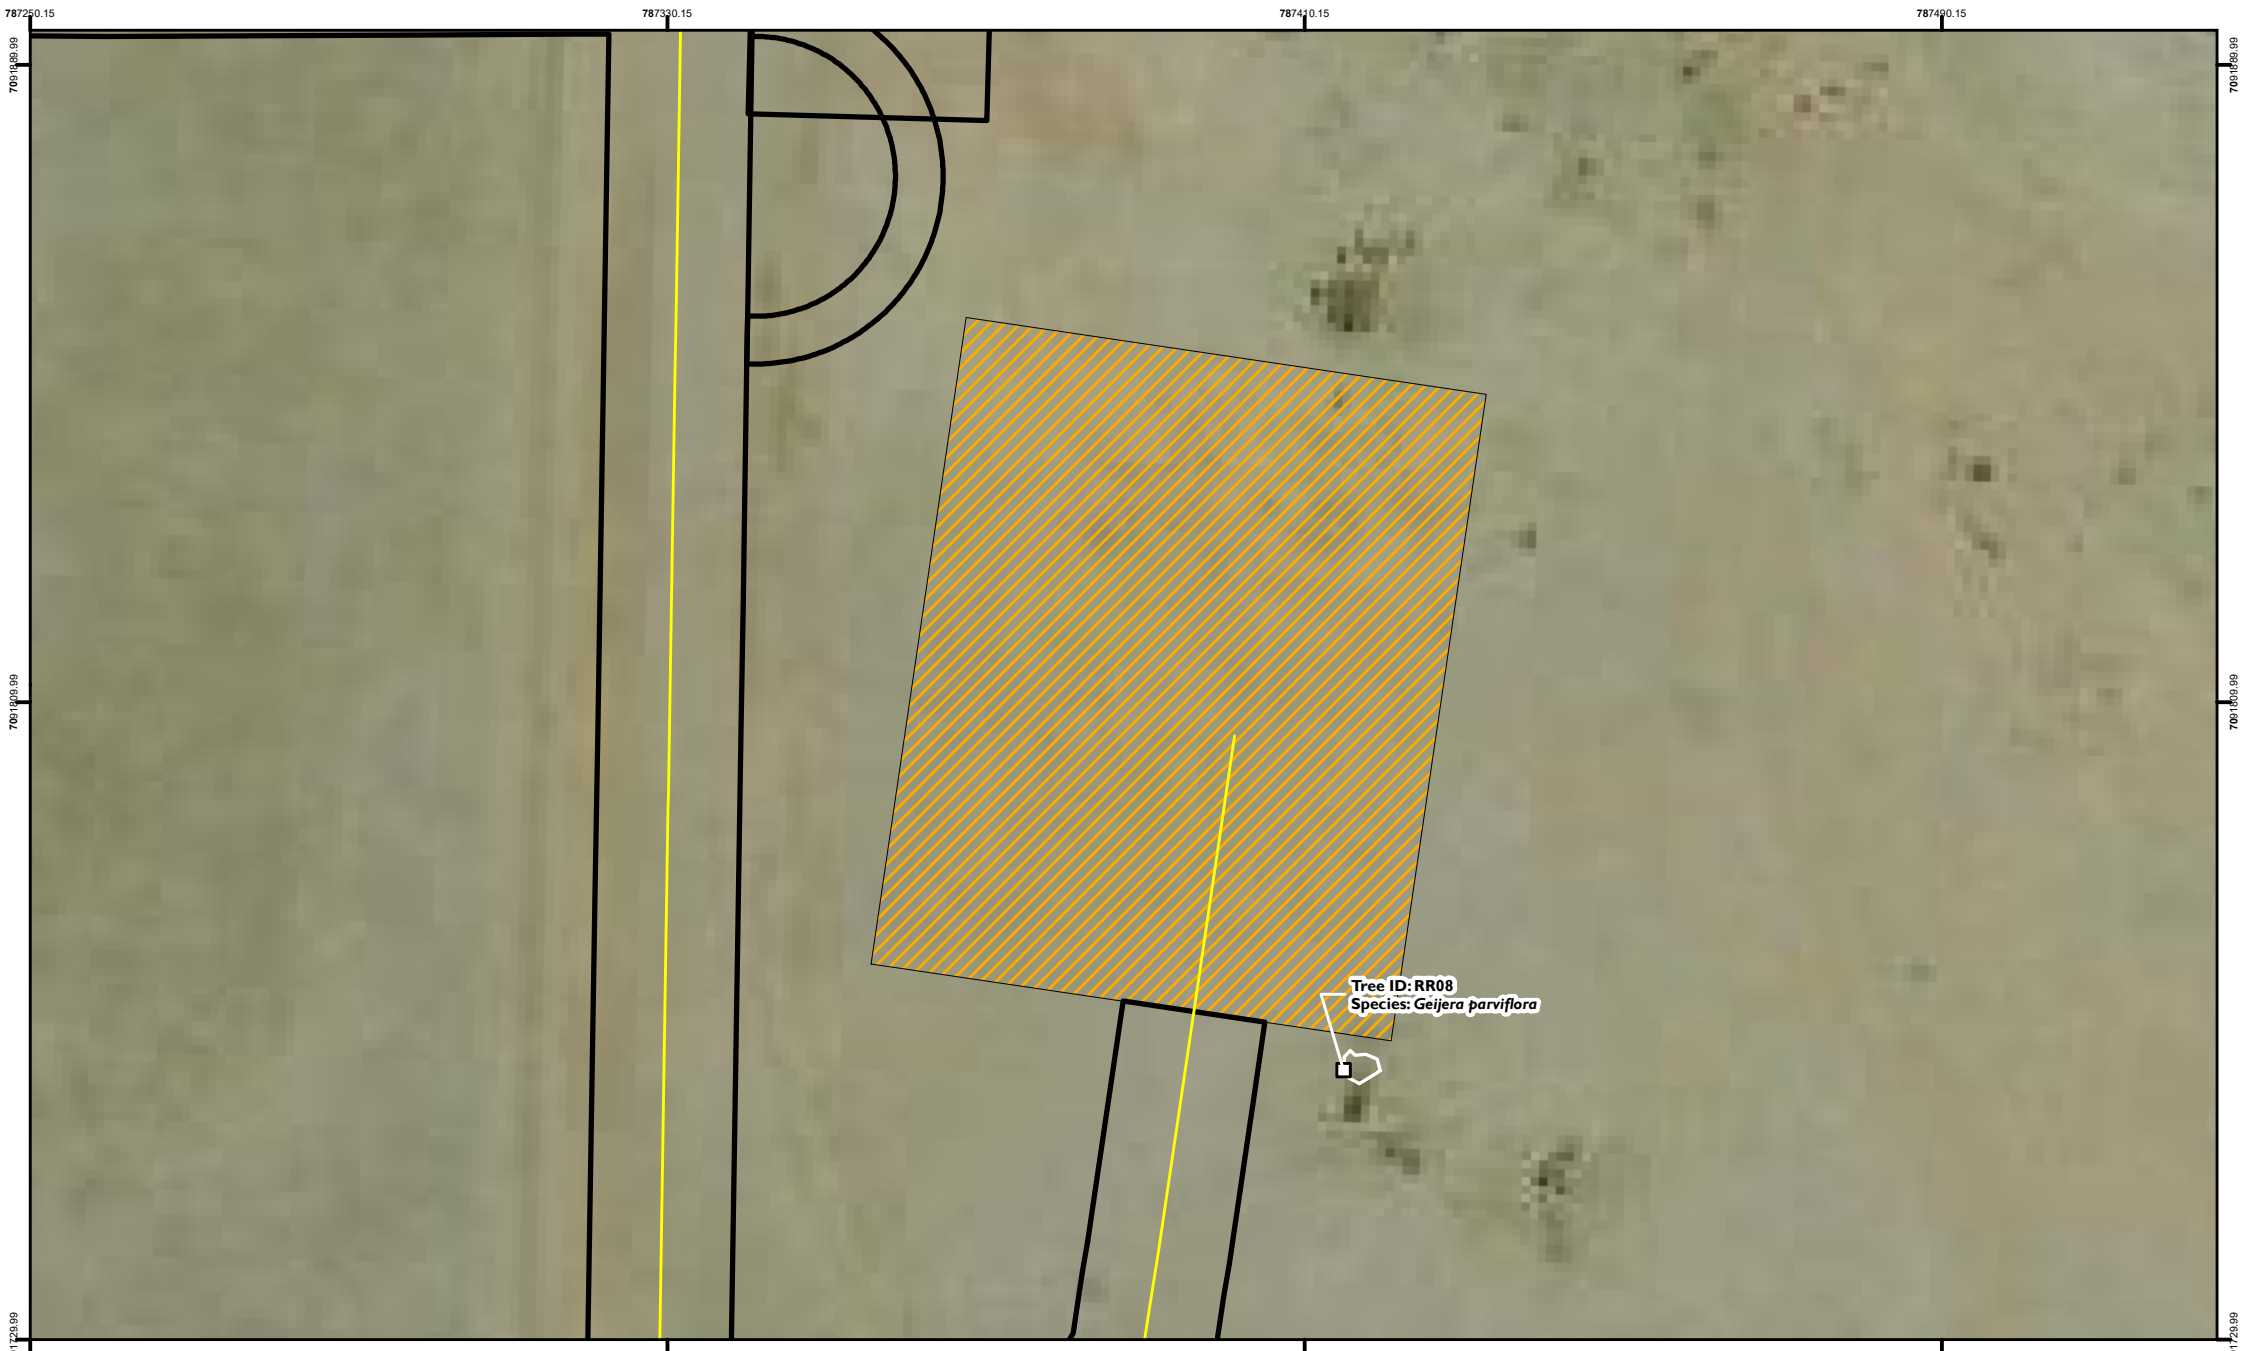
Figure 3.5:
Desktop and Ground-Truthed
Koala Dispersal Habitat Verification
The Peaks South

Tree ID: RR08
Species: *Geijera parviflora*

- Ground-Truthed Tree Centrepoint**
- Retain

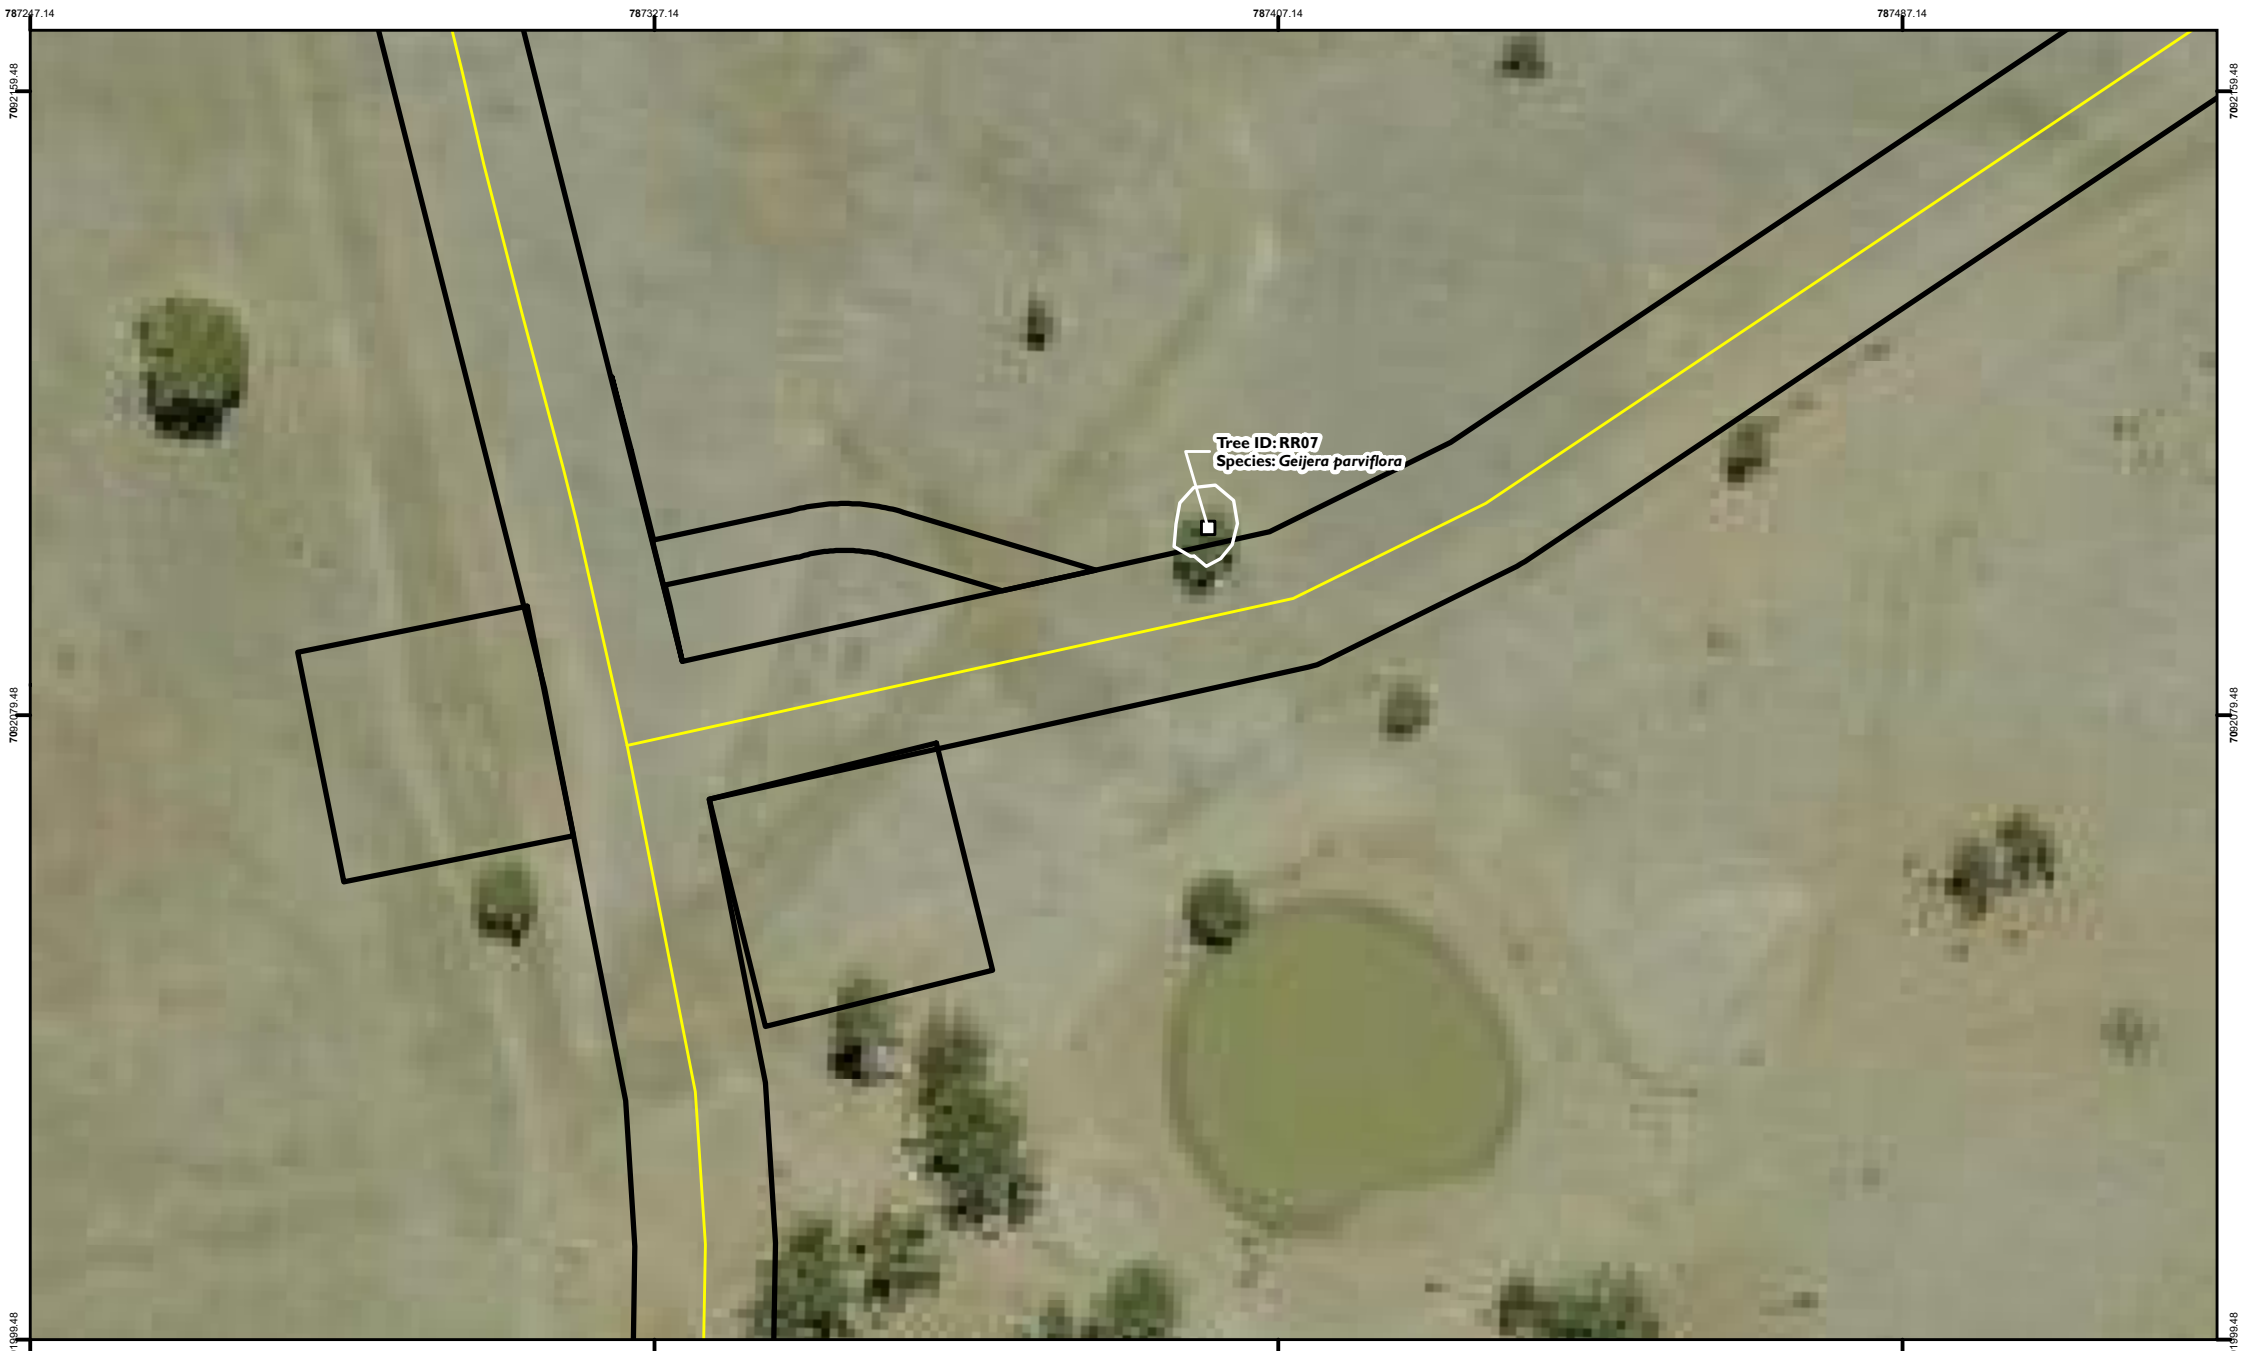
Figure 3.6:
Desktop and Ground-Truthed
Koala Dispersal Habitat Verification
The Peaks South

- Ground-Truthed Tree Centrepoint**
- Retain

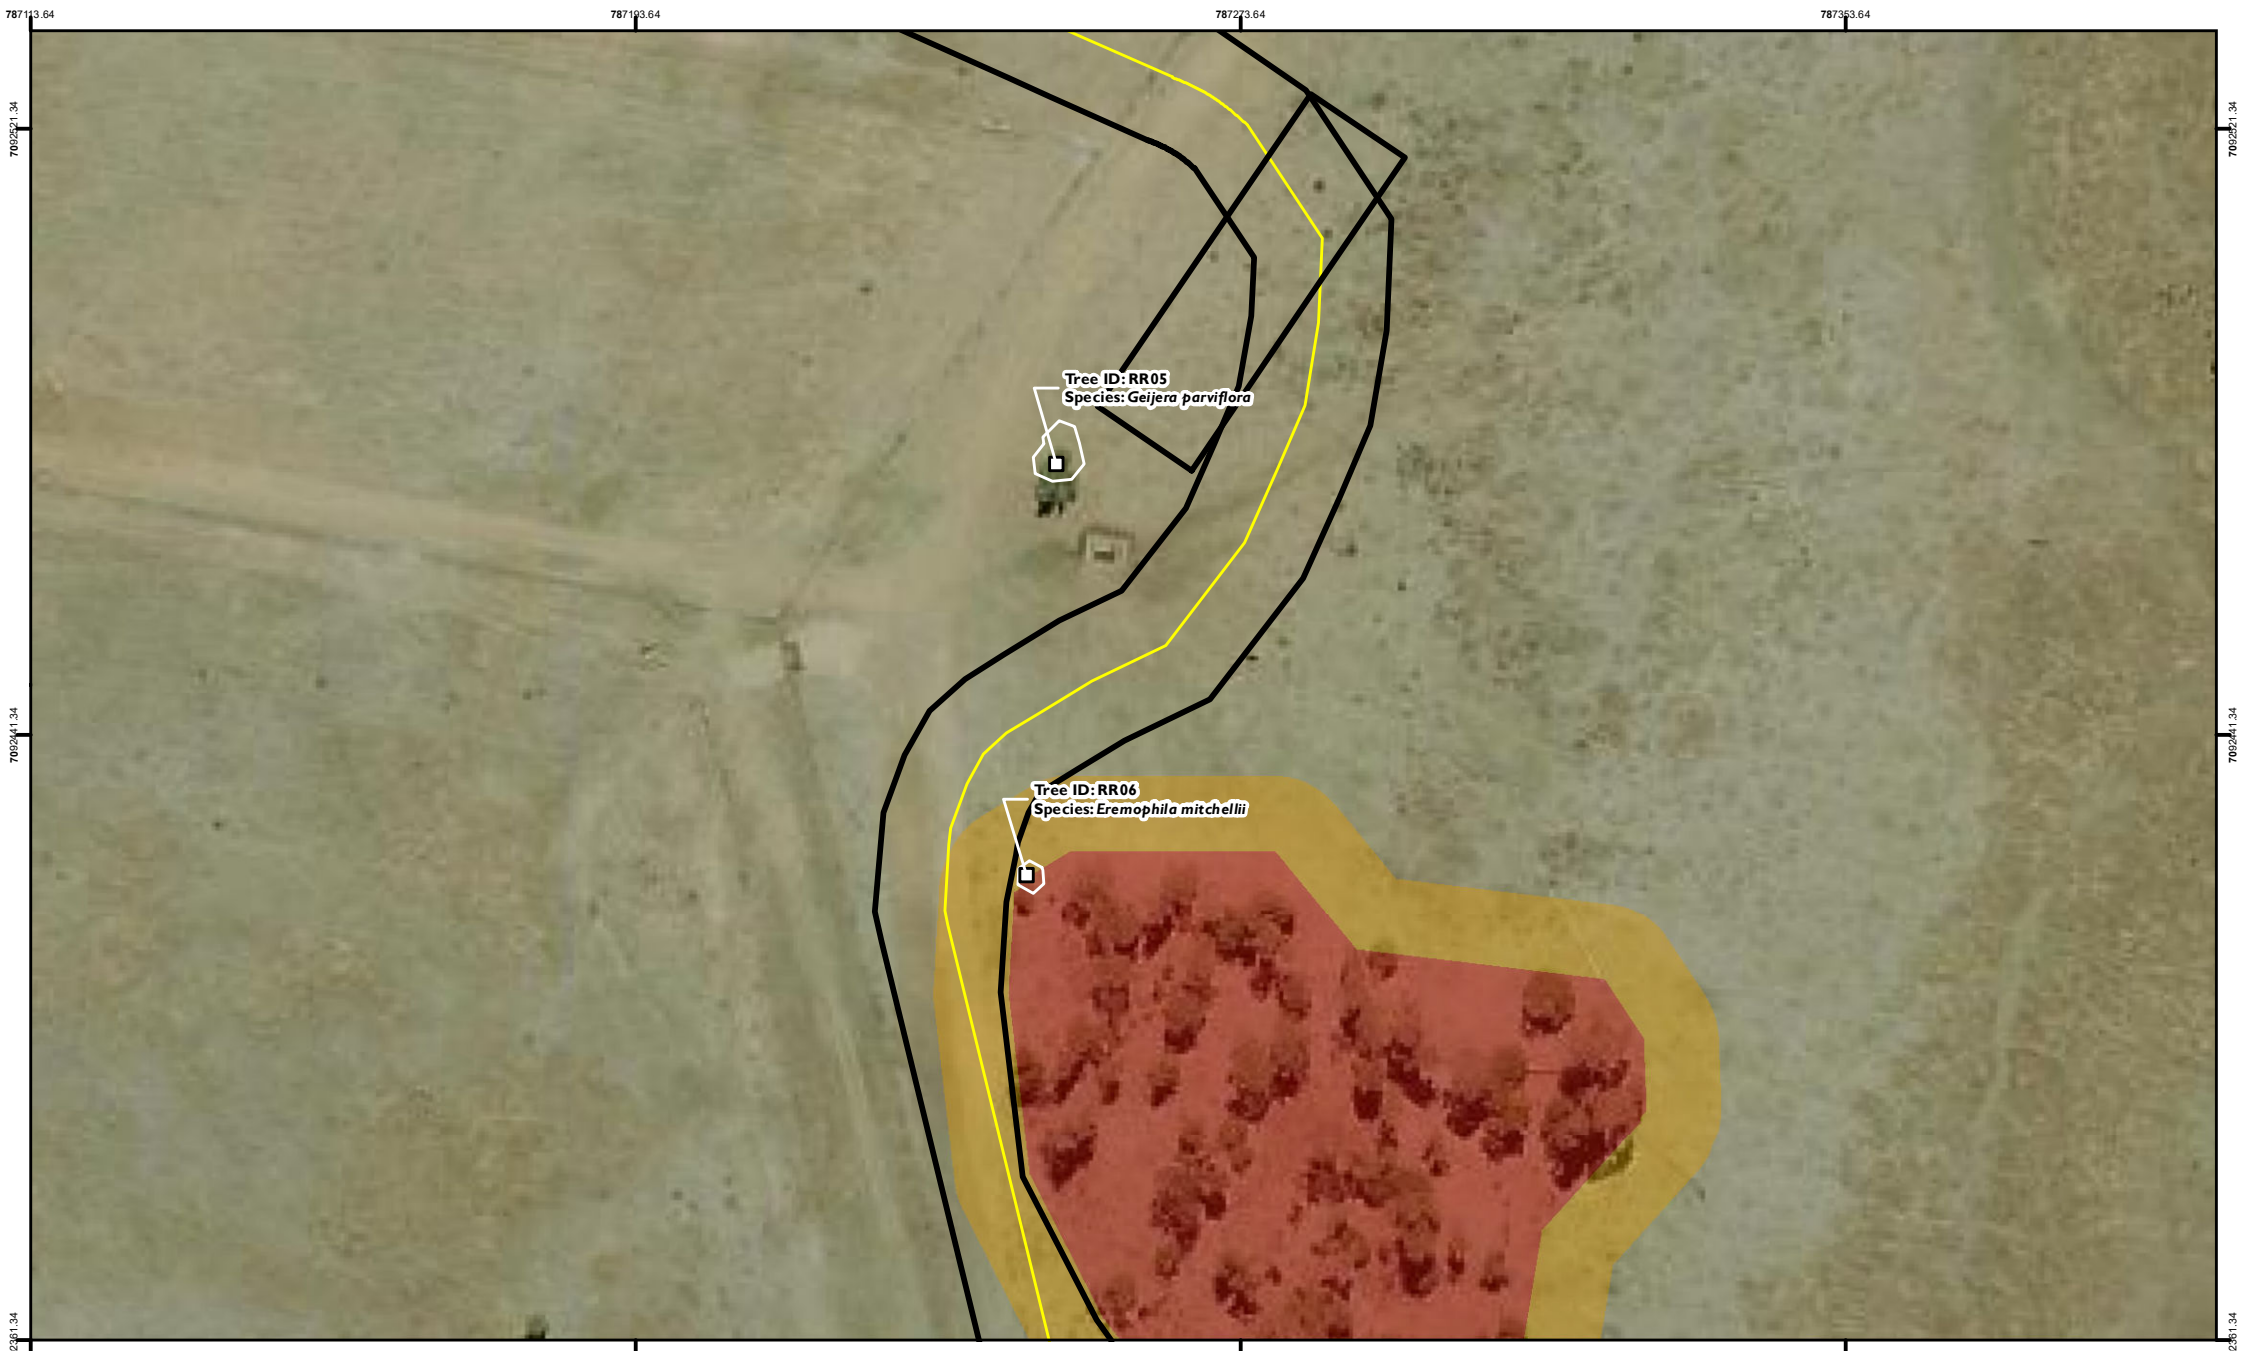
Figure 3.7:
Desktop and Ground-Truthed
Koala Dispersal Habitat Verification
The Peaks South

- Proposed Footprint
 - No Go Area
 - High Constraint Area
- Ground-Truthed Tree Centrepoint**
- Retain
- Dripline Extent**
- Retain

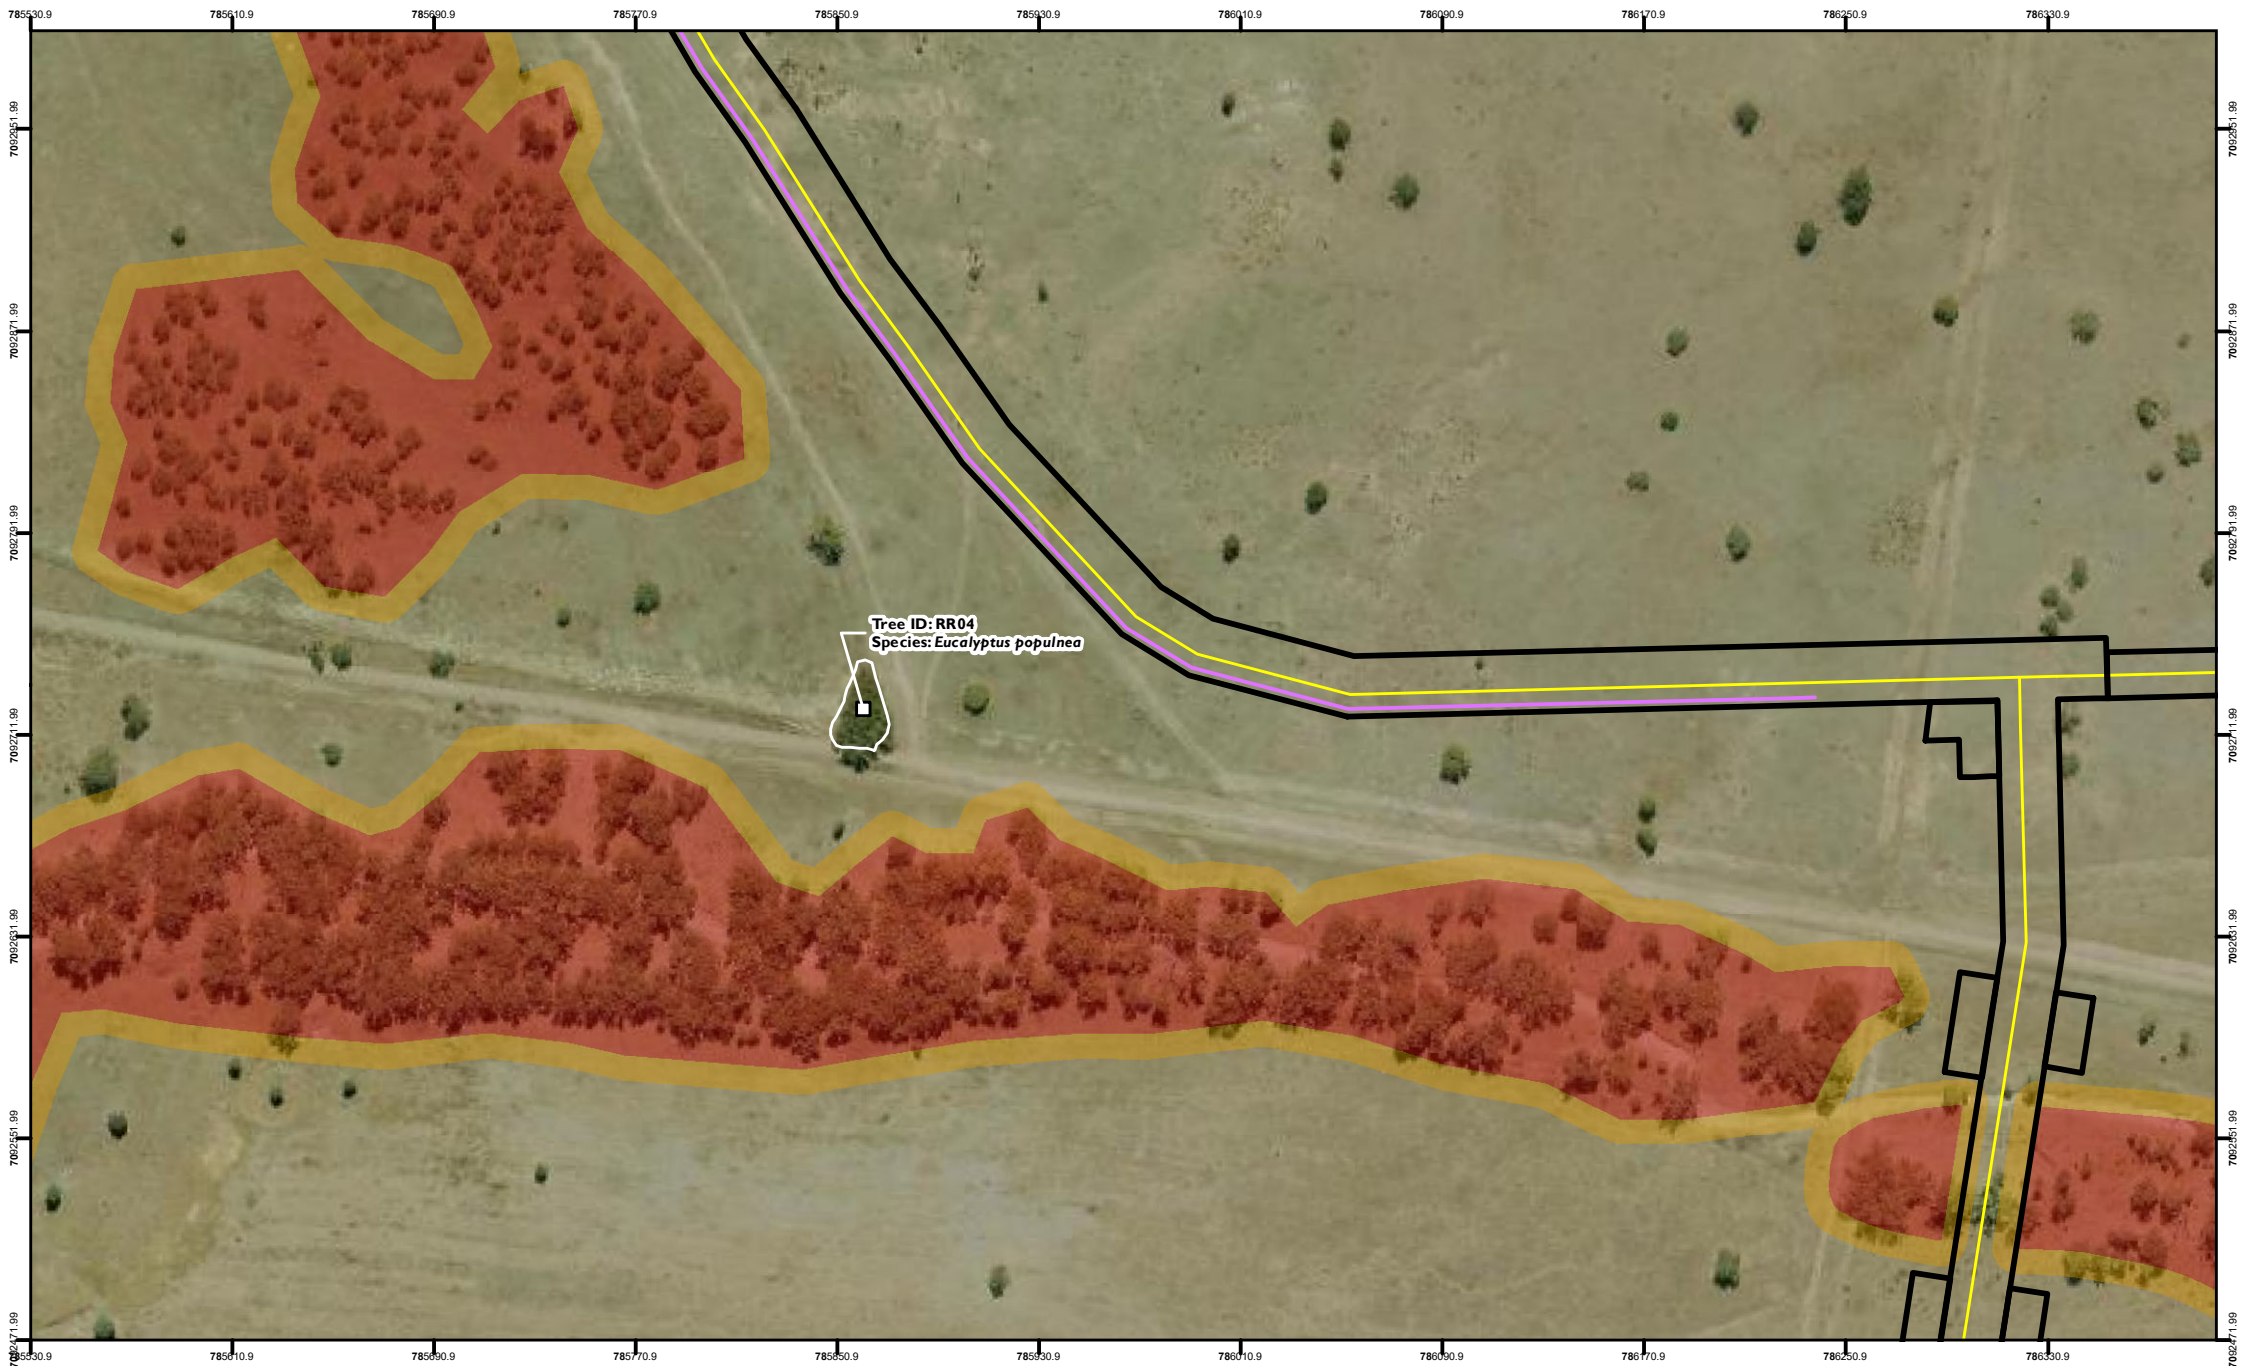
Figure 3.8:
 Desktop and Ground-Truthed
 Koala Dispersal Habitat Verification
 The Peaks South

- Proposed Footprint
 - No Go Area
 - High Constraint Area
- Ground-Truthed Tree Centrepoint**
- Retain
- Dripline Extent**
- Retain
