ATLAS Stage 3 – ATLAS Pre-clearance Survey Report The Peaks South (WPA22A)

Prepared for:
Senex

Report issued:
August 2024

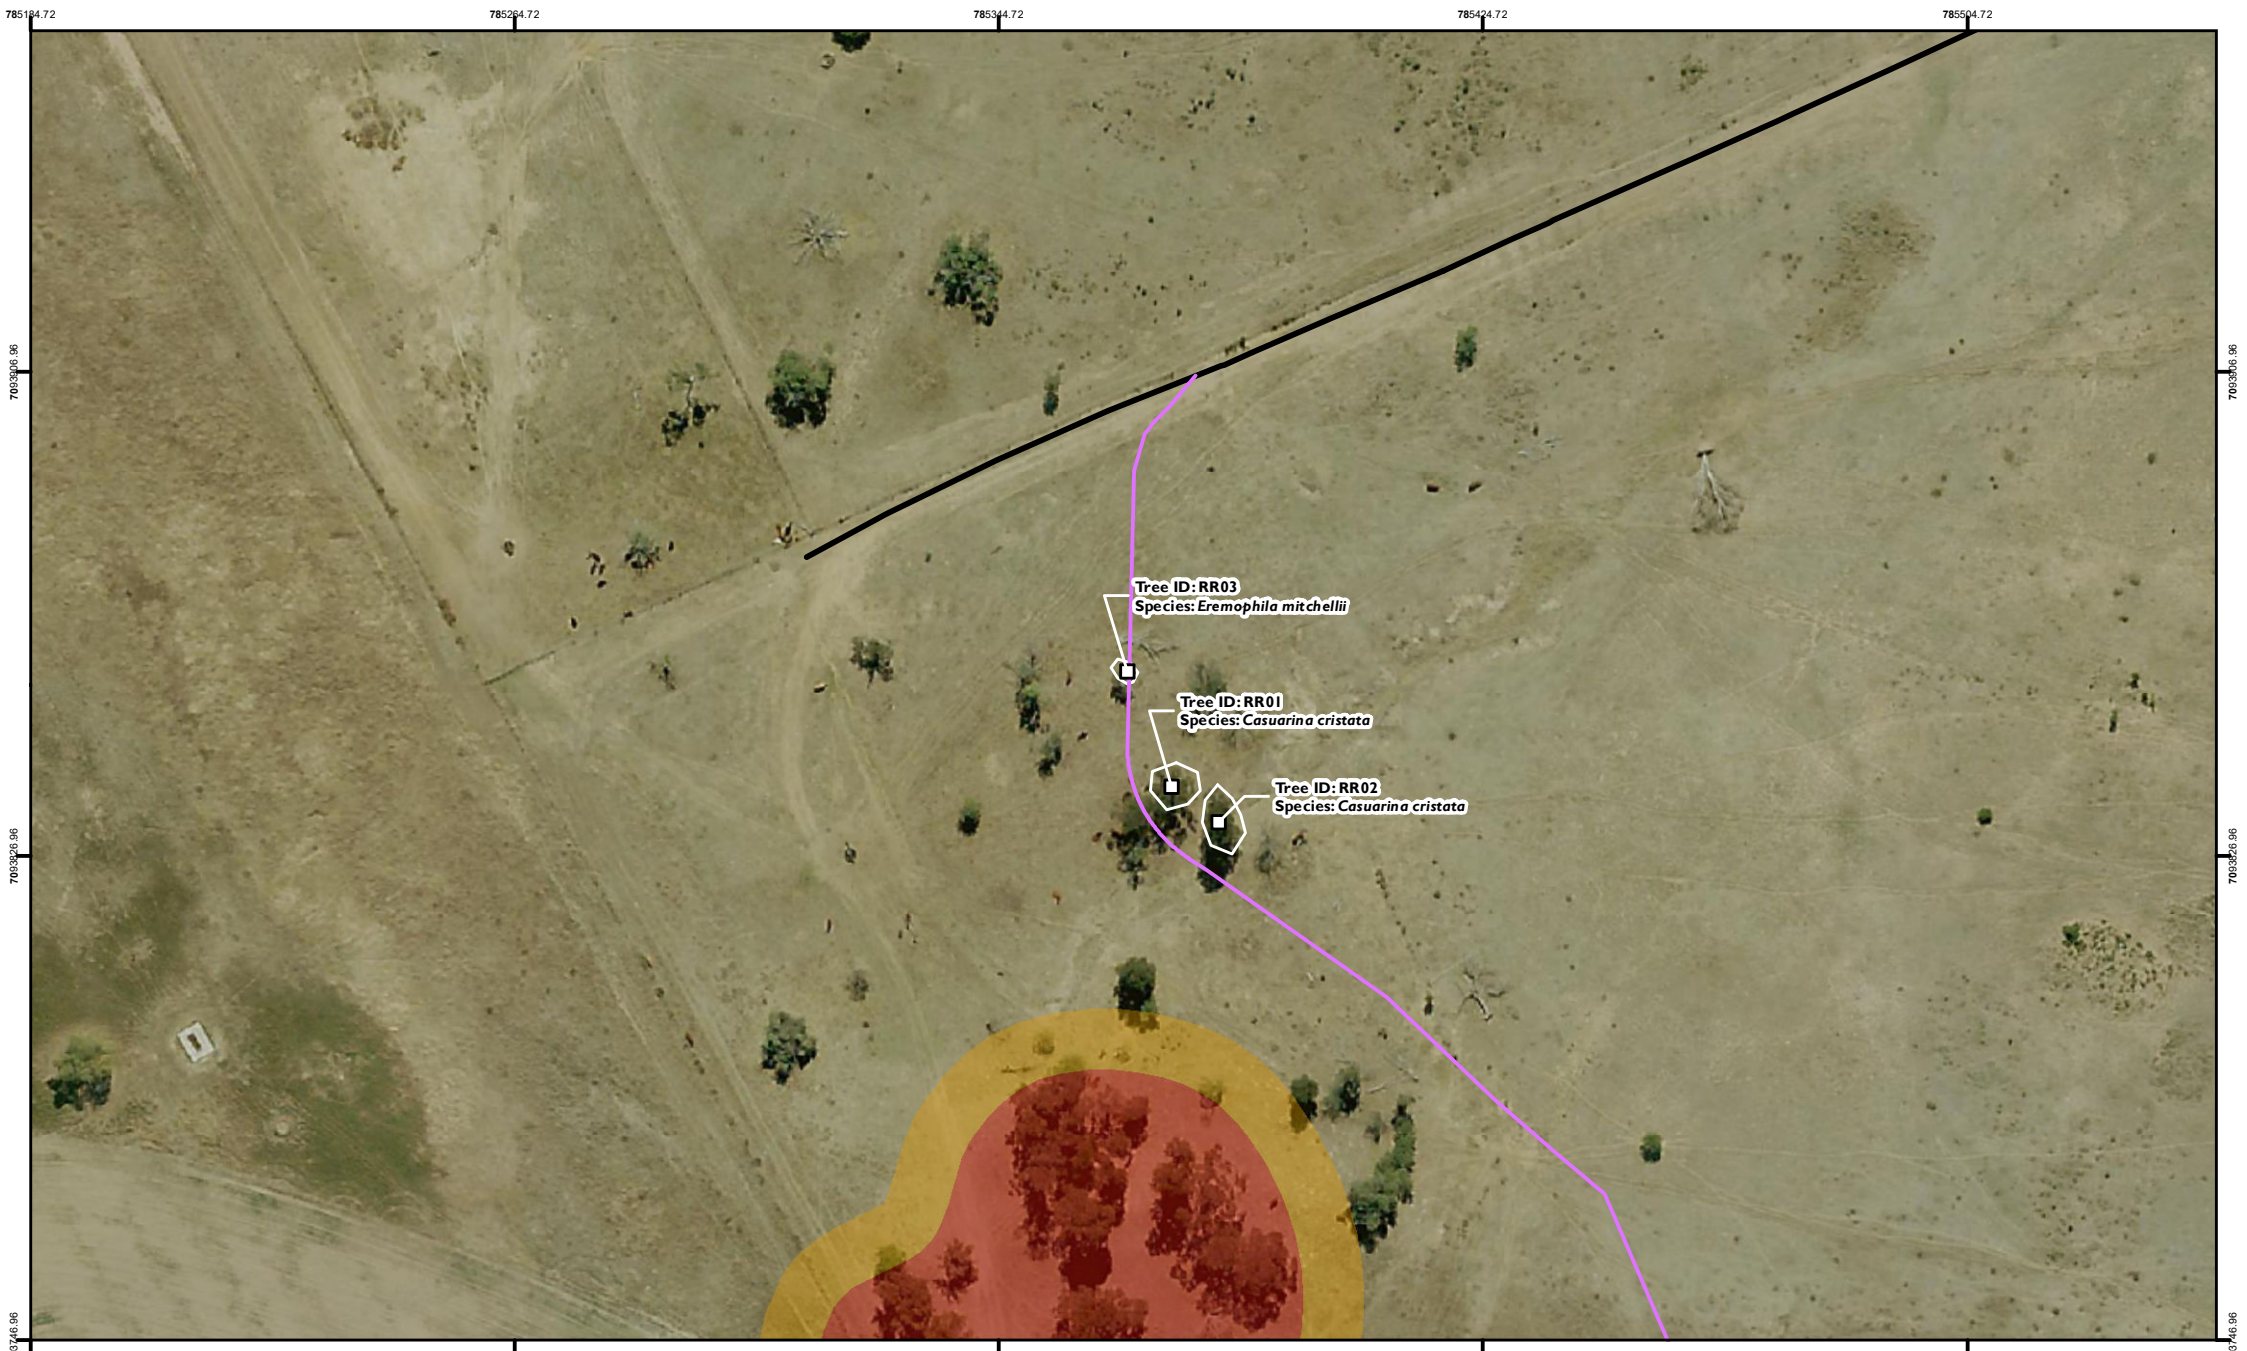
Figure 3.9:
Desktop and Ground-Truthed
Koala Dispersal Habitat Verification
The Peaks South

- Ground-Truthed Tree Centrepoint**
- Retain

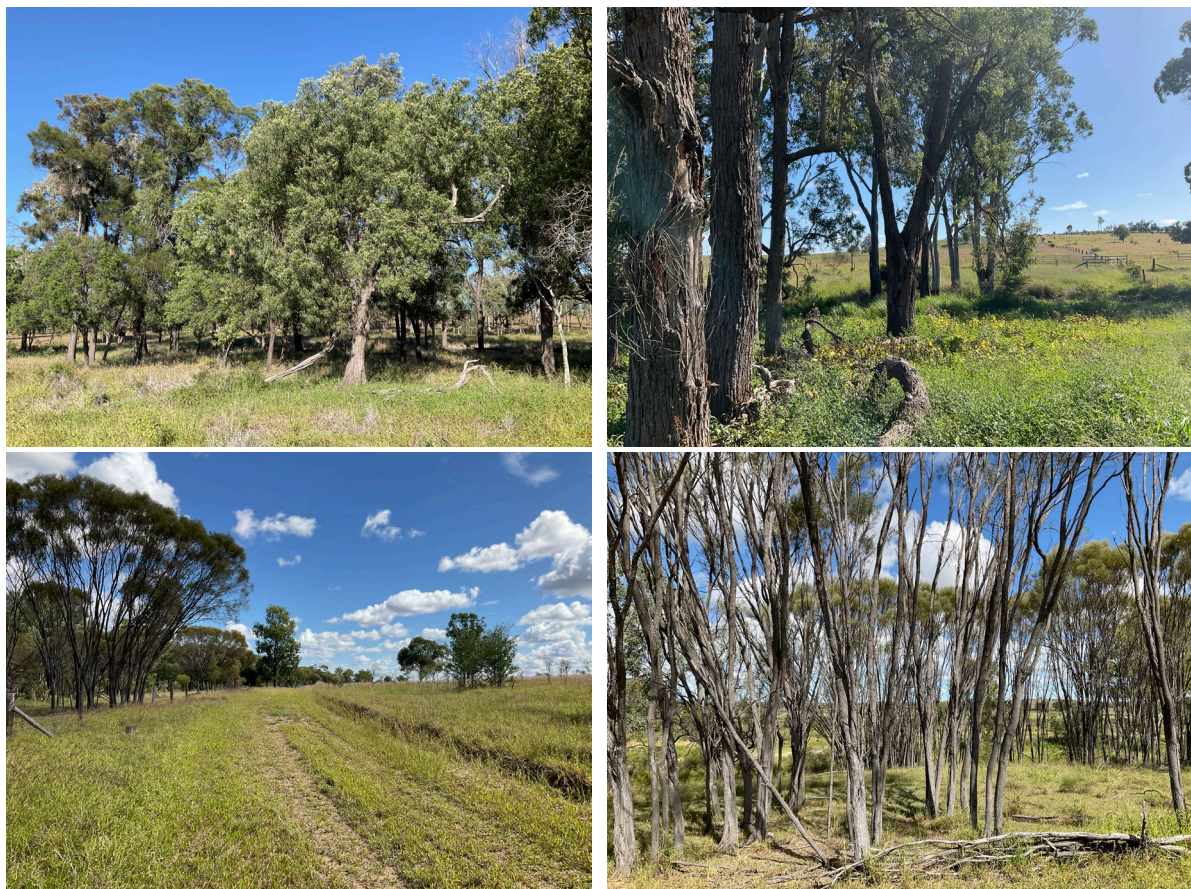
Figure 4-1 Examples of adjacent vegetation avoided by disturbance footprint

The surveys on the “The Peaks” property found that the project impacts to koala dispersal habitat would be minimal, with a total of 0.00891 ha (80.89 m²) to be potentially cleared. The majority of the impact footprint is located within predominantly cleared agricultural areas and Senex has actively avoided patches of remnant and regrowth vegetation, as well as individual paddock trees, resulting in retaining 0.1032 ha (or 1033 m²). In all cases, trees are retained within close proximity to those that are unable to be avoided and the clearing of 0.0081 ha is unlikely to have a significant effect on the ecological function of dispersal habitat on the property for koalas. Adjacent areas of dispersal habitat avoided are shown in Figure 4-1.
