ATLAS Stage 3 – ATLAS Pre-clearance Survey Report Demvale Wells and Gathering

Prepared for:
Senex

Report issued:
September 2024

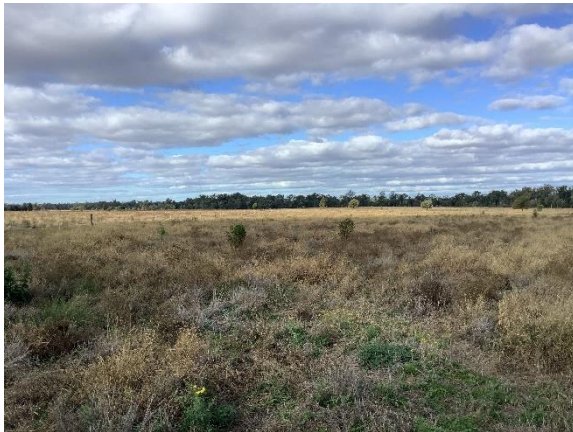
The Demvale property has been historically cleared for cattle grazing and is dominated by cleared pasture lands with some native but mainly introduced pasture grasses, with scattered small patches of remnant and regrowth woodlands. Individual and small patches of paddock trees of various ages and species were also scattered across cleared pastures (Figure 3-1 and Figure 3-2).

Figure 3-1 Patches of woodland beyond the impact footprint

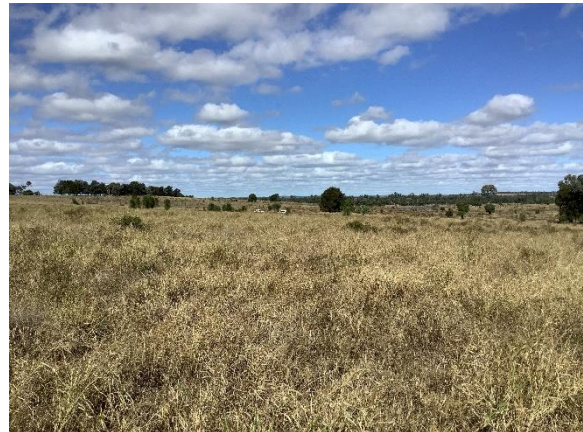
Figure 3-2 Scattered paddock trees

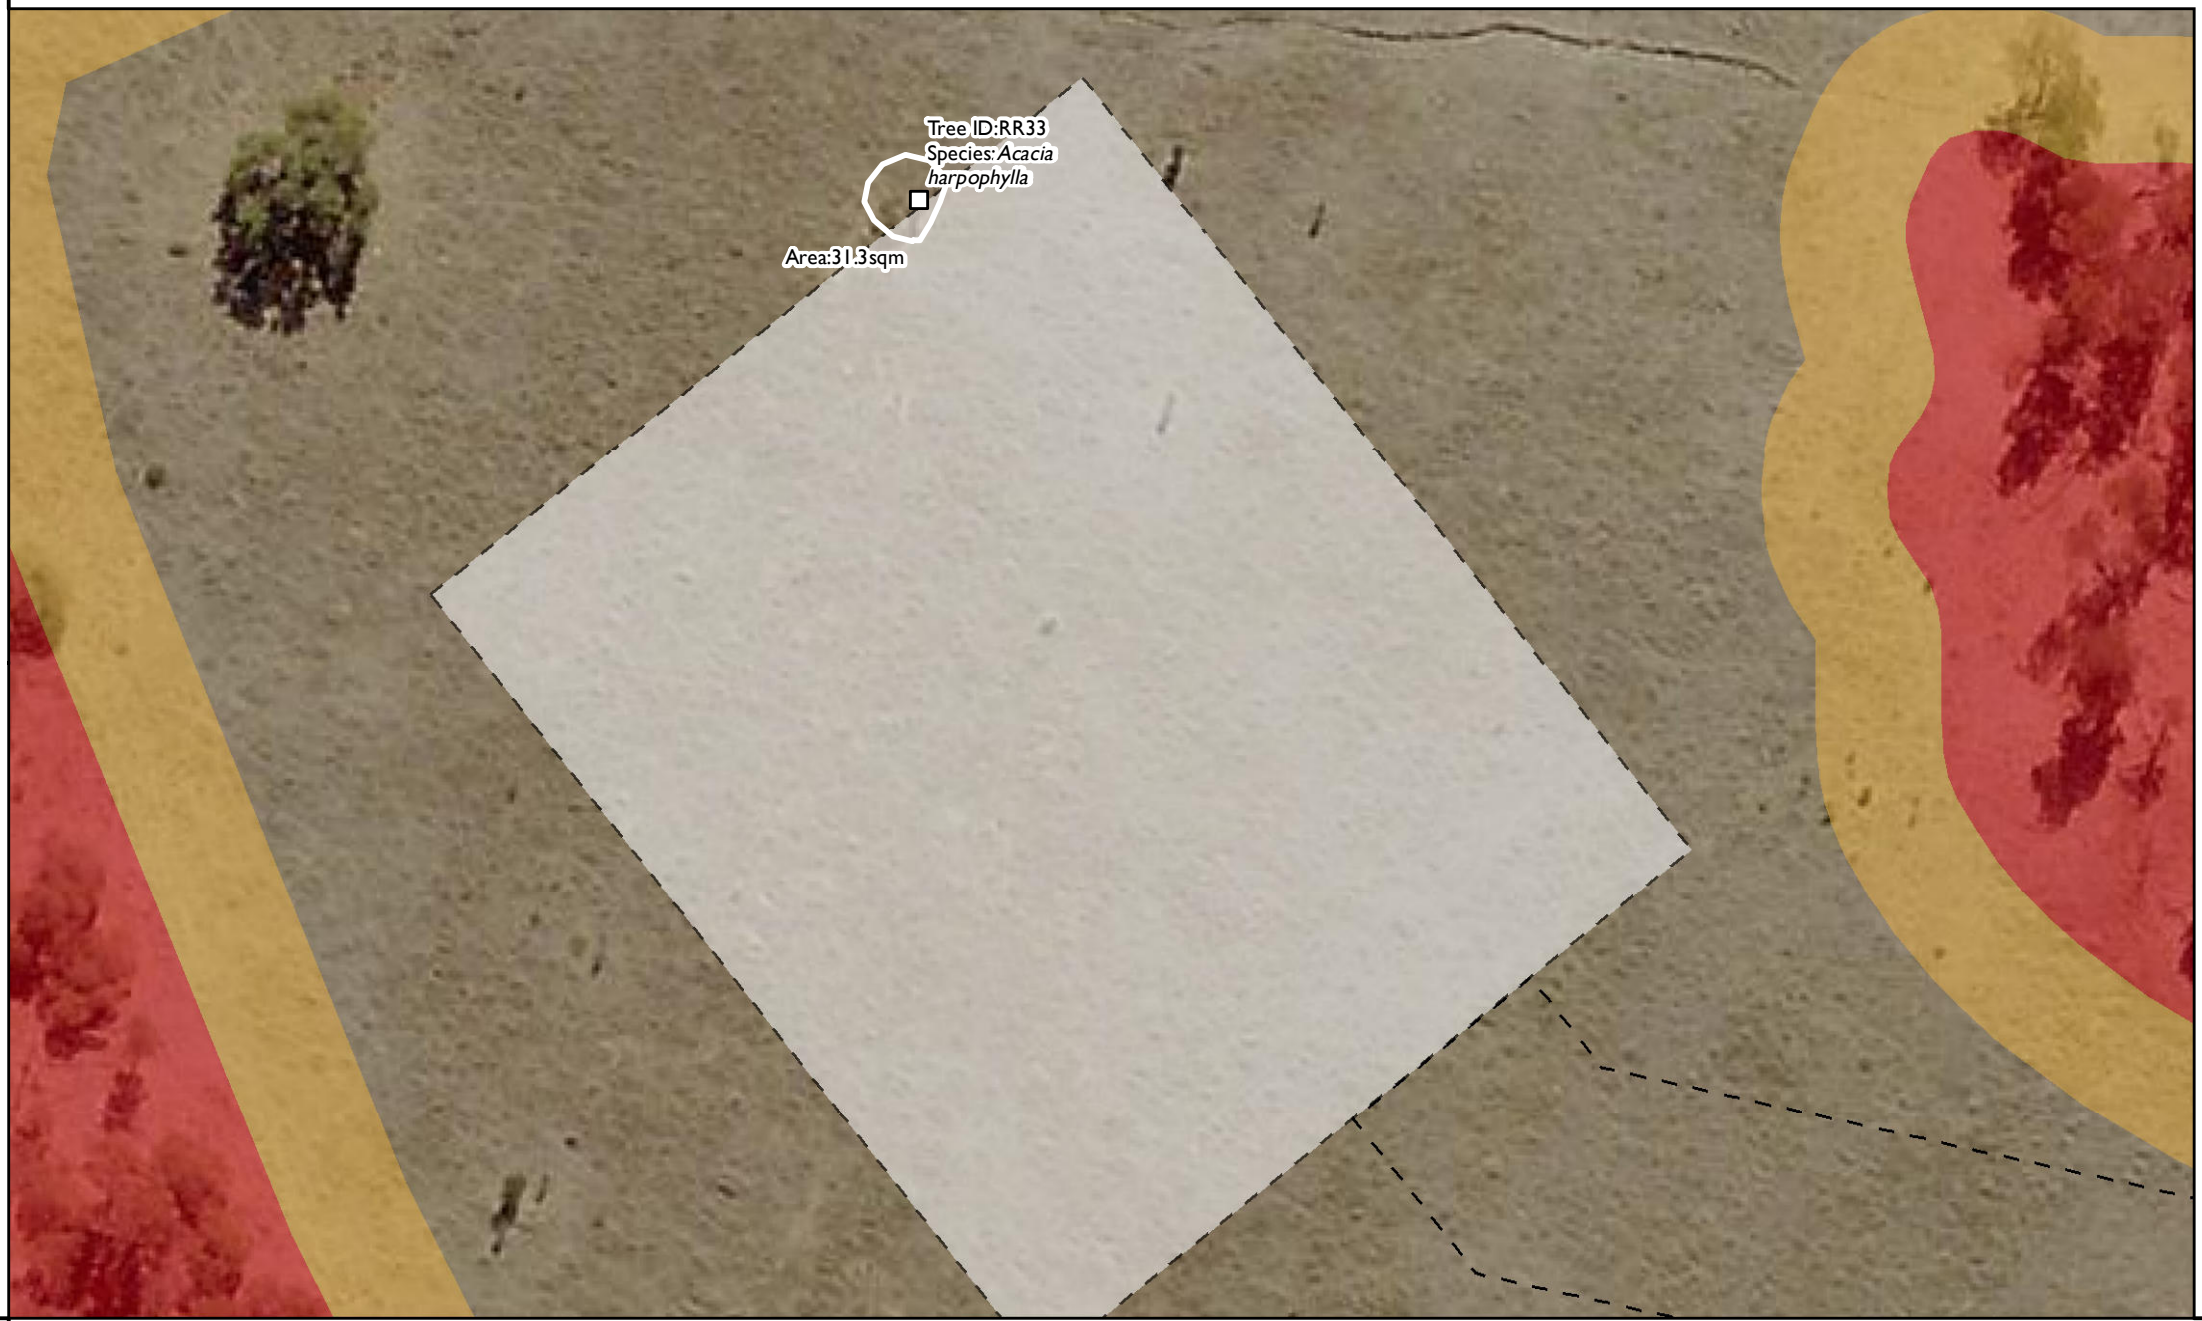
FIGURE 3-6:
Ground-Truthed Tree Dripline
Demvale - Overview

Table 3-1 provides the results including canopy cover, height and DBH of the trees assessed in the field in koala dispersal areas. All trees were assessed and where determined they could be avoided (through underground boring or realignment) they have been marked up as “retain” and will be avoided during construction. Any trees unable to be avoided had their canopy cover assessed and calculated under disturbance limits. Mapping of each location (Desktop ID) are shown in Figure 3-3 to Figure 3-6.

All koala dispersal trees that were observed within the proposed disturbance footprint will be retained as avoidance measures are feasible in all instances.

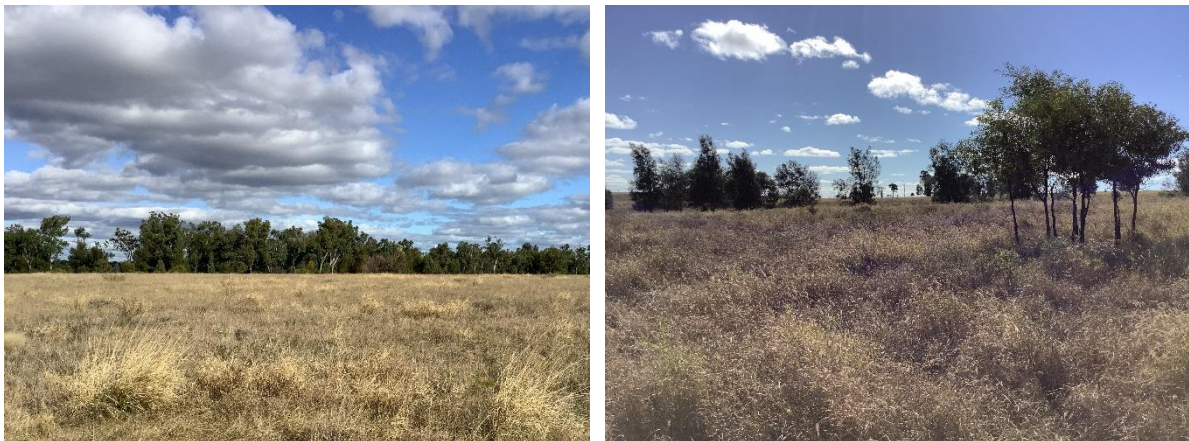
The surveys on the “Demvale” property found that the project impacts to koala dispersal habitat would be minimal, with a total of 0.0061 ha (60.6 m²) to be potentially cleared. Most of the impact footprint is located within predominantly cleared agricultural areas and Senex has actively avoided patches of remnant and regrowth vegetation, as well as individual paddock trees, resulting in retaining 0.0098 ha (or 98.4 m²). In all cases, trees are retained within proximity to those that are unable to be avoided and the clearing of 0.0061 ha is unlikely to have a significant effect on the ecological function of dispersal habitat on the property for koalas. Adjacent areas of dispersal habitat avoided are shown in Figure 4-1.

Figure 4-1 Examples of adjacent vegetation avoided by disturbance footprint
