## **ATLAS Stage 3 – ATLAS Pre-clearance Survey Report The Peaks South (WPA22A)**

**Prepared for:**  
**Senex**

**Report issued:**  
**September 2024**

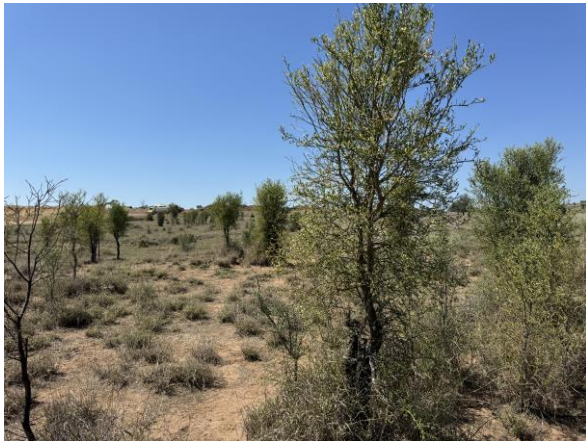
Figure 3-1 Patches of *Citrus glauca* regrowth

The “The Peaks” property has been historically cleared for cattle grazing and is dominated by cleared pasture lands with some native but mainly introduced pasture grasses, with scattered patches of remnant and regrowth woodlands, with scattered patches of remnant and regrowth wilga (*Geijera parviflora*) as well as regrowth desert lime (*Citrus glauca*) (**Error! Reference source not found.** and Figure 3-2 ).

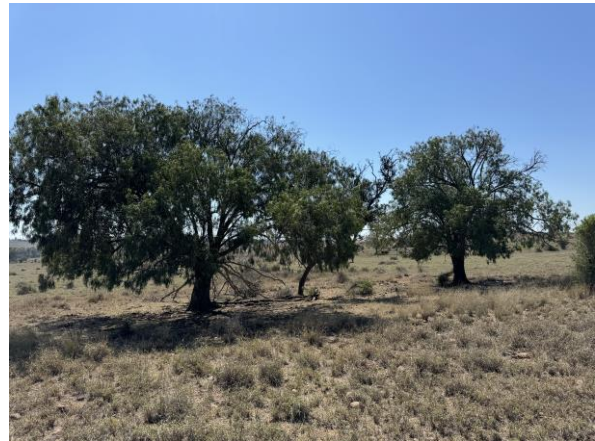
Figure 3-2 Fragmented *Geijera parviflora* paddock trees

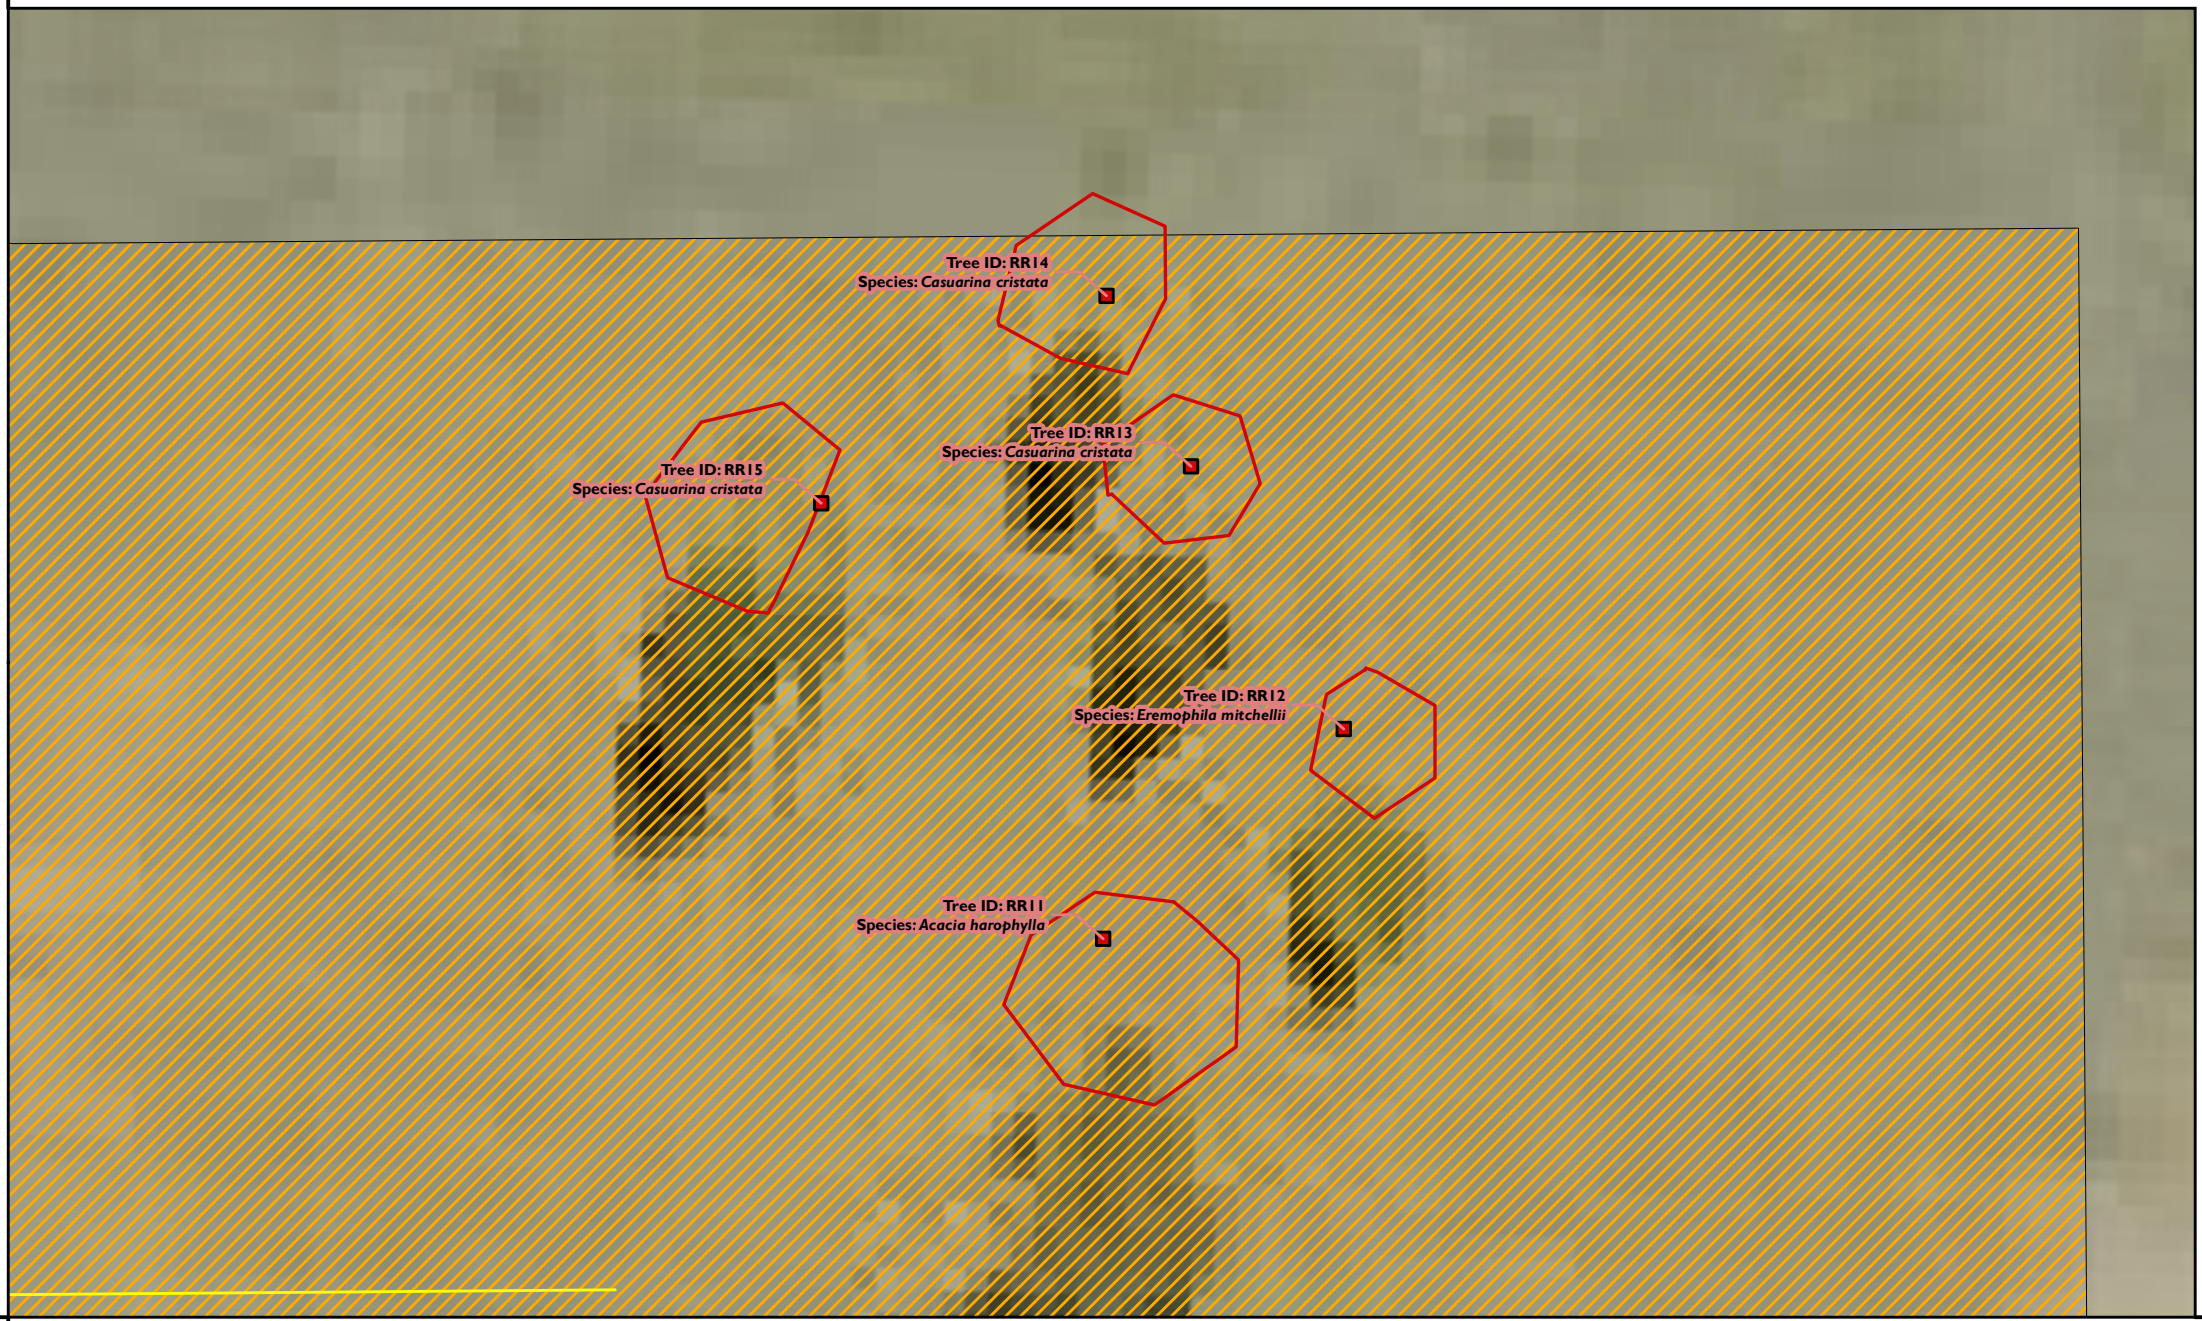
**Figure 3.3:**  
Desktop and Ground-Truthed  
Koala Dispersal Habitat Verification  
The Peaks South

- Proposed Gathering Lines
- Proposed Wellpads
- Ground-Truthed Tree Centrepoint
- Dripline Extent
- Remove
- Remove

Table 3-1 provides the results including canopy cover, height and DBH of the trees assessed in the field in koala dispersal areas. All trees were assessed and where determined they could be avoided (through underground boring or realignment) they have been marked up as “retain” and will be avoided during construction. Trees unable to be avoided have had their canopy cover assessed and calculated under disturbance limits. Mapping of each location (Desktop ID) are shown in Figure 3-3 to Figure 3-9.

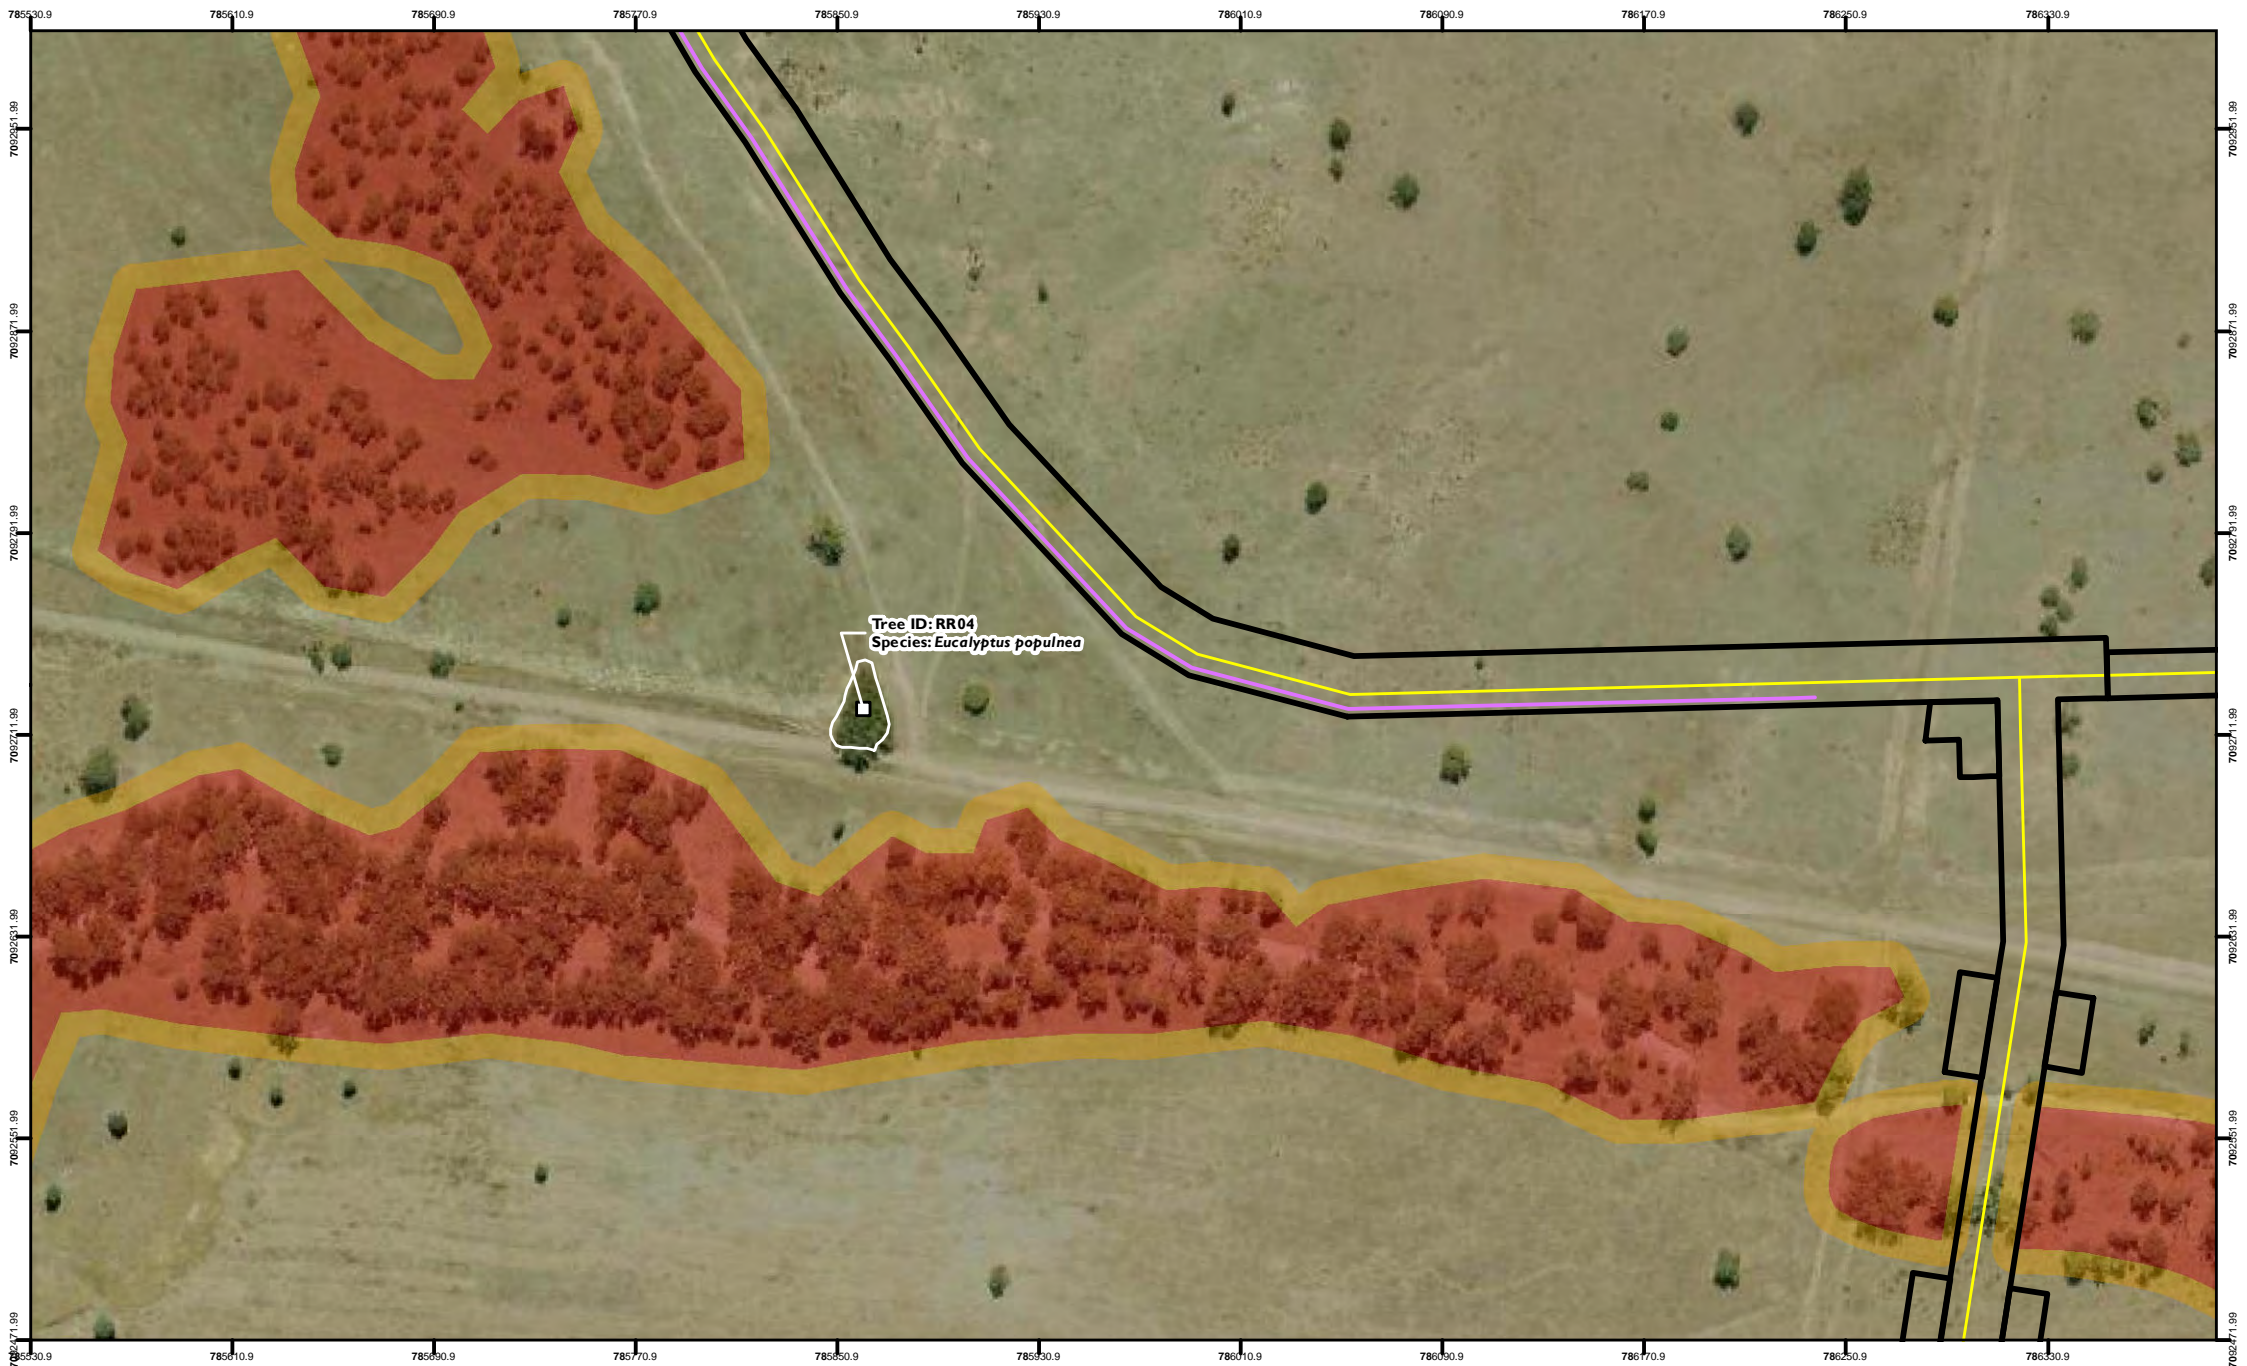
**Figure 3.8:**  
Desktop and Ground-Truthed  
Koala Dispersal Habitat Verification  
The Peaks South

Tree ID: RR04  
Species: *Eucalyptus populnea*

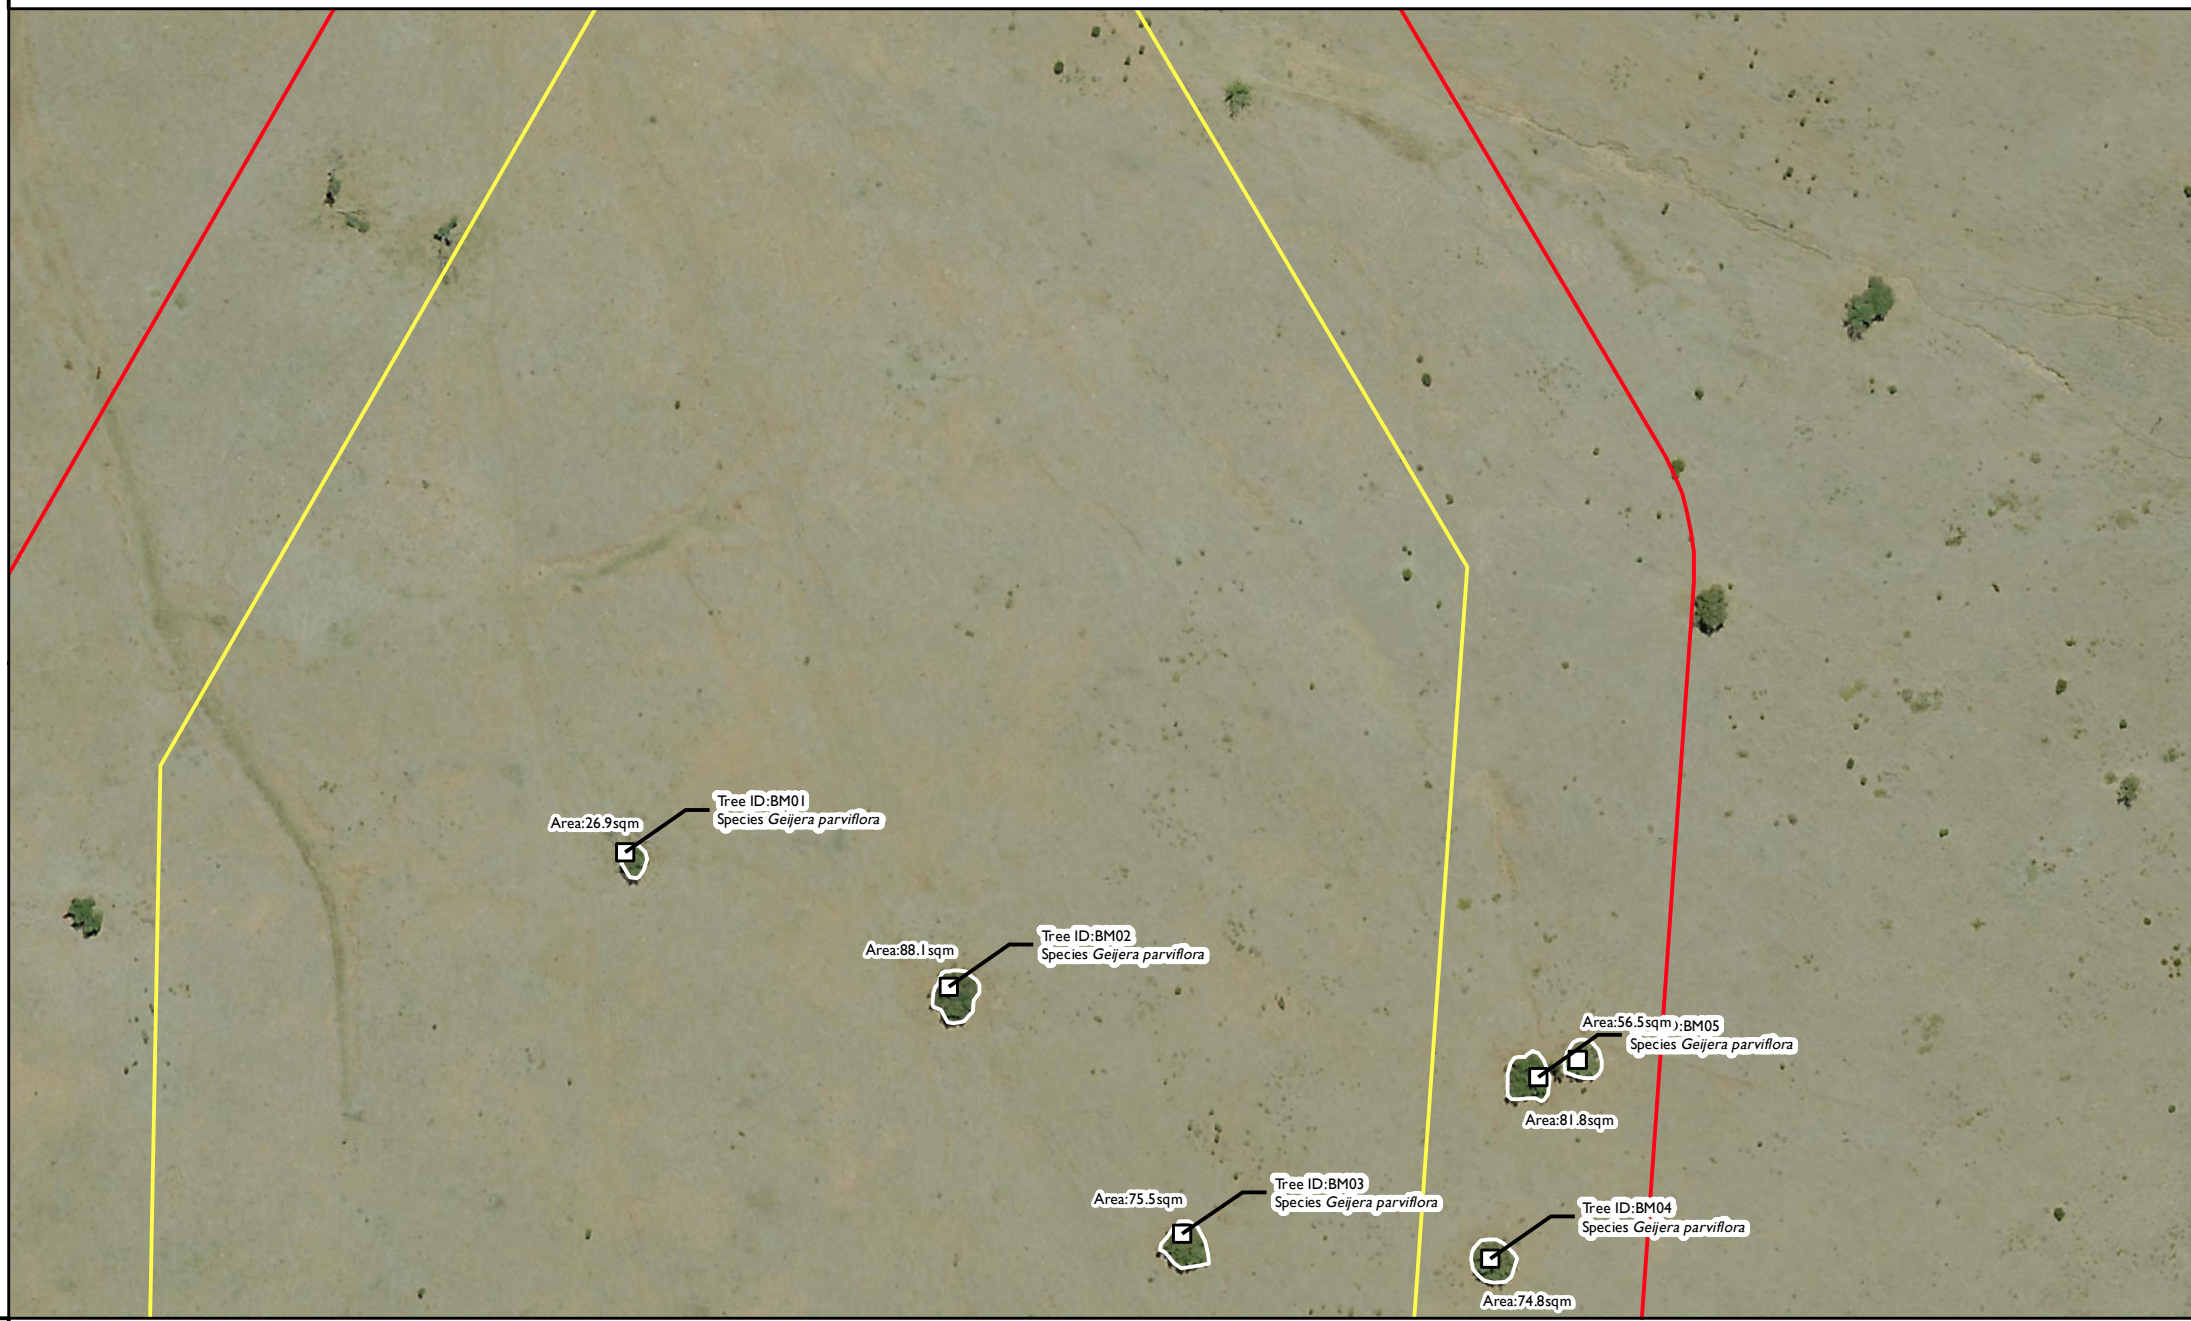
**FIGURE 3-10:**  
The Peaks Landspray Areas  
Altas

- ▭ The Peaks Proposed Landspray Area
- ▭ The Peaks Landspray Survey Area
- Ground-Truthed Tree Centrepoint
- Retain
- Tree Dripline
- Retain

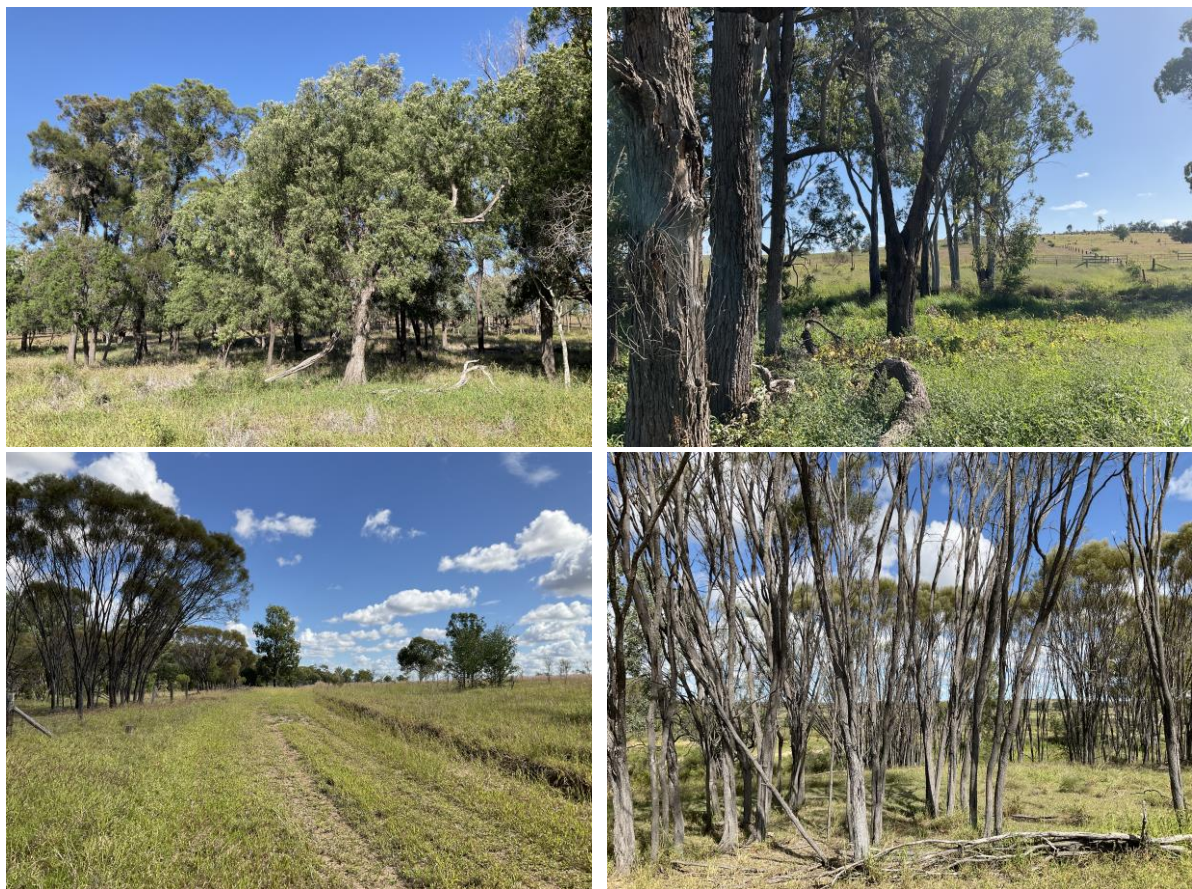
Figure 4-1 Examples of adjacent vegetation avoided by disturbance footprint

The surveys on the “The Peaks” property found that the project impacts to koala dispersal habitat would be minimal, with a total of 0.00891 ha (80.89 m<sup>2</sup>) to be potentially cleared. The majority of the impact footprint is located within predominantly cleared agricultural areas and Senex has actively avoided patches of remnant and regrowth vegetation, as well as individual paddock trees, resulting in retaining 0.1032 ha (or 1033 m<sup>2</sup>). In all cases, trees are retained within close proximity to those that are unable to be avoided and the clearing of 0.0081 ha is unlikely to have a significant effect on the ecological function of dispersal habitat on the property for koalas. Adjacent areas of dispersal habitat avoided are shown in Figure 4-1.
