## **ATLAS Stage 3 – ATLAS Pre-clearance Survey Report Glenhaven Wells and Gathering**

**Prepared for:**  
**Senex**

**Report issued:**  
**January 2025**

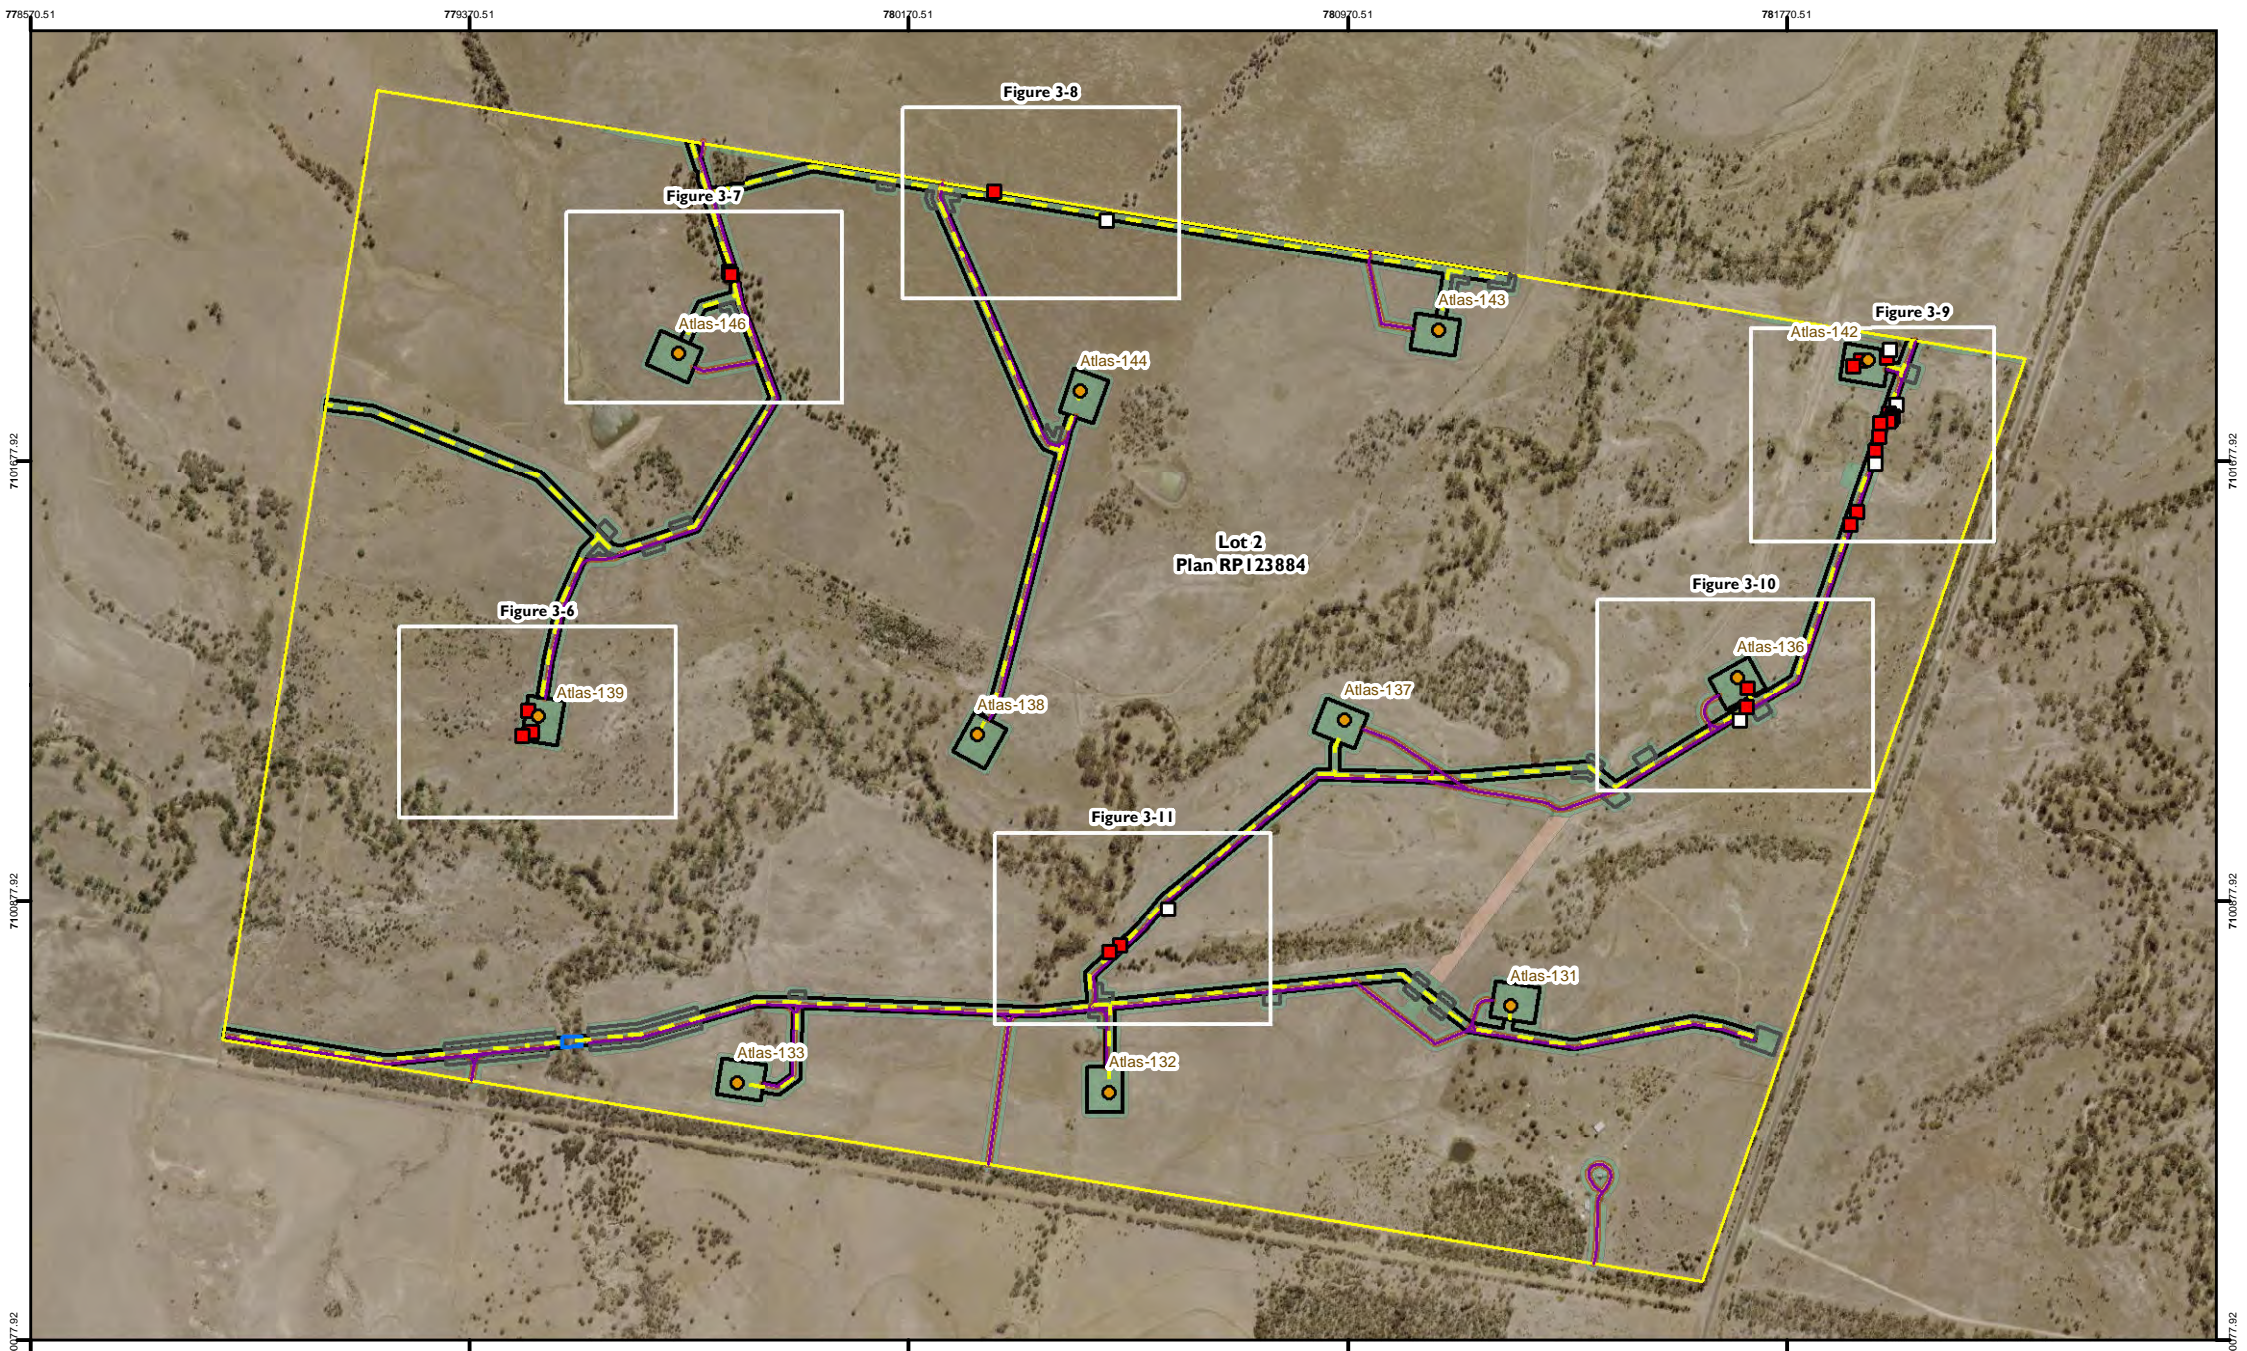
**FIGURE 2-1:**  
 Glenhaven Overview

An Ausecology principal ecologist (Suitably qualified) and ecologist conducted field surveys on foot on the 7<sup>th</sup> of July 2024 and 24<sup>th</sup> August 2024 with the Senex team to determine any further impacts not already identified to be avoided by re-aligning gas gathering, access tracks and well pads. The area surveyed and mapped in this report include the Glenhaven property as shown in Figure 2-1.

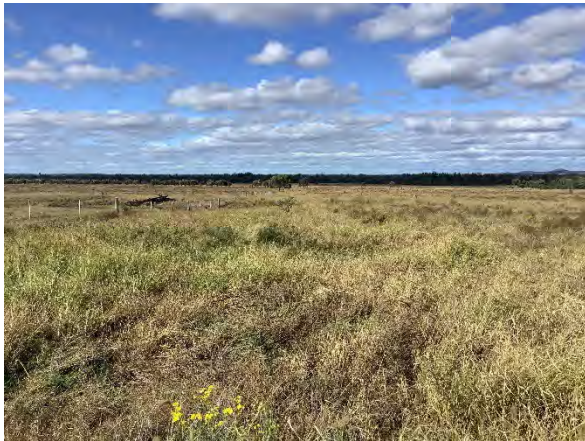
The Glenhaven property has been historically cleared for cattle grazing and is dominated by cleared pasture lands with some native species but mainly introduced pasture grasses, with scattered small patches of remnant and regrowth woodlands. A corridor of remnant vegetation consists along Wandoan Creek that runs throughout the property consisting of poplar box (*Eucalyptus populnea*), forest red gum (*Eucalyptus tereticornis*) and some patches of Brigalow (*Acacia harpophylla*). Individual and small patches of paddock trees of various ages and species were also scattered across cleared pastures along with areas where some vegetation have been pelleted (Figure 3-1 to Figure 3-4).

Figure 3-1 Non remnant pasture grass paddocks

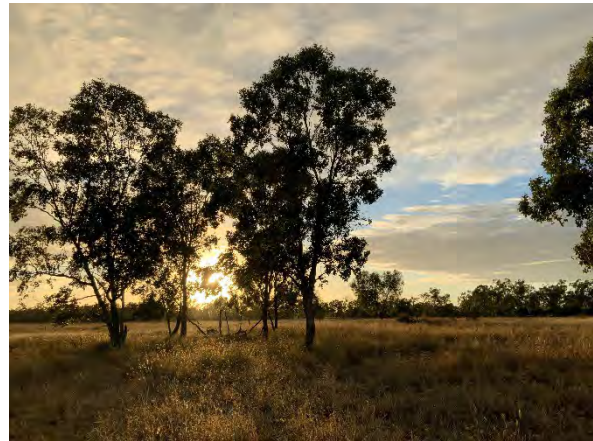
Figure 3-2 Scattered paddock trees

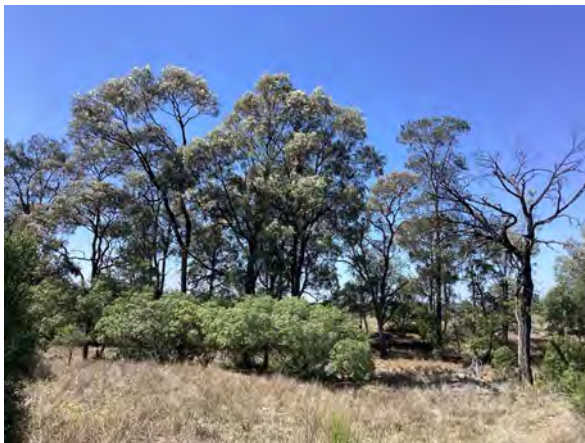
Figure 3-3 Brigalow patch to be under-bored to avoid impact to constraints mapped area

Where mapped constraint areas occurred within the disturbance footprint or 30 m buffer, these were assessed in the field to ensure they aligned with the mapping. A patch of vegetation near the 30 m buffer was reassessed to RE11.9.5 from 11.3.1. There are not enough alluvial influences at this patch as it is a drainage line through landzone 9. This does not have any implications for the project since any impacts have been avoided through re-alignment of the gathering lines. The survey also confirmed that the proposed disturbance areas do not impact on any listed TECs.

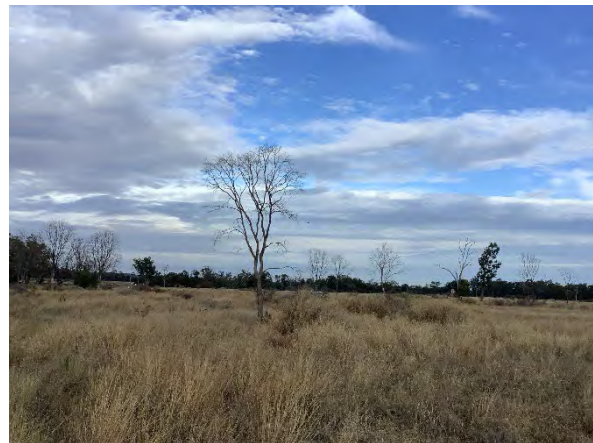
Figure 3-4 Patch of dead trees, likely pelleted

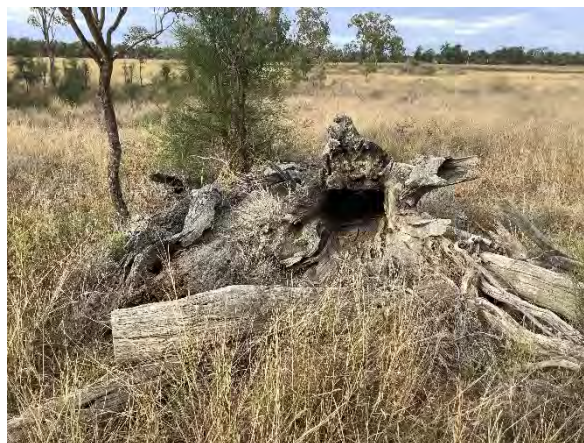
Active searches were not required within the disturbance footprint as no searchable fauna habitat was present (Either mapped as constraints or identified during the survey). One habitat feature (other than the koala dispersal trees) was recorded during the surveys, a log pile located at -26.185139, 149.806963, however no fauna were detected (Figure 3-5).

Figure 3-5 Log pile

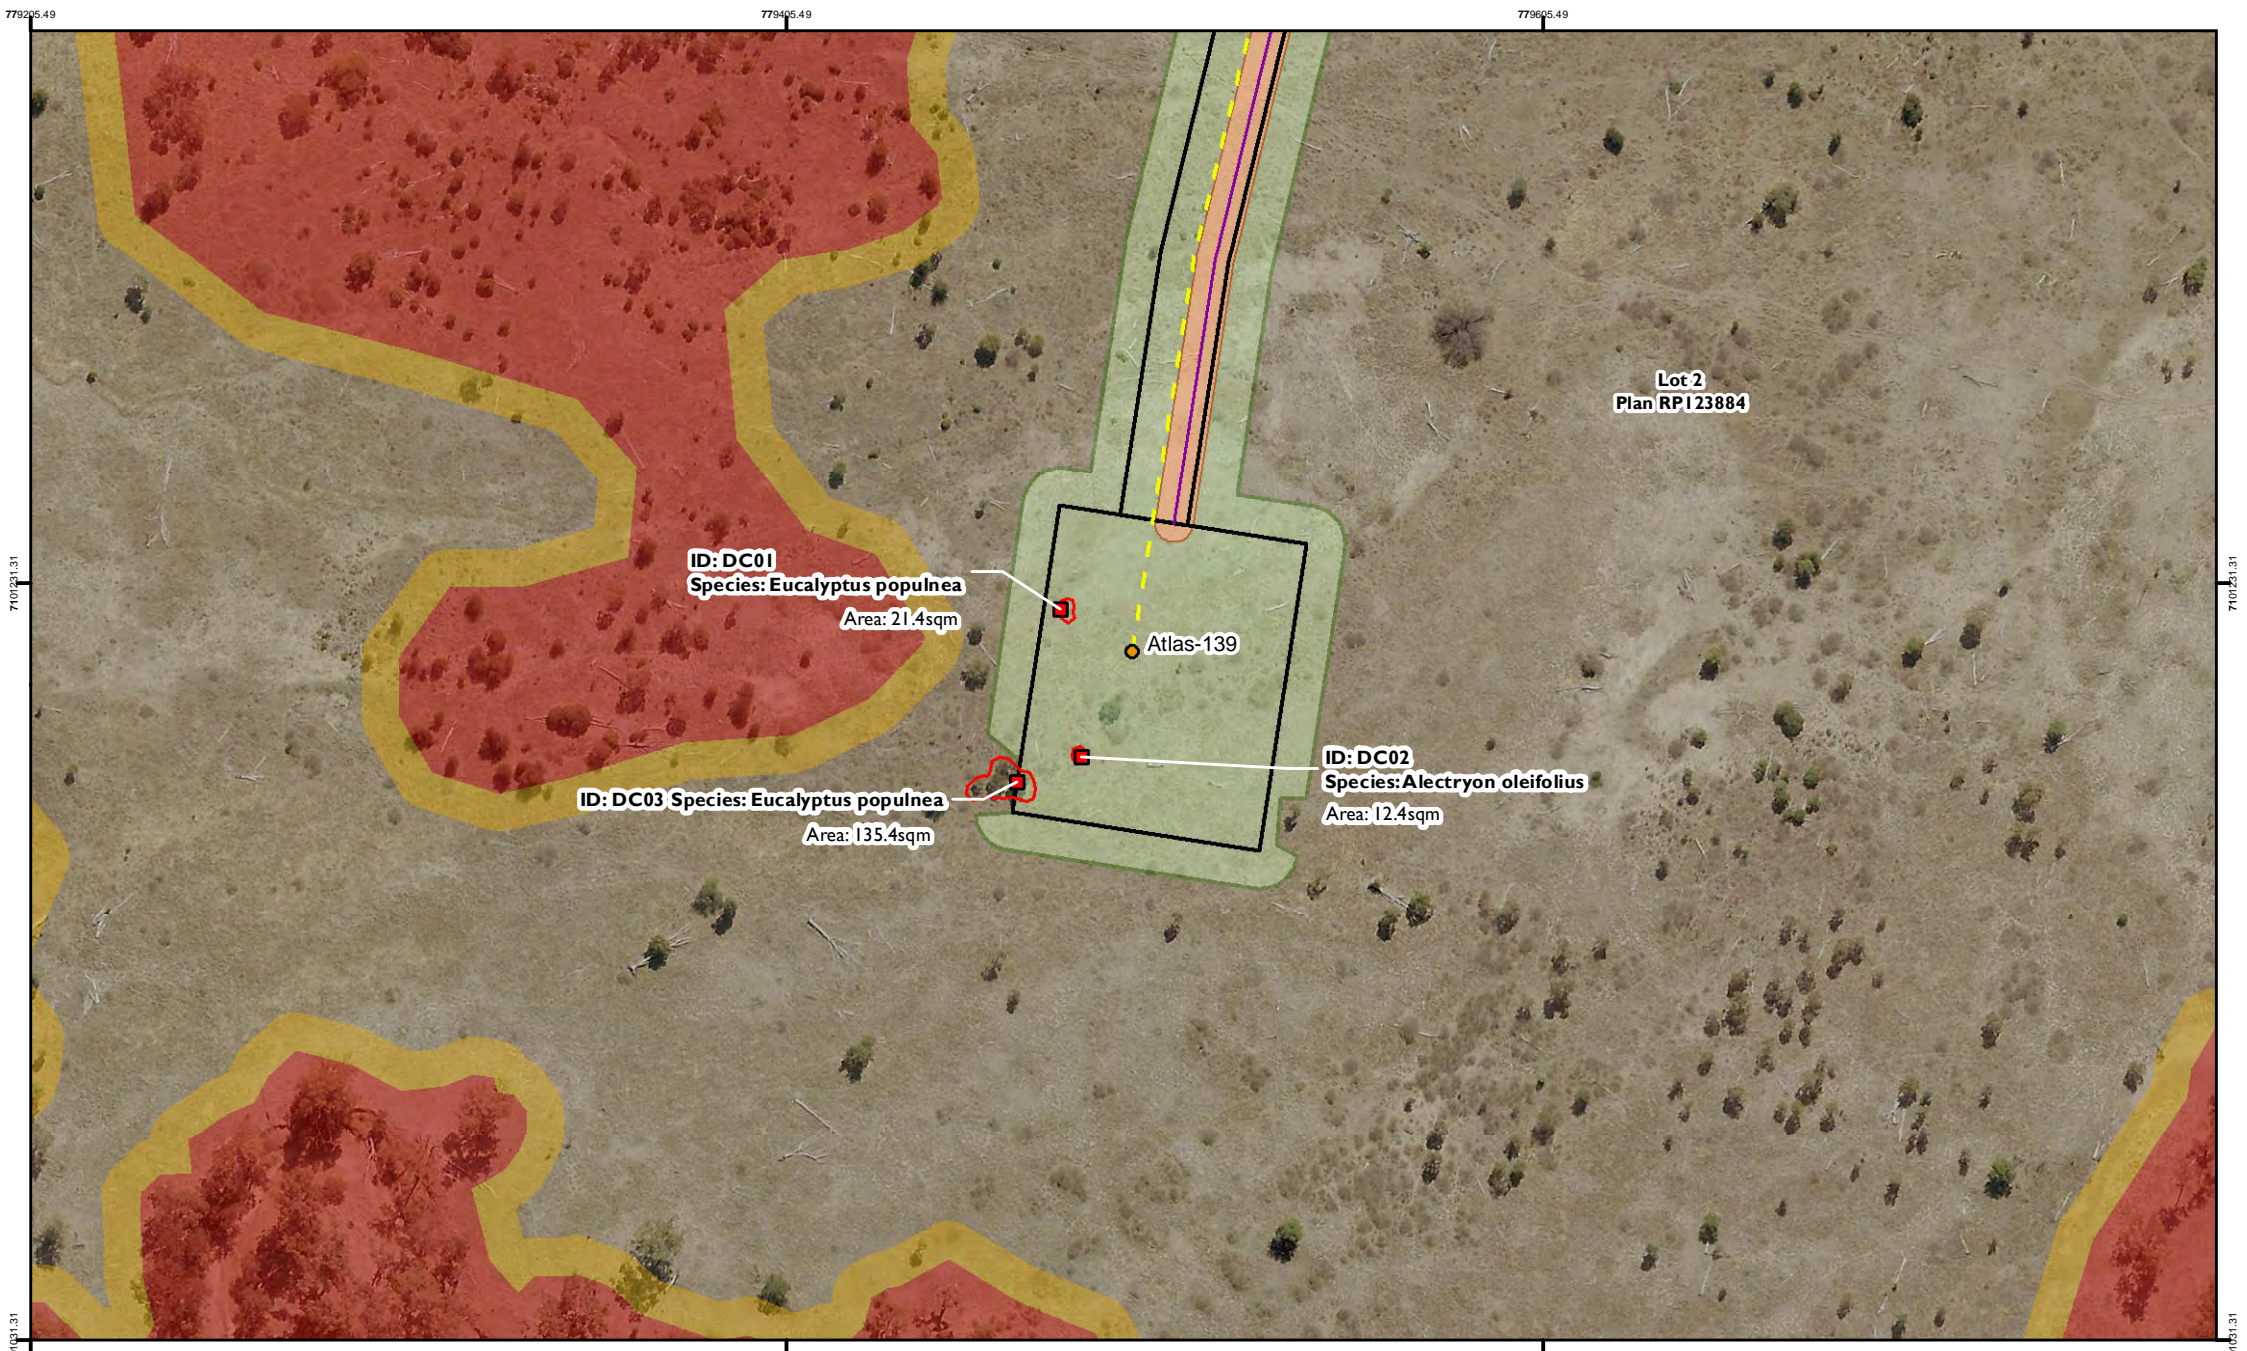
**FIGURE 3-6**  
Glenhaven - Koala tree surveys

Table 3-1 provides the results including canopy cover, height and DBH of the trees assessed in the field in koala dispersal areas. All trees were assessed and where determined they could be avoided (through underground boring or realignment) they have been marked up as “retain” and will be avoided during construction. Any trees unable to be avoided had their canopy cover assessed and calculated under disturbance limits. Mapping of each location (Desktop ID) are shown in Figure 3-6 to Figure 3-11.

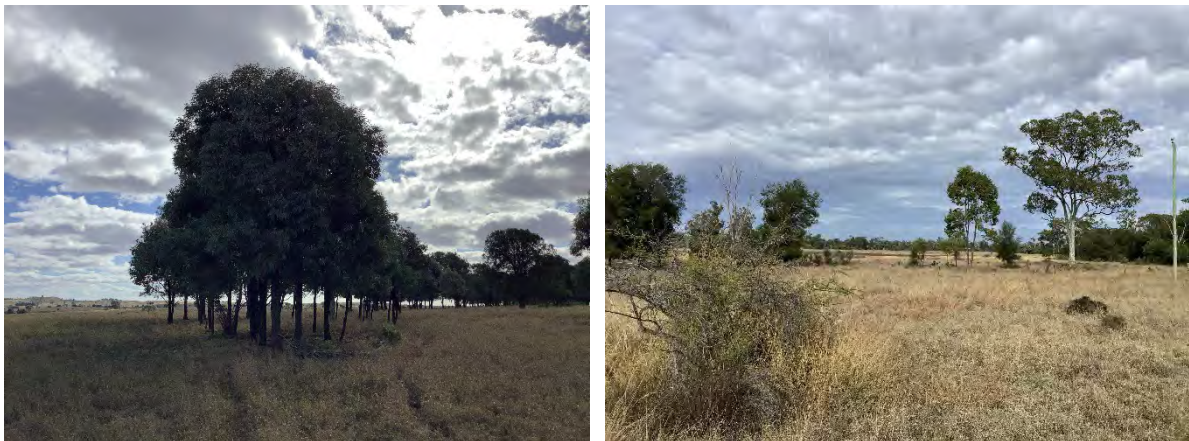
The surveys on the “Glenhaven” property found that the project impacts to koala dispersal habitat would be minimal, with a total of 0.11 ha (1161.25 m<sup>2</sup>) to be potentially cleared. Most of the impact footprint is located within predominantly cleared agricultural areas and Senex has actively avoided patches of remnant and regrowth vegetation, as well as individual paddock trees, resulting in retaining 0.06 ha (or 555.09 m<sup>2</sup>) of koala dispersal habitat. In all cases, trees are retained within proximity to those that are unable to be avoided and the clearing of 0.11 ha is unlikely to have a significant effect on the ecological function of dispersal habitat on the property for koalas. Adjacent areas of dispersal habitat avoided are shown in Figure 8-1.

Figure 8-1 Examples of adjacent vegetation avoided by disturbance footprint

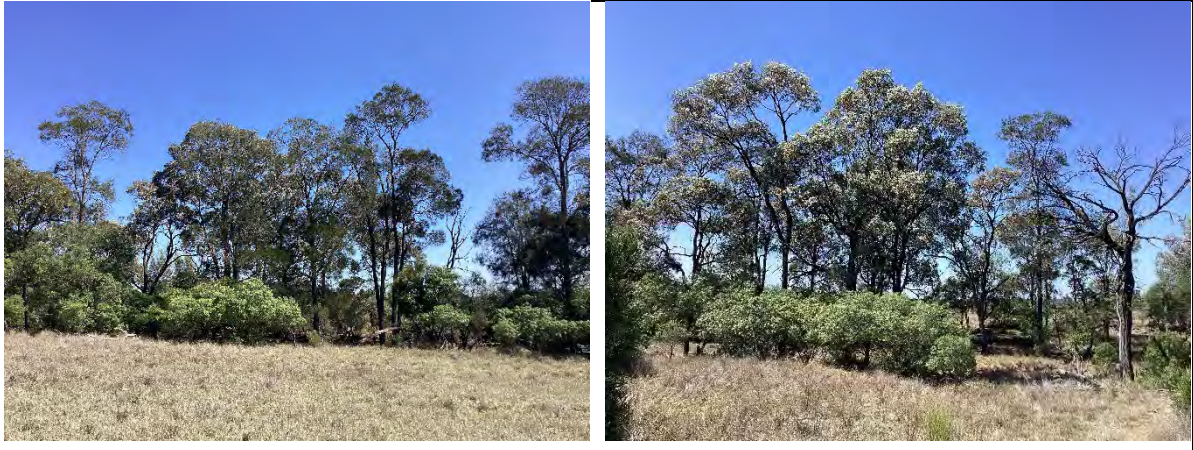
*Figure 8-2 – Vegetation to be under-bored*

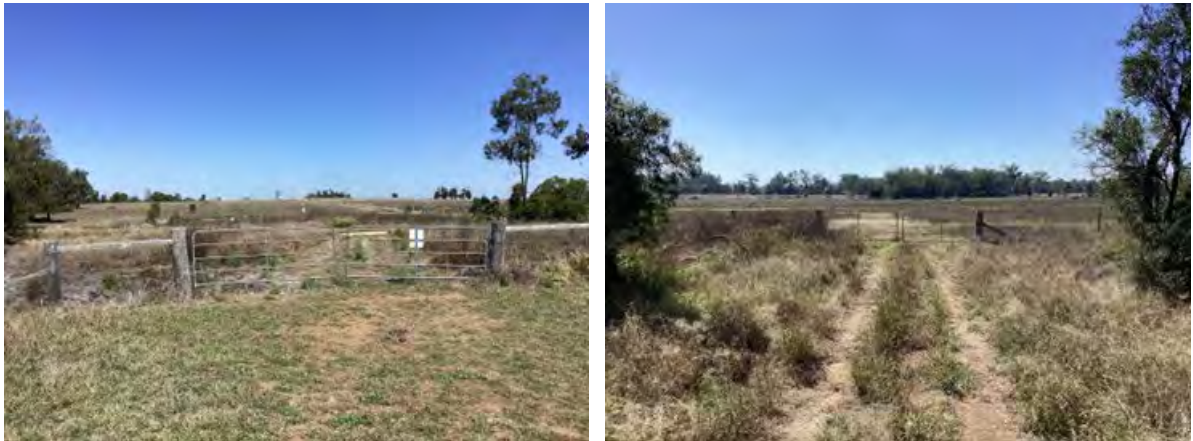
Threatened flora searches found no threatened species within or in proximity to the impact footprint. No threatened flora were encountered during the survey and no TECs are present within the disturbance footprint or within 30m of the disturbance footprint. During surveys weed species were found on the property including *Harrisia* cactus (*Harrisia martini*), Mexican poppy (*Agremone ochroleuca*) and *Opuntia* spp. No remnant or HVR regulated vegetation, potential threatened fauna habitat or environmentally sensitive areas (ESAs) are present within the disturbance footprint, other than where an under-bore will be carried out shown in Figure 8-2. Access from Weldons Road shows no impact to surrounding vegetation on road reserves as per Figure 8-3.

*Figure 8-3 – Entrances from Weldons Road*
