ATLAS Stage 3 – ATLAS Pre-clearance Survey Report Bellaringa Wells, Gathering and Landspray

Prepared for:
Senex

Report issued:
February 2025

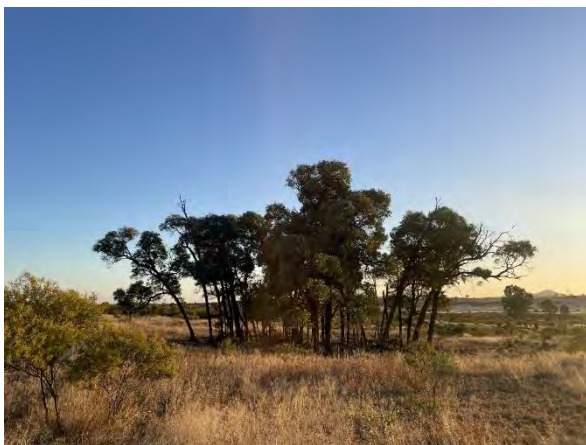
Figure 3-1 Patches of remnant or old regrowth brigalow

The Bellaringa property has been historically cleared for cattle grazing and is dominated by cleared pasture lands of introduced pasture grasses. Large areas of the cleared areas on the property have dense regrowth of either *Acacia decora* or the invasive sweet acacia (*Vachellia farnsiana*). The property has scattered patches of remnant and regrowth vegetation including Brigalow (*Acacia harpophylla*) woodland (RE 11.9.5), as well as ironbark and callitris pine (*E. melanophloia* and *Callitris glaucophylla*) woodlands (RE 11.5.5, 11.5.1 and 11.3.19). Many creek lines around the property have disturbed and/or regrowth vegetation in along the drainage features, including riverine river red gum woodlands (RE 11.3.25), ironbark (*Eucalyptus melanophloia*) woodlands (RE 11.3.39), and poplar box (*Eucalyptus populnea*) woodlands (RE 11.3.2). Individual and small patches of paddock trees of various ages and species were also scattered across cleared pastures (Figure 3-1 to Figure 3-4).

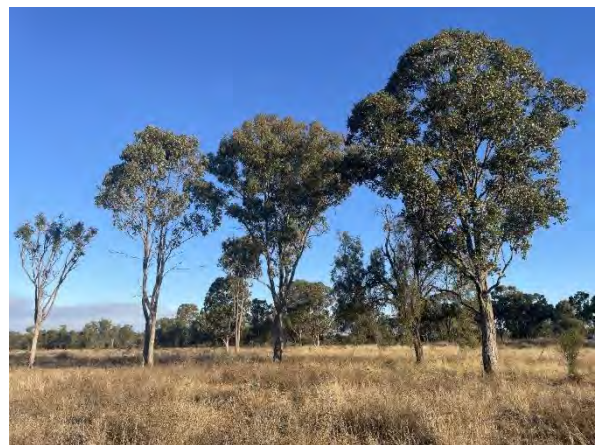
Figure 3-2 Fragmented riverine eucalypt forest

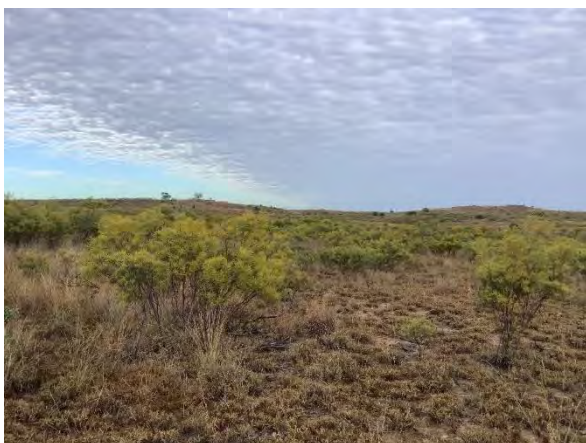
Figure 3-3 Extensive cleared areas, often with dense young regrowth *Acacia decora*

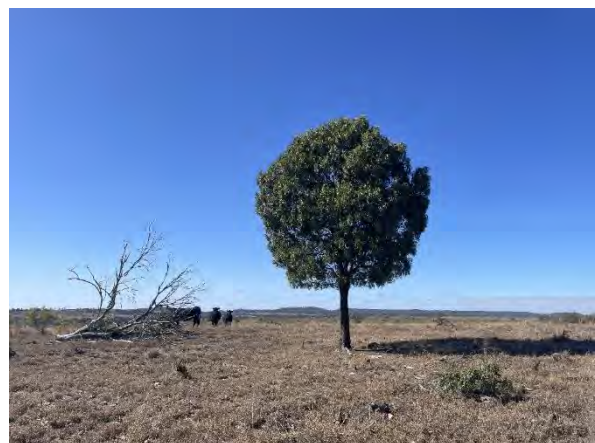
Figure 3-4 Cleared grazing land with sparse paddock trees

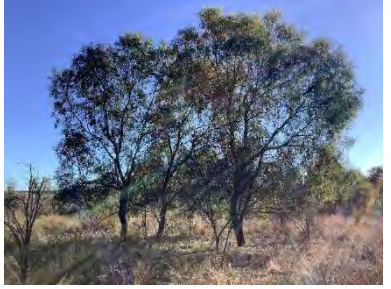
| Location (Desktop ID) | Area (sqm) | Species | DBH (cm) | Height (m) | Action | Photo |
|---|---|---|---|---|---|---|
| LE01-03 | 110.47 | <i>Acacia salicina</i> | 23 23 23.5 | 11.2 12 11 | Remove | |

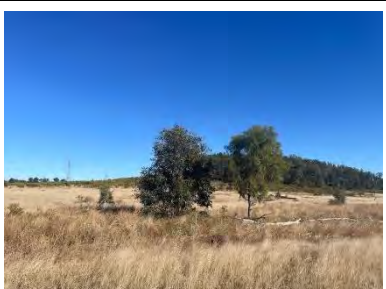
| Location (Desktop ID) | Area (sqm) | Species | DBH (cm) | Height (m) | Action | Photo |
|---|---|---|---|---|---|---|
| LE26-27 | 43.63 | <i>Acacia salicina</i> <i>Eucalyptus camaldulensis</i> | 13 15 | 5.6 5.8 | Remove | |

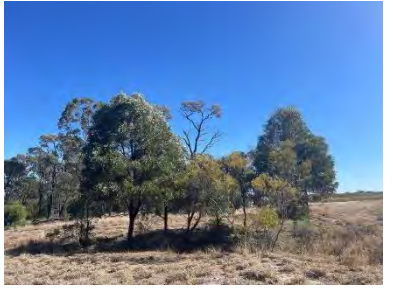
| Location (Desktop ID) | Area (sqm) | Species | DBH (cm) | Height (m) | Action | Photo |
|---|---|---|---|---|---|---|
| LE35 | 97.42 | <i>Acacia harpophylla</i> | 22 | 7.4 | Remove | |

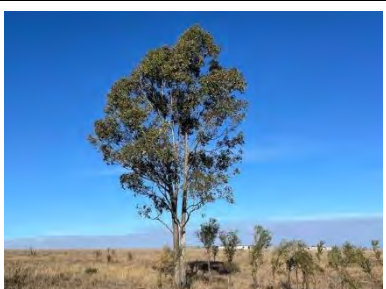
| Location (Desktop ID) | Area (sqm) | Species | DBH (cm) | Height (m) | Action | Photo |
|---|---|---|---|---|---|---|
| LE52 | 53.82 | <i>Eucalyptus populnea</i> | 25.5 | 13.4 | Remove | |

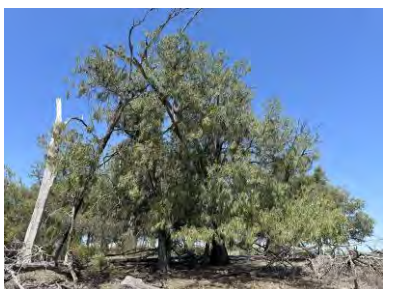
| Location (Desktop ID) | Area (sqm) | Species | DBH (cm) | Height (m) | Action | Photo |
|---|---|---|---|---|---|---|
| RR105 | 88.4 | <i>Geijera parviflora</i> | 33 | 8 | Remove | |

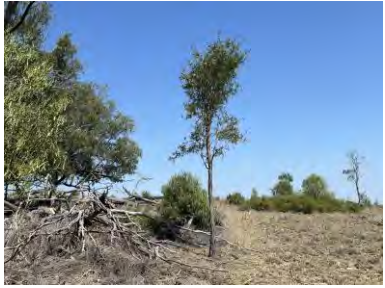
| Location (Desktop ID) | Area (sqm) | Species | DBH (cm) | Height (m) | Action | Photo |
|---|---|---|---|---|---|---|
| RR106 | 2.5 | <i>Acacia excelsa</i> | 10 | 5 | Remove | |

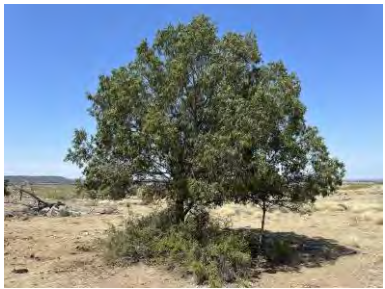
| Location (Desktop ID) | Area (sqm) | Species | DBH (cm) | Height (m) | Action | Photo |
|---|---|---|---|---|---|---|
| RR107 | 56.4 | <i>Geijera parviflora</i> | 34 | 7 | Remove | |

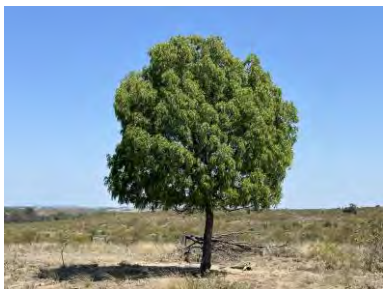
| Location (Desktop ID) | Area (sqm) | Species | DBH (cm) | Height (m) | Action | Photo |
|---|---|---|---|---|---|---|
| RR108 | 27.5 | <i>Owenia acidula</i> | 22 | 6 | Retain | |

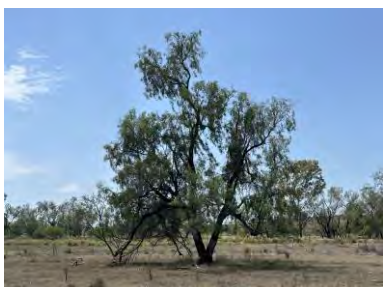
| Location (Desktop ID) | Area (sqm) | Species | DBH (cm) | Height (m) | Action | Photo |
|---|---|---|---|---|---|---|
| RR109 | 116.2 | <i>Acacia salicina</i> | 45 | 11 | Retain | |

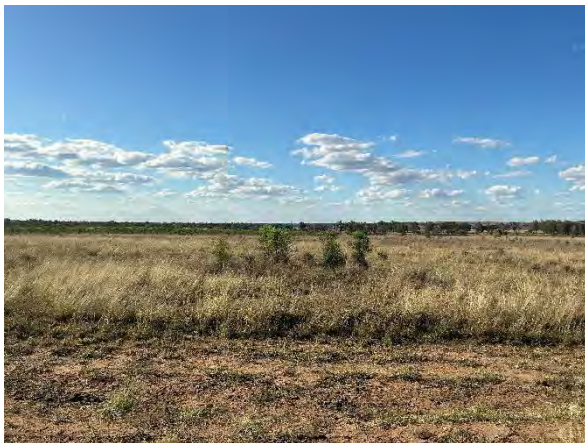
The landspray areas surveyed in September 2024 were characterised by cleared paddocks dominated by non-remnant pasture grasses (Figure 3-5 to Figure 3-7). The field surveys found the following in the landspray areas:

Figure 3-5 Landspray Area 1

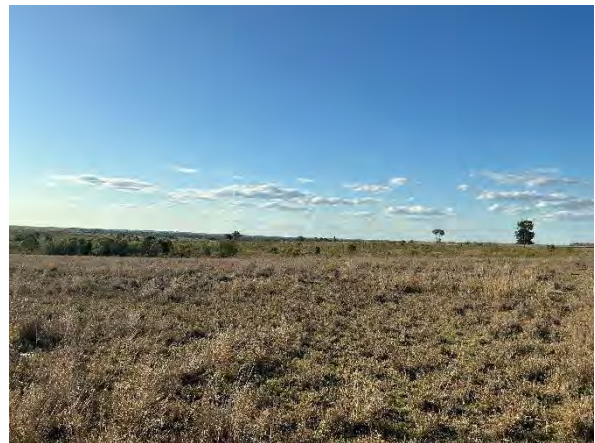
Figure 3-6 Landspray Area 2

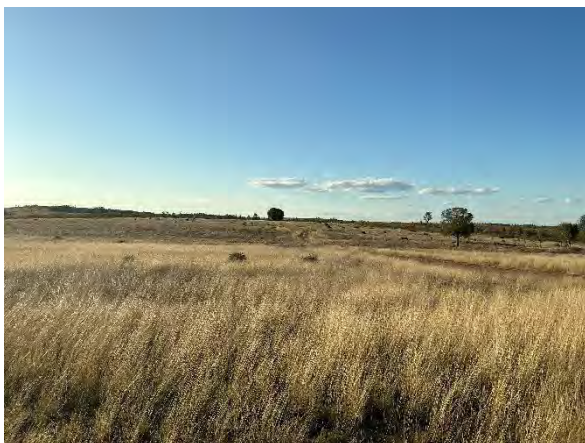
- Hairyflower Lovegrass (*Eragrostis trichphora*) is widespread across the Bellaringa property, however there is a high coverage of the exotic grass in landspray area 3. Several velvety tree pears (*Opuntia tomentosa*) were also noted within the landspray areas.

Figure 3-7 Landspray Area 3

The three landspray areas had minimal native trees, with only five koala habitat dispersal trees between 4 m – 7 m in height, being mapped. Area 3 was dominated by African lovegrass (*Eragrostis curvula*), which will need to be considered when using site for landspray to ensure the weed is not spread.

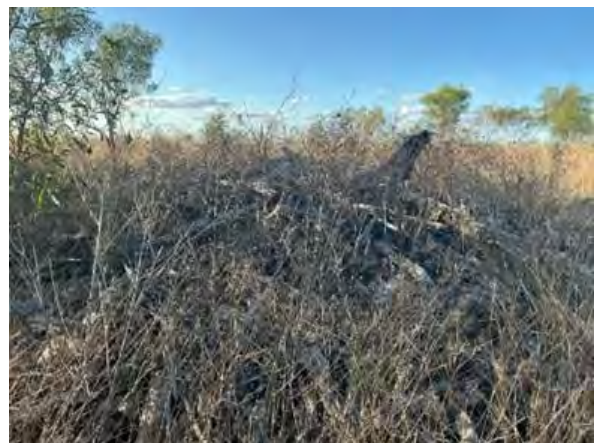
- No listed threatened flora were identified within the landspray areas or nearby mapped species habitat.
- One habitat feature was recorded in landspray area 2, a small log pile (Figure 3-8). This log pile will be avoided as landspray does not require clearing, works will be able to be undertaken around the habitat feature. No active searches were required within the disturbance footprint as no other searchable fauna habitat was present (mapped as constraints or identified during the survey).

Figure 3-8 Log pile in Landspray Area 2

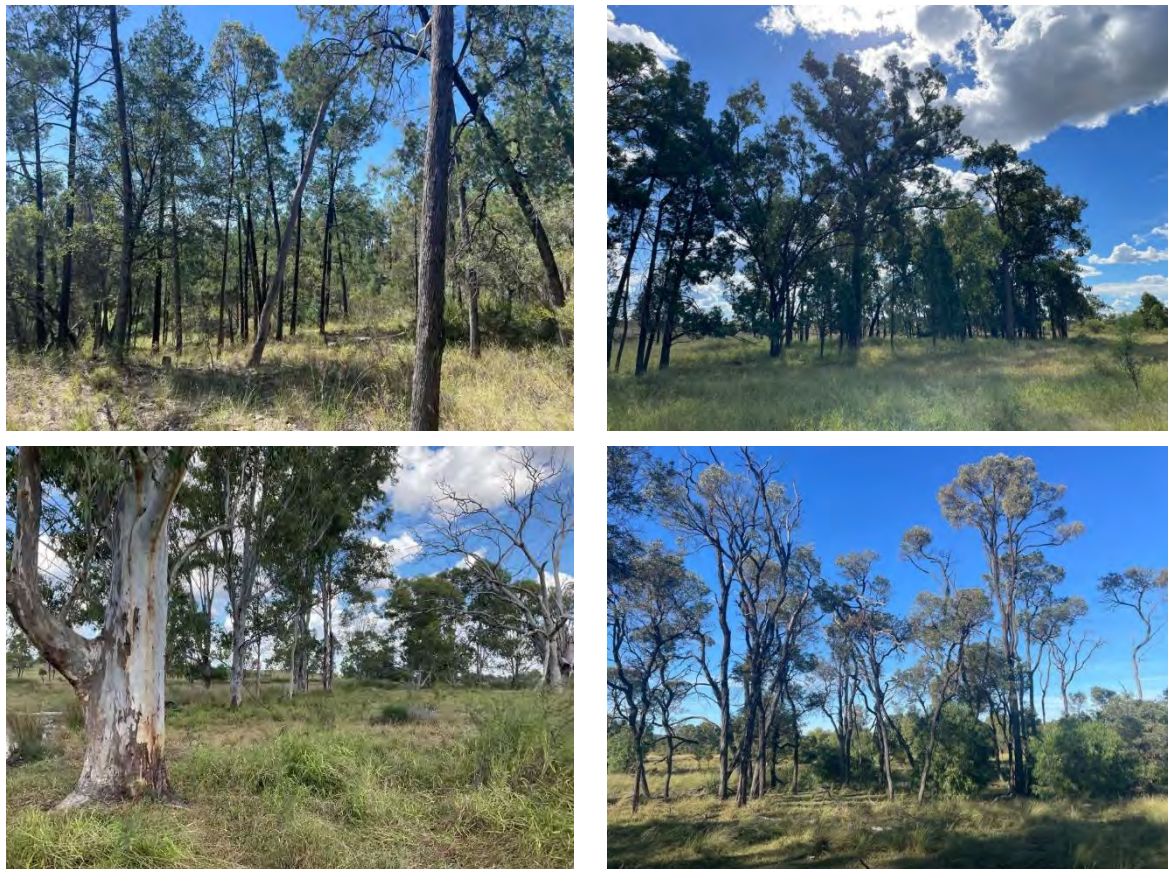
The surveys on the Bellaringa property found that the project impacts to koala dispersal habitat would be minimal, with a total of 0.32 ha (**3,173.2** m²) to be potentially cleared. This impact is across the approximately 92 ha disturbance footprint on the property, including well pads, gathering, workspaces and laydowns. The majority of the impact footprint is located within predominantly cleared agricultural areas and Senex has actively avoided patches of remnant and regrowth vegetation, as well as individual paddock trees, resulting in retaining at least 0.76 ha (or **7,563.9** m²) in close proximity to the alignment. In all cases, trees are retained within close proximity to those that are unable to be avoided, and the clearing of 0.32 ha is unlikely to have a significant effect on the ecological function of dispersal habitat on the property for koalas. Adjacent areas of dispersal habitat avoided are shown in Figure 4-1.

Figure 4-1 Example images of retained dispersal habitat adjacent to the disturbance footprint

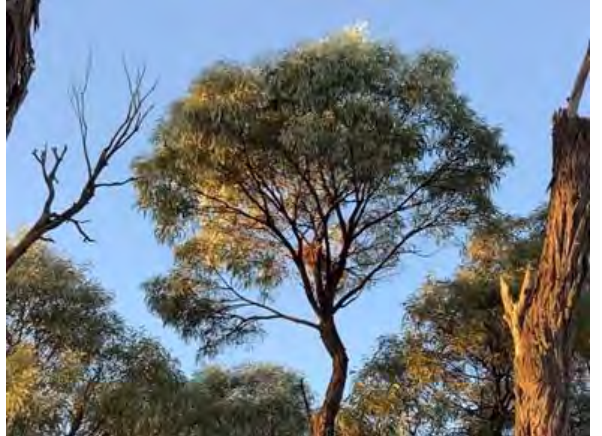
| Habitat type | Latitude, Longitude | Photo |
|---|---|--|
| Stick nest | -26.28701785, 149.8471746 | |

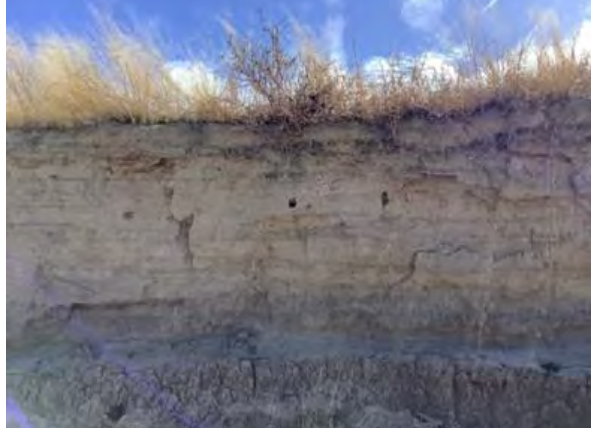
| Habitat type | Latitude, Longitude | Photo |
|---|---|--|
| Pardalote burrows in bank | -26.26478632, 149.8451892 | |

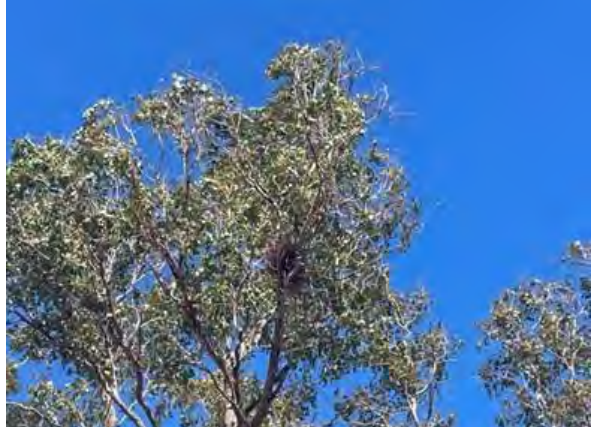
| Habitat type | Latitude, Longitude | Photo |
|---|---|--|
| Stick nest | -26.27081501, 149.8429162 | |
