## **ATLAS Stage 3 – ATLAS Pre-clearance Survey Report Glenhaven Wells and Gathering**

**Prepared for:**  
**Senex**

**Report issued:**  
**May 2025**

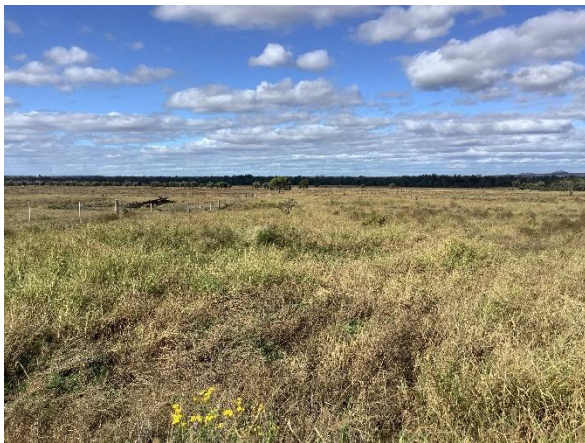
The Glenhaven property has been historically cleared for cattle grazing and is dominated by cleared pasture lands with some native species but mainly introduced pasture grasses, with scattered small patches of remnant and regrowth woodlands. A corridor of remnant vegetation consists along Wandoan Creek that runs throughout the property consisting of poplar box (*Eucalyptus populnea*), forest red gum (*Eucalyptus tereticornis*) and some patches of Brigalow (*Acacia harpophylla*). Individual and small patches of paddock trees of various ages and species were also scattered across cleared pastures along with areas where some vegetation have been pelleted (Figure 3-1 to Figure 3-4).

Figure 3-1 Non remnant pasture grass paddocks

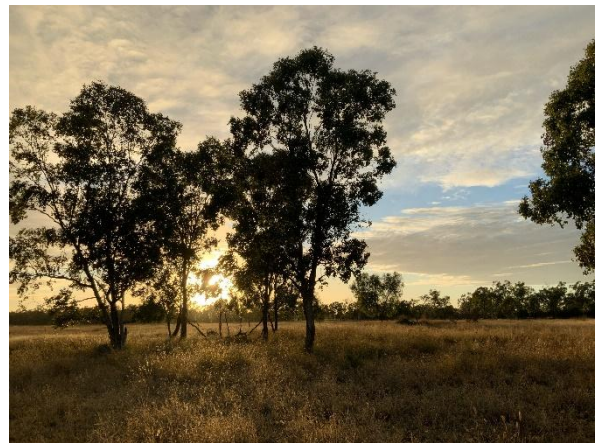
Figure 3-2 Scattered paddock trees

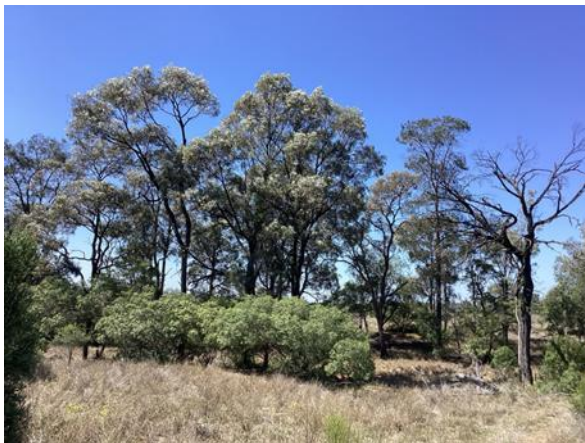
Figure 3-3 Brigalow patch to be under-bored to avoid impact to constraints mapped area

Where mapped constraint areas occurred within the disturbance footprint or 30 m buffer, these were assessed in the field to ensure they aligned with the mapping. A patch of vegetation near the 30 m buffer was reassessed to RE11.9.5 from 11.3.1. There are not enough alluvial influences at this patch as it is a drainage line through landzone 9. This does not have any implications for the project since any impacts have been avoided through re-alignment of the gathering lines. The survey also confirmed that the proposed disturbance areas do not impact on any listed TECs.

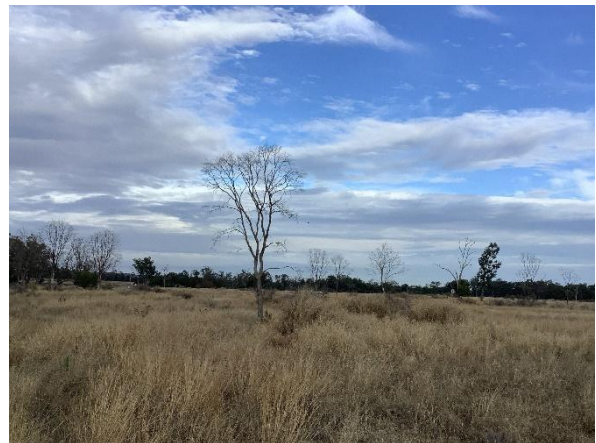
Figure 3-4 Patch of dead trees, likely pelleted

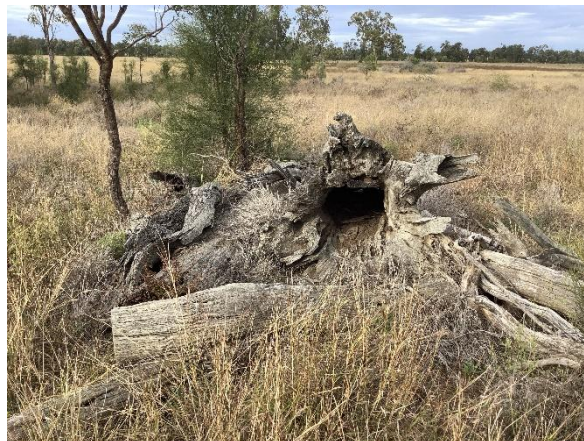
Active searches were not required within the disturbance footprint as no searchable fauna habitat was present (Either mapped as constraints or identified during the survey). One habitat feature (other than the koala dispersal trees) was recorded during the surveys, a log pile located at -26.185139, 149.806963, however no fauna were detected (Figure 3-5).

Figure 3-5 Log pile

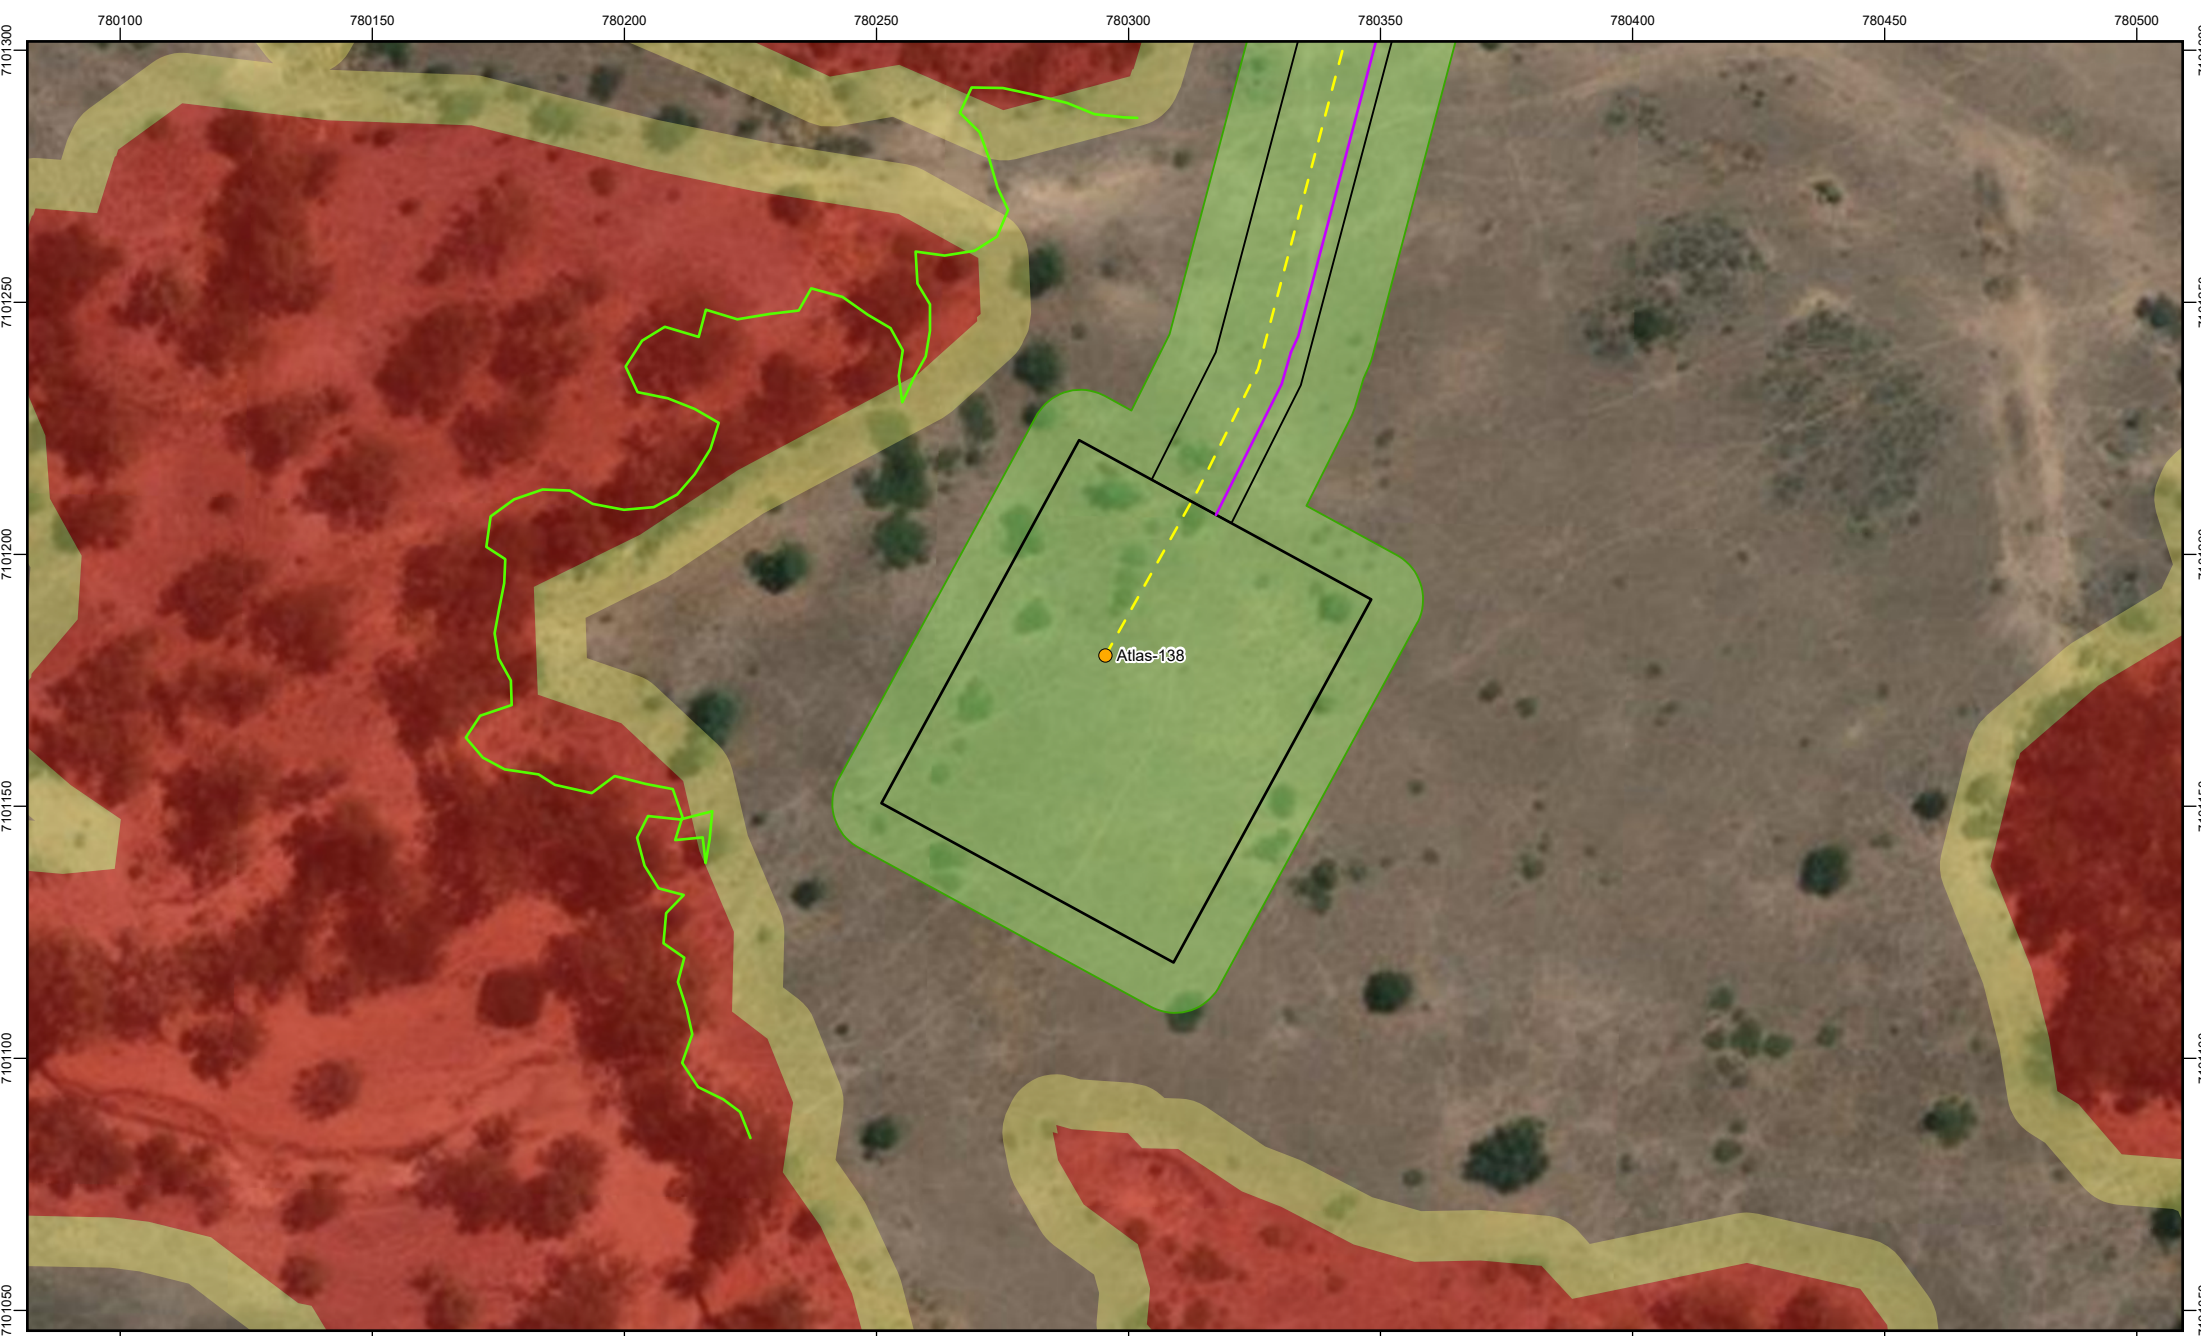
**Figure 3-13:**  
Glenhaven Plant Surveys

Potentially occurring threatened species in the area as per the ECPPFD are Belson's panic (*Homopholis belsonii*), red soil woolly wrinklewort (*Rutidosia lanata*) and winged nightshade (*Solanum stenopterum*). Random meanders walked in the constraint areas are shown in Figure 3-12 to Figure 3-15.

No Belson's panic (*Homopholis belsonii*), red soil woolly wrinklewort (*Rutidosia lanata*) and winged nightshade (*Solanum stenopterum*) were identified within the areas mapped as constraints for these species during targeted threatened flora surveys (Figure 3-13 to Figure 3-17). The disturbance footprint is impacted by grazing and hence these threatened species are not expected to be present within the footprint. Some areas outside of the footprint but within the 30m buffer meet the remnant status and are in better condition than the surrounding non-remnant areas, but these areas also did not contain any of the listed threatened flora species.

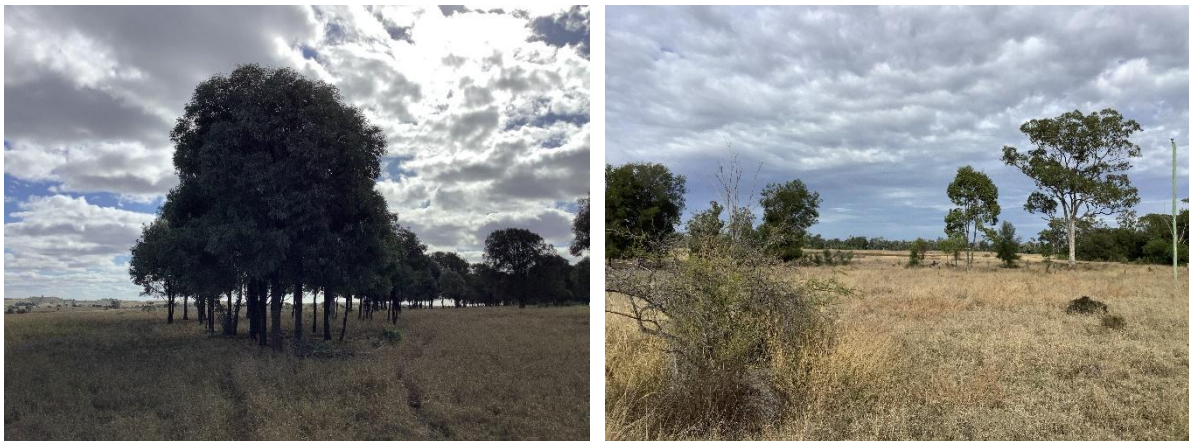
The surveys on the “Glenhaven” property found that the project impacts to koala dispersal habitat would be minimal, with a total of 0.11 ha (1161.25 m<sup>2</sup>) to be potentially cleared. Most of the impact footprint is located within predominantly cleared agricultural areas and Senex has actively avoided patches of remnant and regrowth vegetation, as well as individual paddock trees, resulting in retaining 0.06 ha (or 555.09 m<sup>2</sup>) of koala dispersal habitat. In all cases, trees are retained within proximity to those that are unable to be avoided and the clearing of 0.11 ha is unlikely to have a significant effect on the ecological function of dispersal habitat on the property for koalas. Adjacent areas of dispersal habitat avoided are shown in Figure 8-1.

Figure 8-1 Examples of adjacent vegetation avoided by disturbance footprint

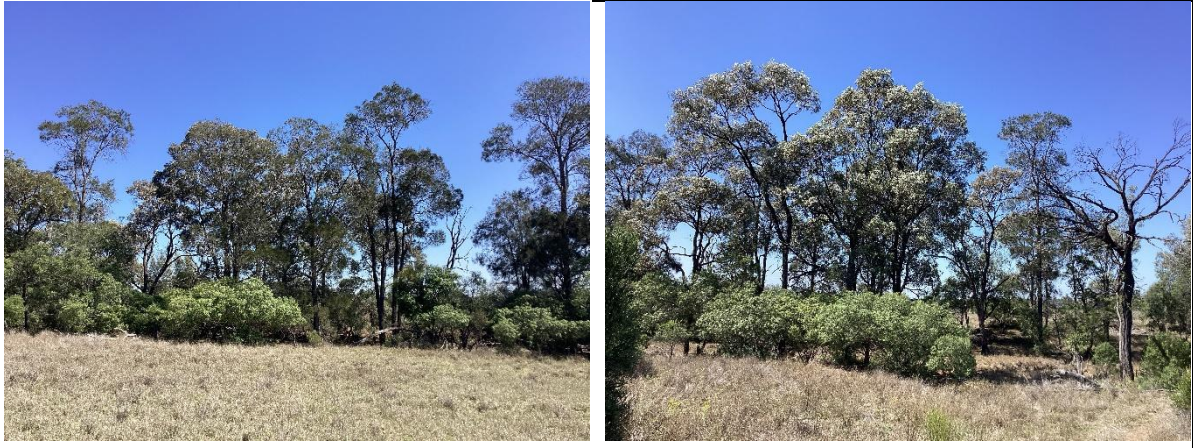
*Figure 8-2 – Vegetation to be under-bored*

Threatened flora searches found no threatened species within or in proximity to the impact footprint. No threatened flora were encountered during the survey and no TECs are present within the disturbance footprint or within 30m of the disturbance footprint. During surveys weed species were found on the property including *Harrisia* cactus (*Harrisia martini*), Mexican poppy (*Agremone ochroleuca*) and *Opuntia* spp. No remnant or HVR regulated vegetation, potential threatened fauna habitat or environmentally sensitive areas (ESAs) are present within the disturbance footprint, other than where an under-bore will be carried out shown in Figure 8-2. Access from Weldons Road shows no impact to surrounding vegetation on road reserves as per Figure 8-3.

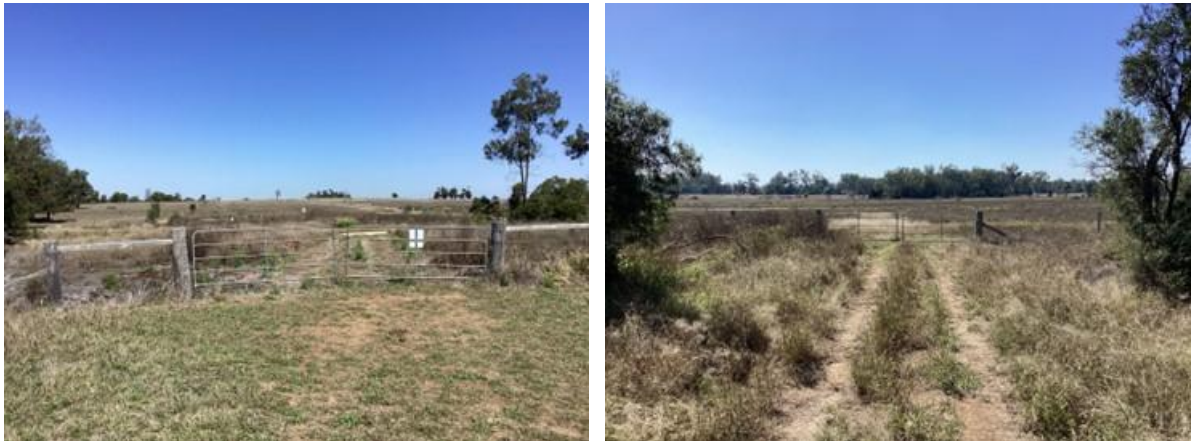
*Figure 8-3 – Entrances from Weldons Road*
