ATLAS Stage 3 – EPBC Pre-clearance Survey Report – Pecos Valley Access Track

Prepared for: Senex Report issued: May 2025

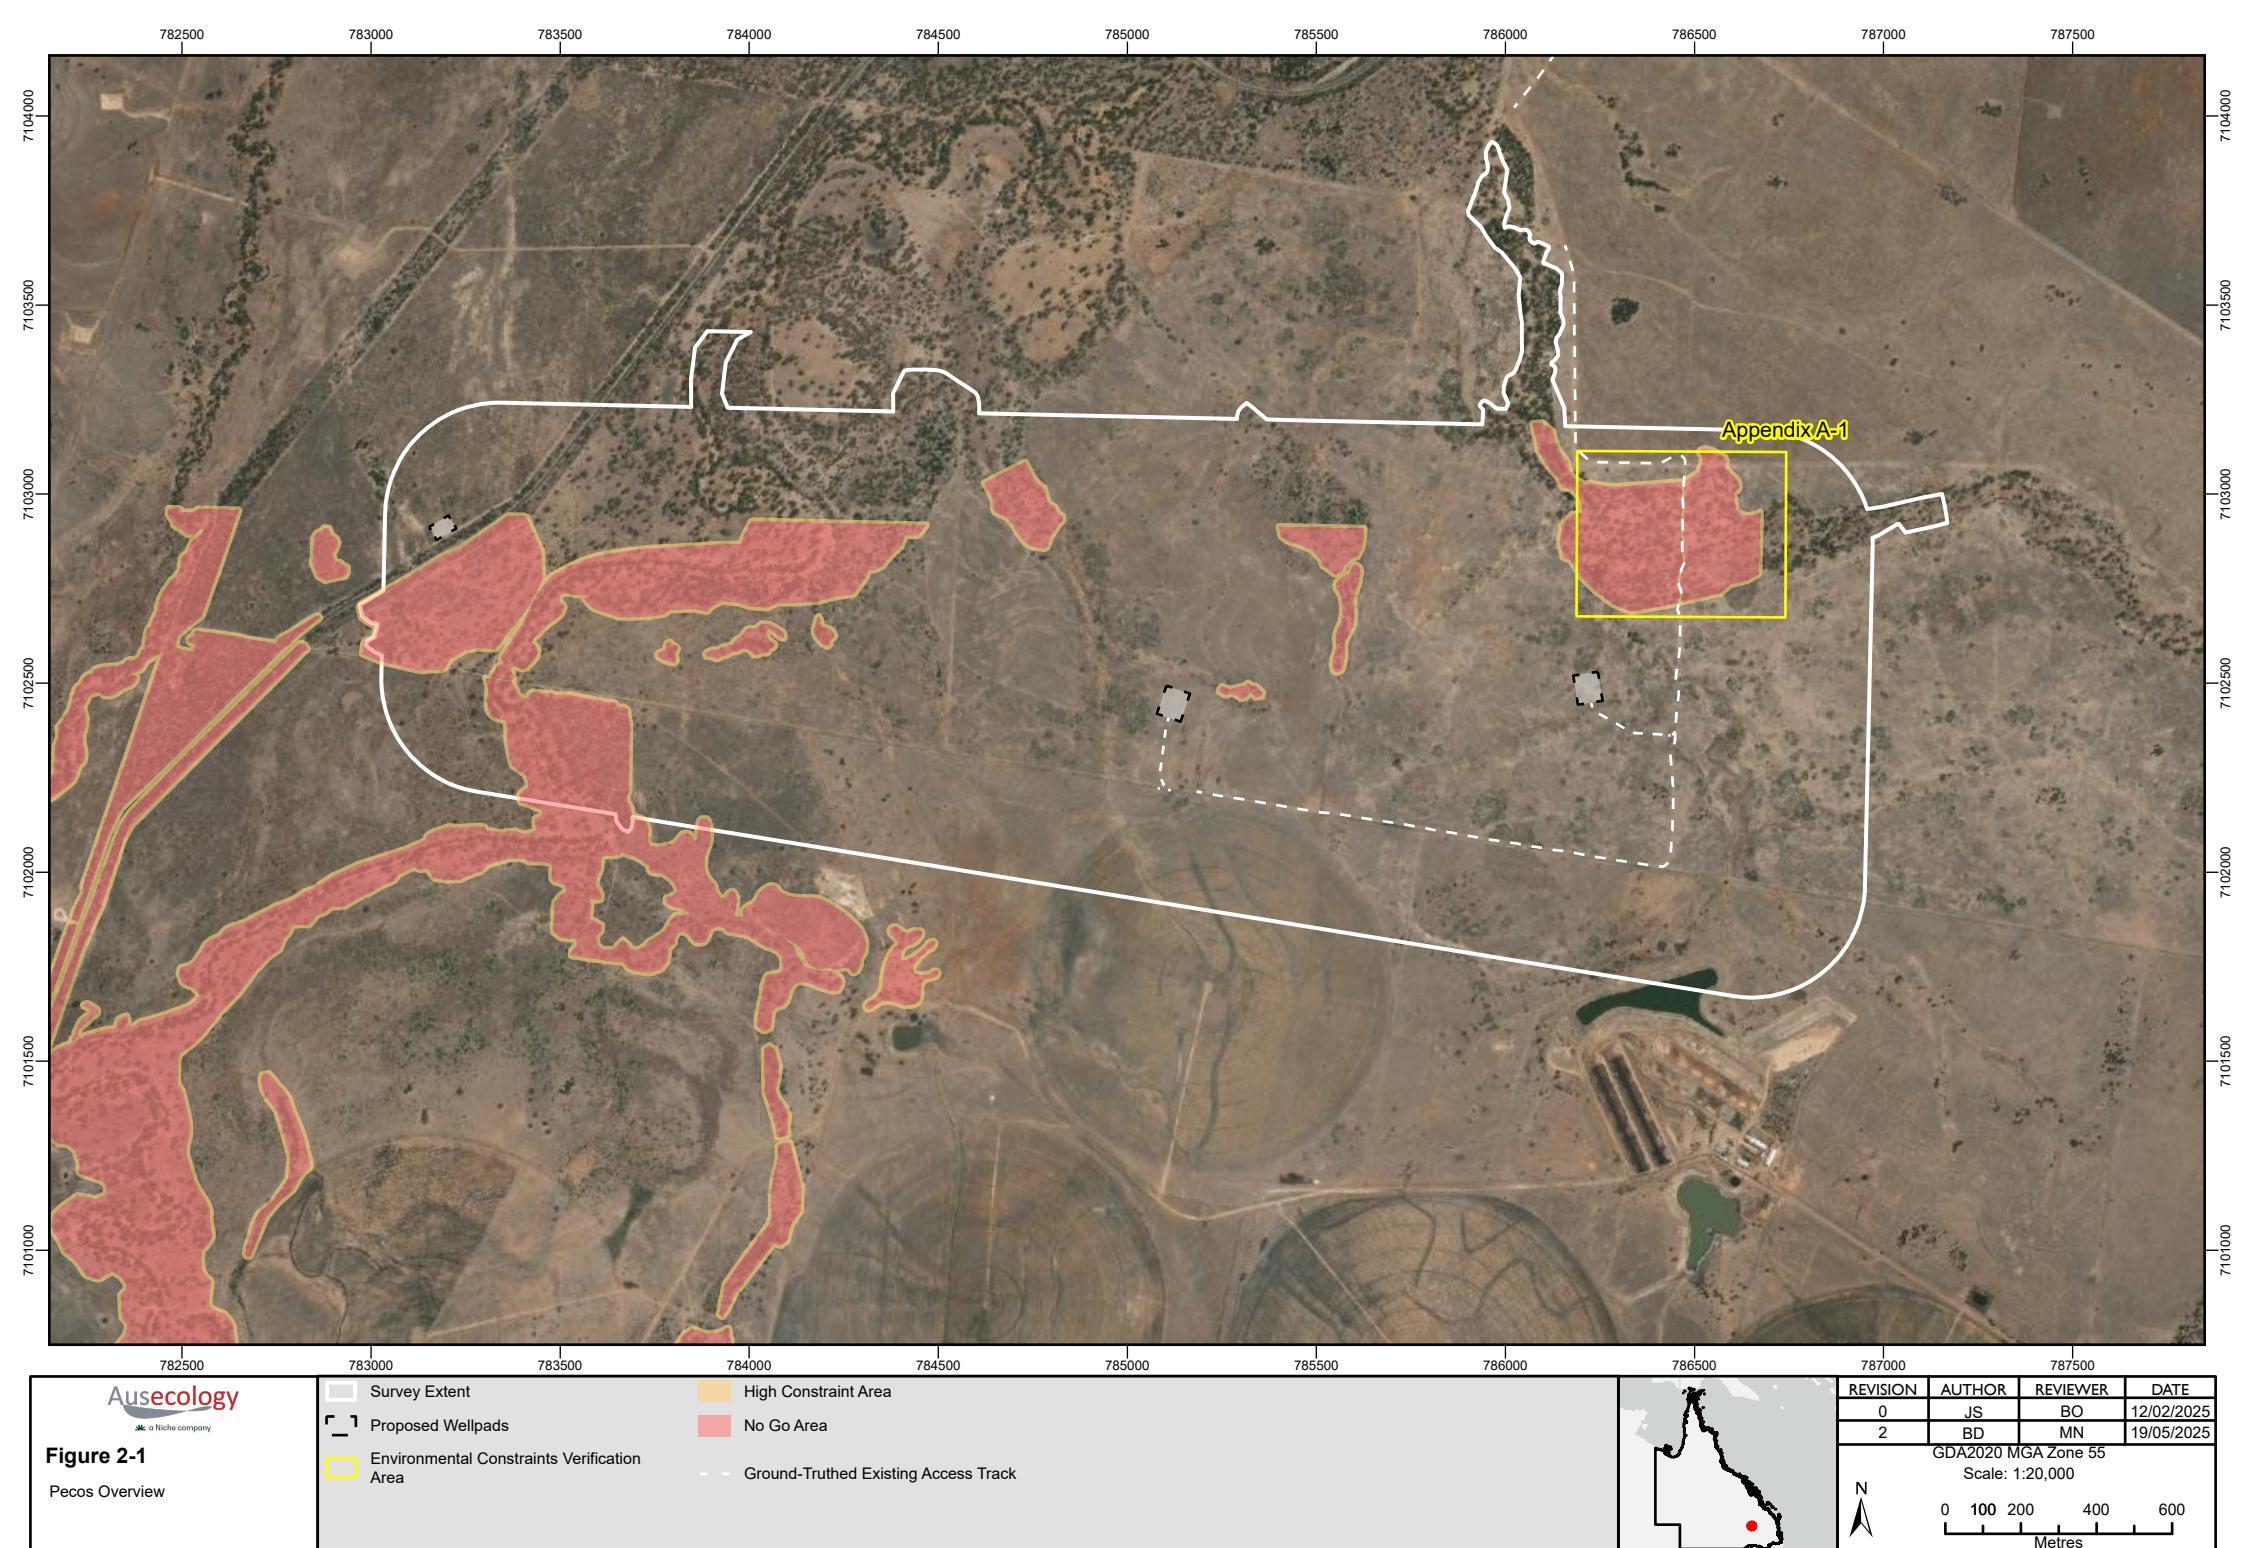
An Ausecology Senior ecologist (suitably qualified) and ecologist conducted field constraint surveys on foot on the 21st of January 2025 to determine potential impacts of upgrading an existing landholder access track on the Pecos Valley property as shown in Figure 2-1.

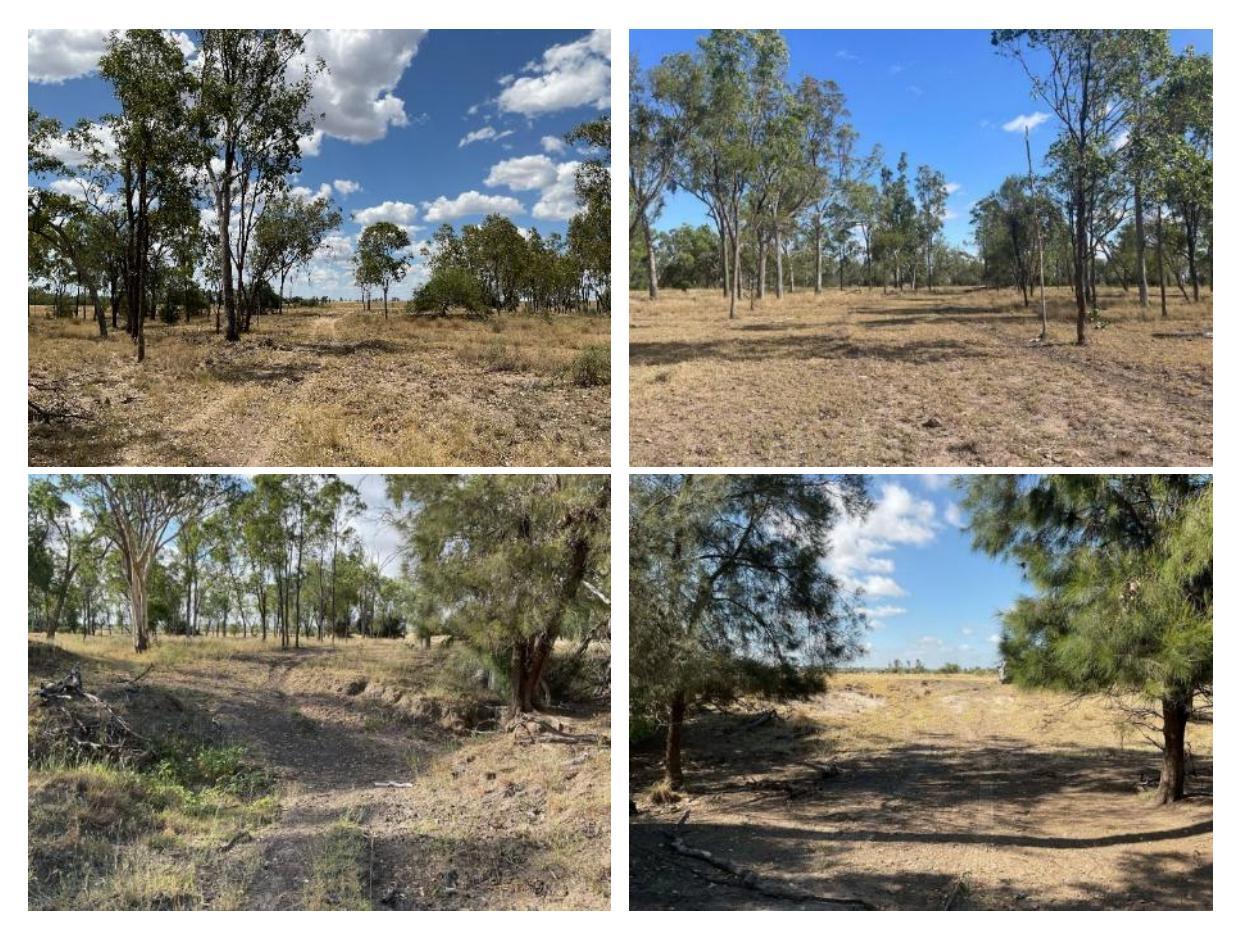
Figure 3-1 Example images along access track

The complete survey area was checked and it was noted that the existing landholder access track runs through a patch of remnant Poplar box (*Eucalyptus populnea*) woodland on alluvial plains (RE 11.3.2) which was also confirmed as Poplar Box Grassy Woodland on Alluvial Plains TEC. Ausecology recorded the maximum width of the existing track using a sub-10 cm accuracy handheld Trimble GPS unit to record a high accuracy vegetation boundary (Appendix A).

At its narrowest point the track is a minimum of seven meters wide between trees and as discussed with Senex, they will be able to utilise the existing track without clearing any vegetation. There was no other vegetation found outside of this section.

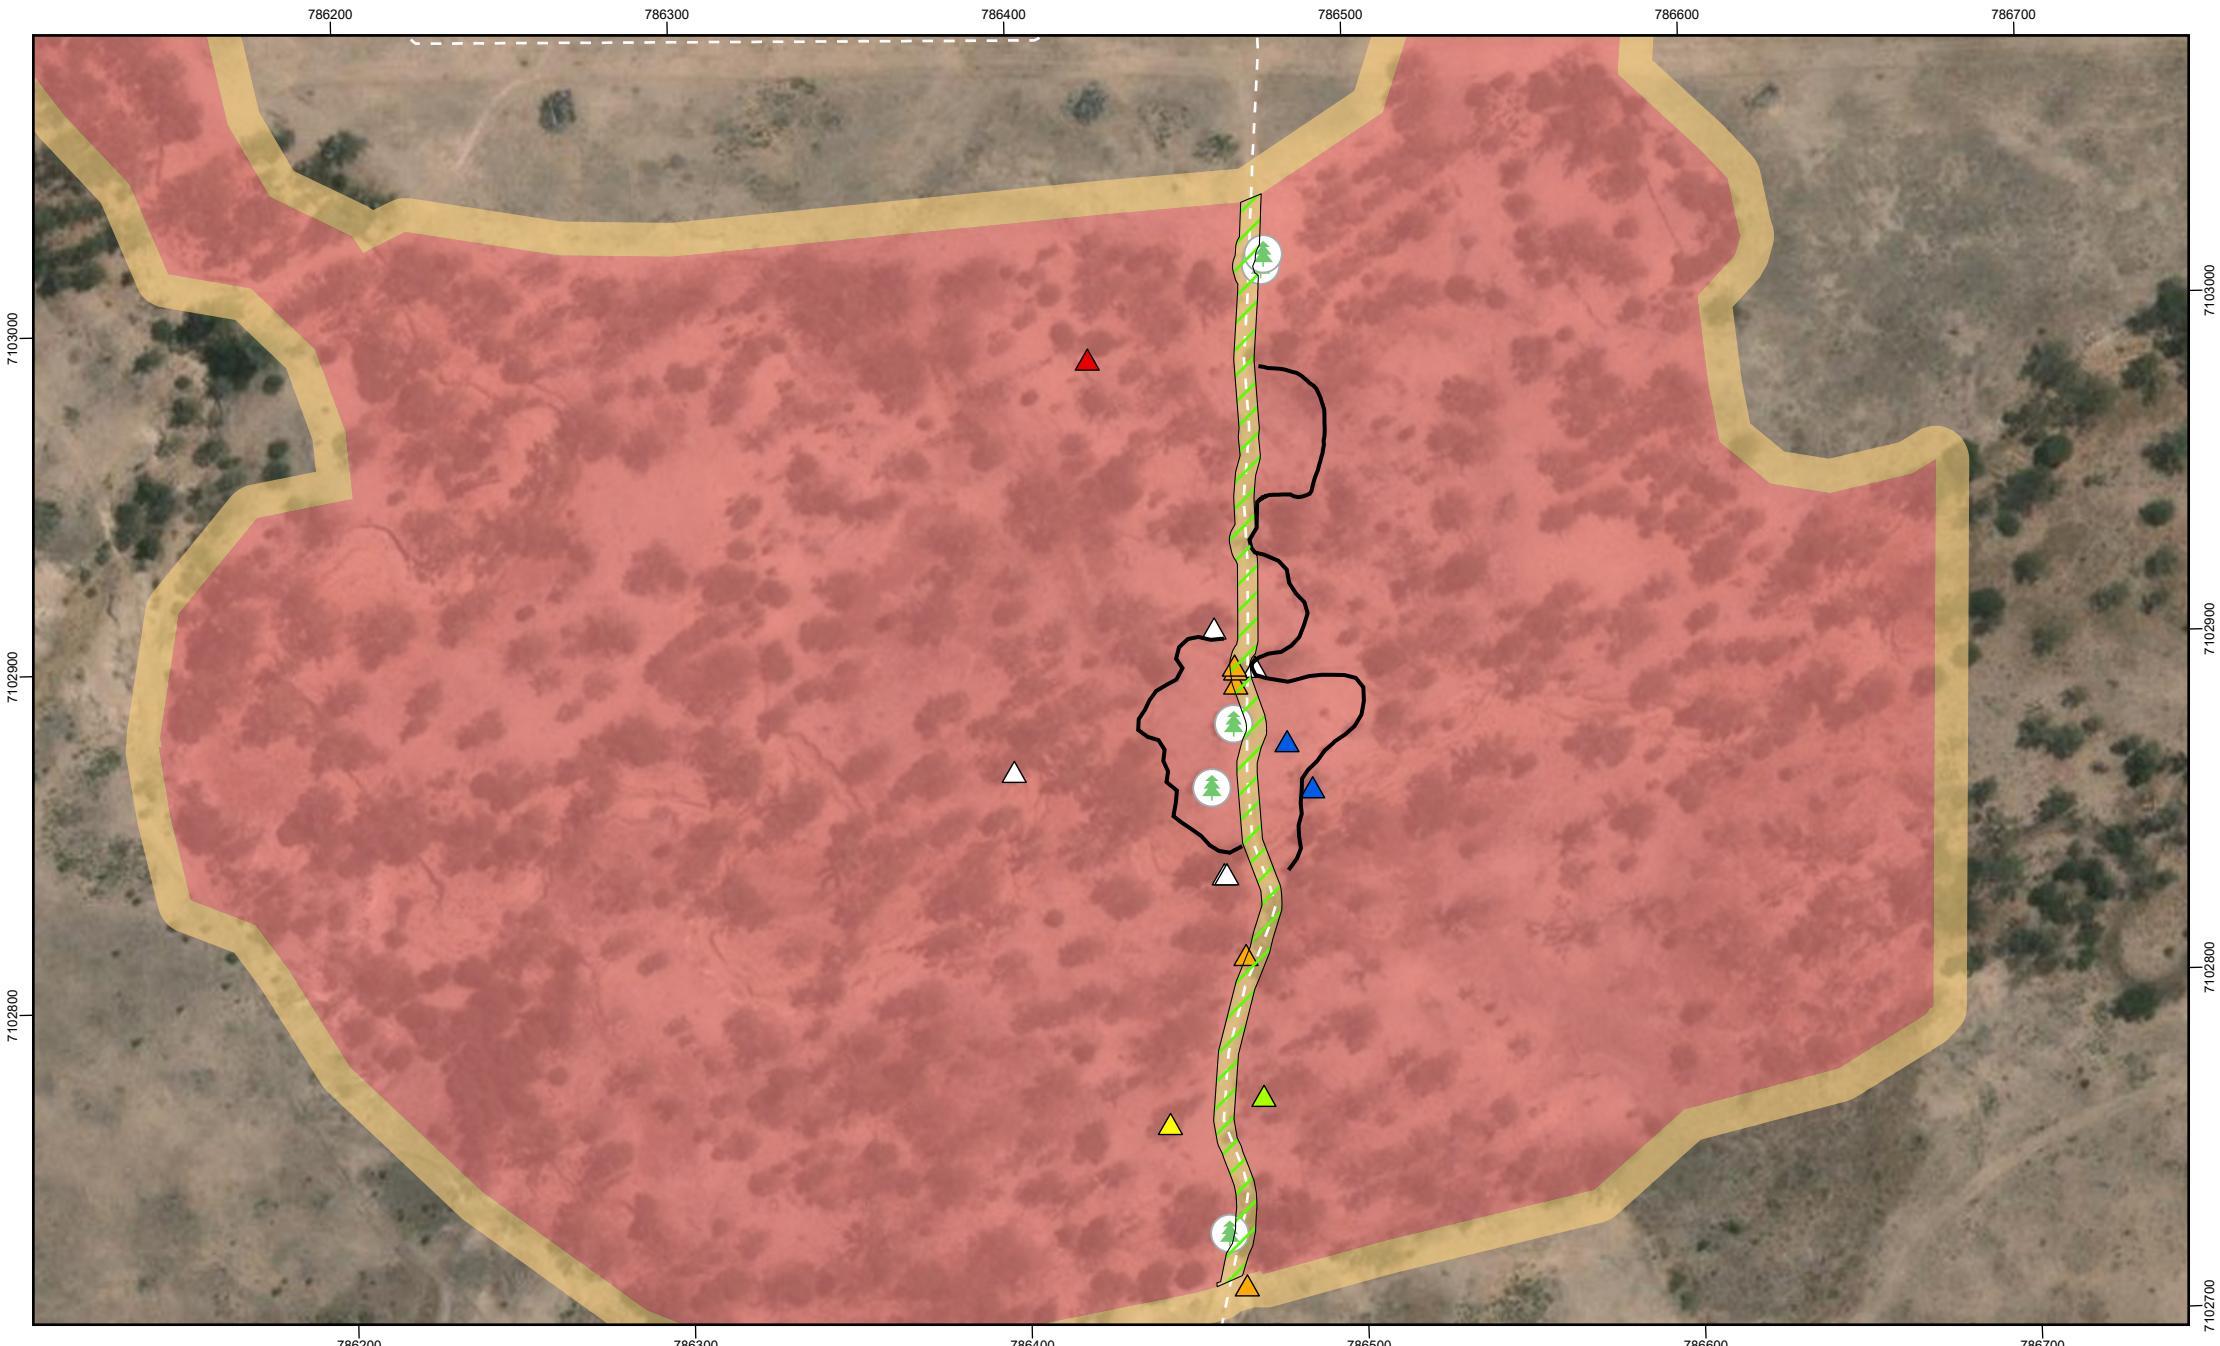
Appendix A – Mapping

Table 3-1 provides the results including canopy cover, height and DBH of the trees assessed in the field in koala dispersal areas. All trees were assessed and, where determined they could be avoided (through underground boring or realignment), have been marked up as "retain" and will be avoided during construction. Trees unable to be avoided have had their canopy cover assessed and calculated under disturbance limits. Mapping of nearby vegetation within the 30m buffer of access track can be found in Appendix A.
